STEP 1: DETERMINATION OF SIGNIFICANCE
STAFF REPORT

Site: 36 Munroe Street

Case: HP23-000010

HPC Meeting Date: April 2, 2024

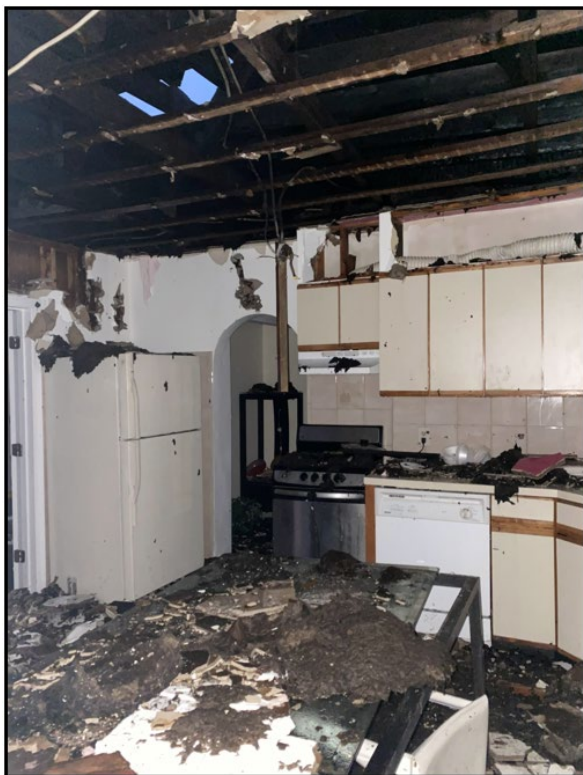
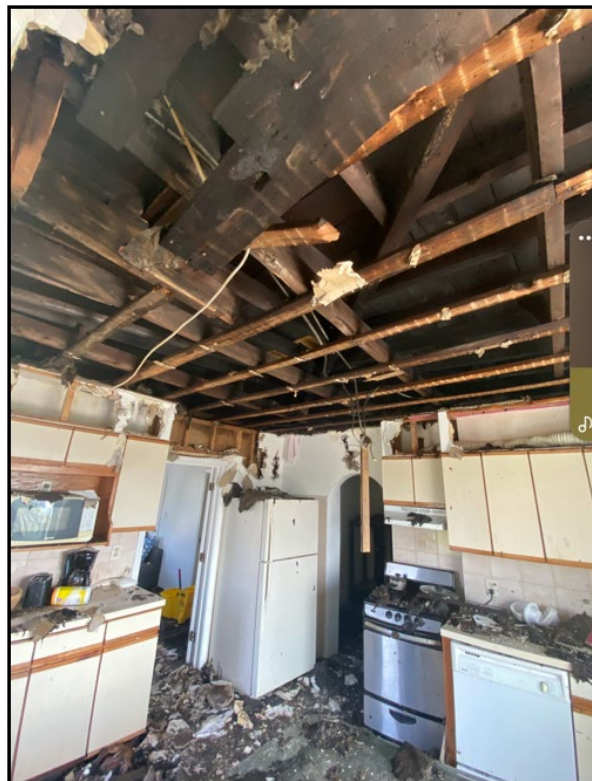
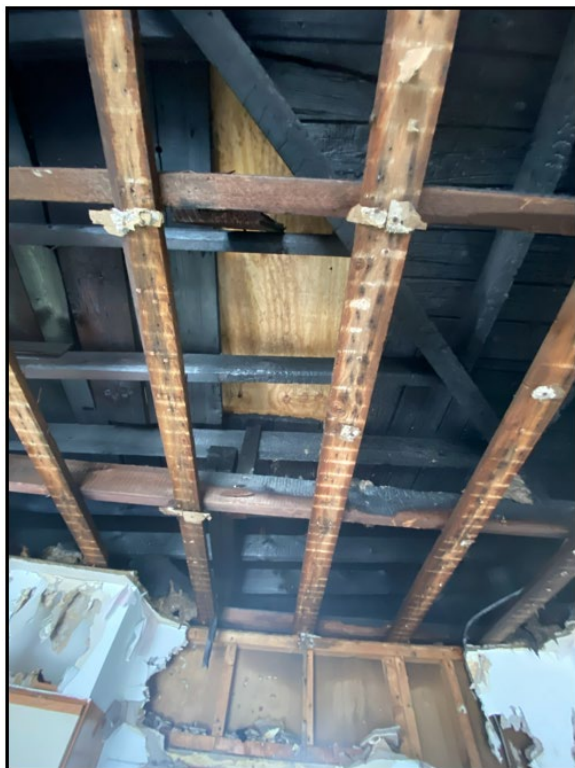
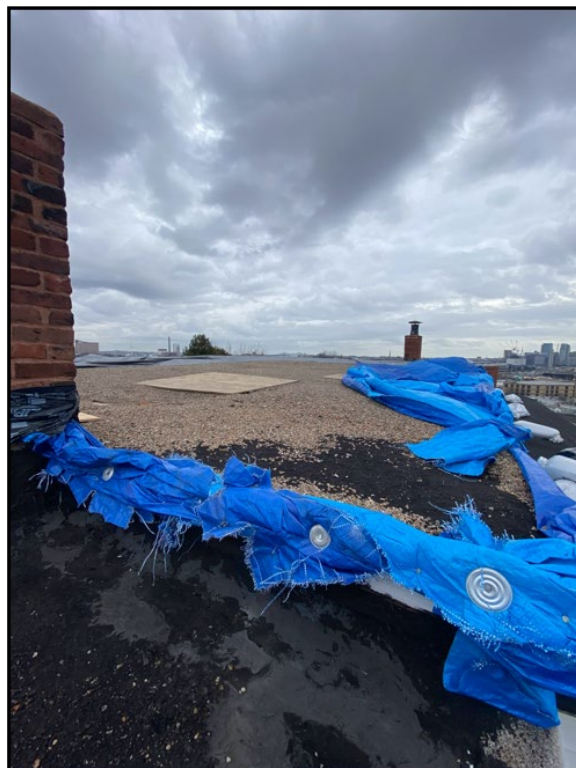
The Applicant stated the property was hit by lightning and subsequently doused by storm water and Firehose water on Aug 23, 2020. Since then, the property has stood boarded up and vacant with all utilities cut. The Applicant stated that there are two large holes in the roof which have been leaking over the last three years. The Applicant further claims that the water and fire damage caused significant mold growth, which further compromised the structure of the property and that they believe it unsafe to work on and that a full demolition would be the safer option. The photos below depict the current state of the interior.
