STEP 1: DETERMINATION OF SIGNIFICANCE
STAFF REPORT

Site: 33 Vinal Avenue

Case: HP24-000045

Legal Ad: *The Applicant seeks to demolish a principal structure constructed a minimum of 75 years ago.*

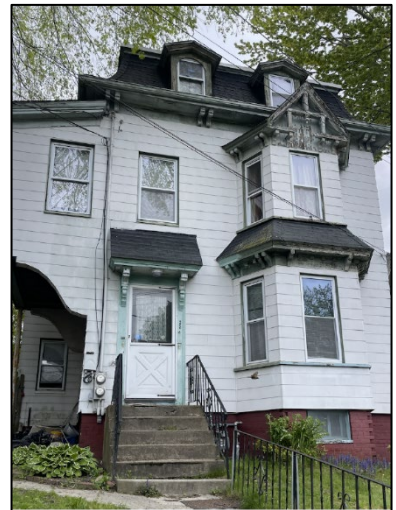
Top: Front elevation

- Front Elevation

- The front elevation presents an asphalt-shingled mansard roof with a bracketed eave.

- There is a two story projecting polygonal bay with bracketed eaves on the first story and a trussed gable roof on the second story.
 - Asphalt-shingled door hood over front entry door.

- A set of concrete steps leading to the front entrance.
 - The first story bay presents three (3) one-over-one double hung windows; the second story bay presents three (3) one-over-one double hung windows and there are also two (2) other one-over-one double-hung window on the second story; the third attic story presents two (2) one-over-one double hung dormer windows.

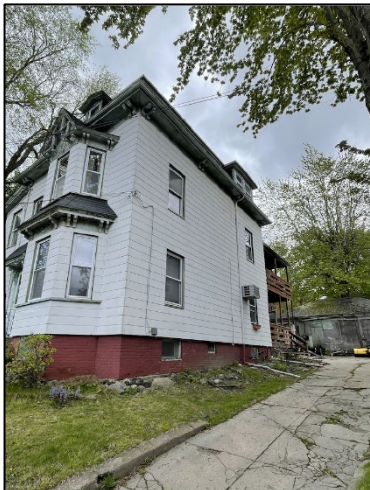
Bottom, left: Right elevation

- Right Elevation
- The front massing presents an asphalt-shingled mansard roof with a bracketed eave and a double-wide two-window dormer; the rear massing presents a shallow sloped asphalt roof overhanging two stories of wooden exterior porch.

- The front massing fenestration presents two (2) one-over-one double hung windows on the first story, two (2) one-over-one double hung windows on the second story, and a double-wide dormer with two (2) one-over-one double hung windows on the third attic story.

- The rear massing fenestration presents two (2) one-over-one double hung windows on the first story and two (2) one-over-one double hung windows on the second story.

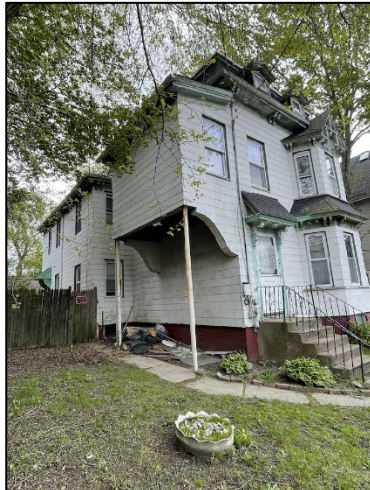
Bottom, middle: Left elevation

- Left Elevation
- The front massing has projecting addition on the second story with an asphalt-shingle shed roof, added sometime after the mid-20th century; the front massing also presents a asphalt-shingled mansard roof.

- Slightly overhung eave on the second story projecting addition.
 - The rear massing presents a shallow sloped asphalt roof with a bracketed eave.
 - The rear massing also has a rear egress with a door hood.

- Fenestration of the front massing includes no windows on the second story projecting addition.
 - Fenestration of the rear massing presents two (2) one-over-one double-hung windows on the first story and three (3) one-over-one double hung windows on the second story.

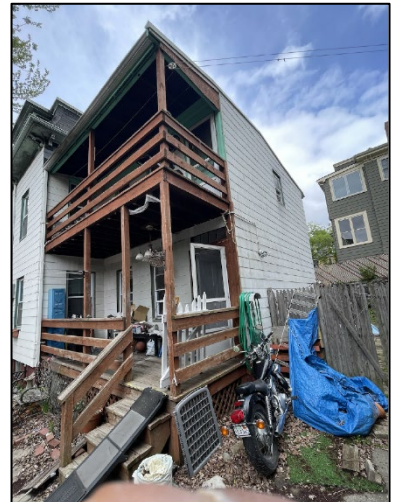
Bottom, right: Rear elevation

- Rear Elevation
- The rear elevation presents a shallow-pitched gable with no eave.
 - Fenestration includes one rear window.

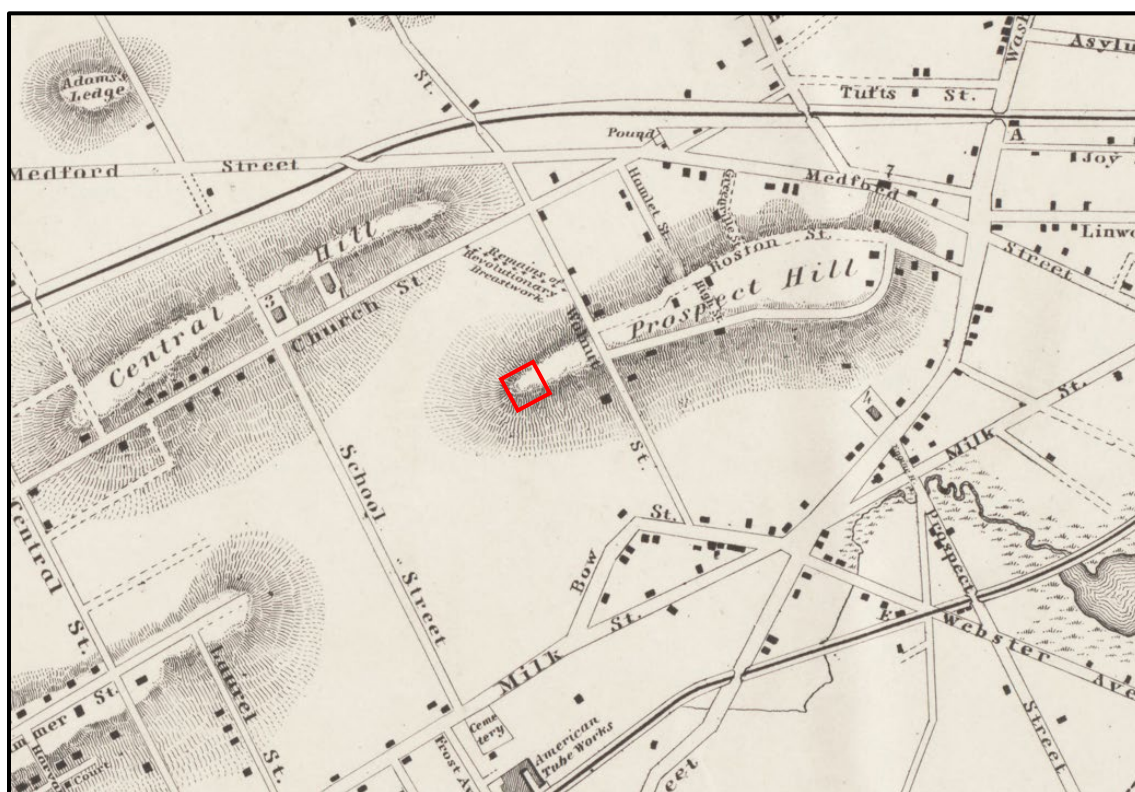
The 1852 Draper map below shows the approximate location of 33 Vinal Avenue at the western foot of Prospect Hill, which by mid-19th century had become a desirable location for the construction of businessmen's homes, but was otherwise sparsely occupied.

Above: 1852 Draper Map with the approximate location of 33 Vinal Avenue indicated.

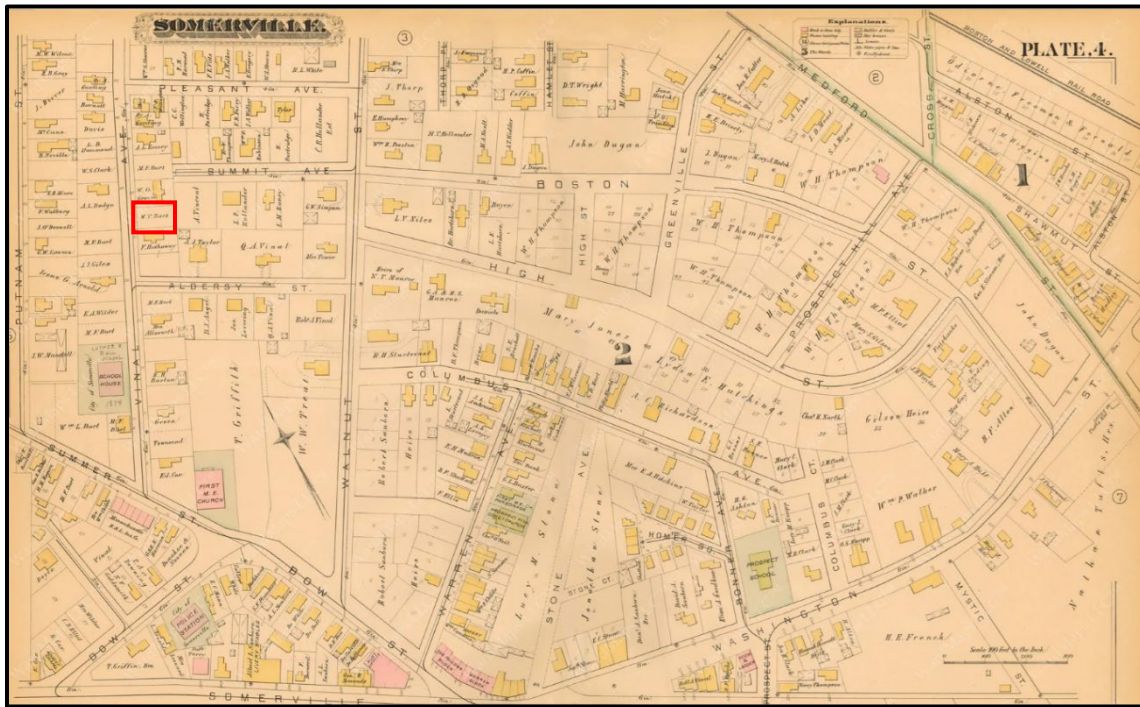
Above: 1884 Hopkins Map, Plate 4, with the location of 33 Vinal Avenue indicated.

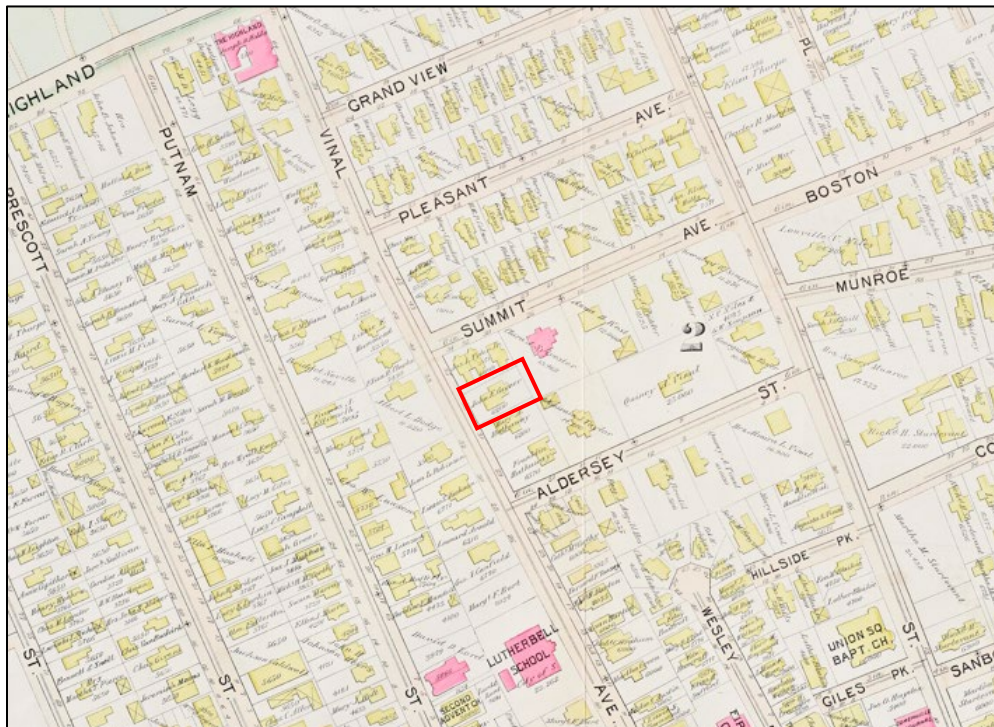
Above: 1895 Bromley Map, Plate 1, with the location of 33 Vinal Avenue indicated.

Figure 1: 1895 Bromley Map

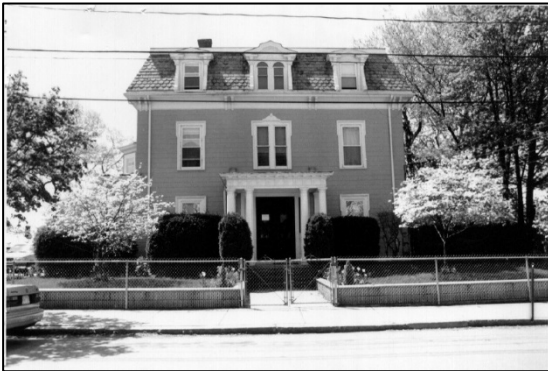
16-18 Summit Avenue – Edward N. Jackman House

When the house at 33 Vinal Street was constructed between 1884 and 1895—during Somerville's period of most rapid residential growth—it was also built in the Second Empire style to mimic those nearby houses of prominent citizens (for example, the Edward N. Jackman House and the Adoniram Taylor House).

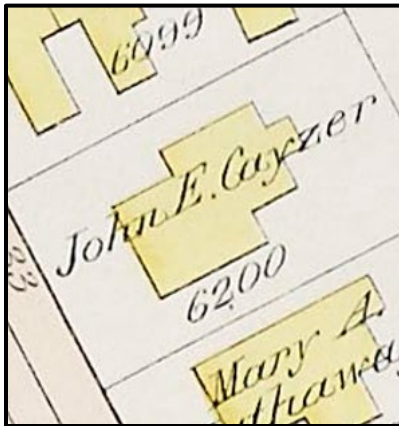
Fig 1

- Shows the original footprint of the structure.
- Mansard roof and 2.3 story front massing; shallow gable roof and 2 story rear massing

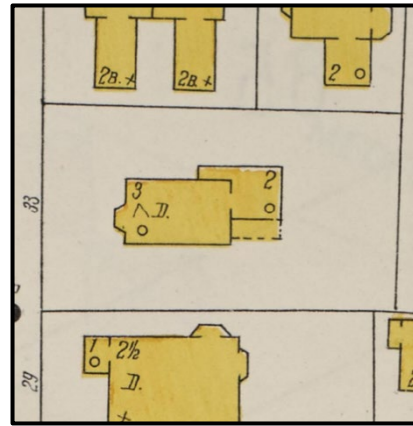
Fig 2

Figure 2: 1900 Sanborn Map

- Removal of a small massing at the rear of the property, possibly a rear entry foyer.
- Possible addition of a two-story projecting polygonal bay with a gable hood (unclear if this was part of the original footprint).

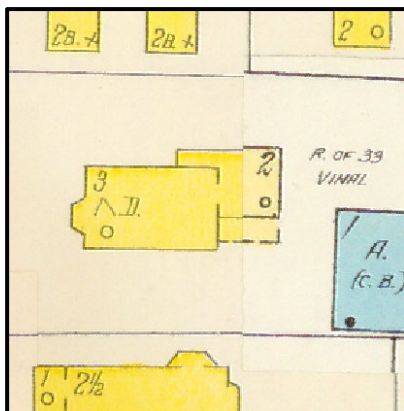
Fig 3

Figure 3: 1925 Sanborn Map,

- Shows the same footprint.
- Addition of a rear concrete block garage at the rear.

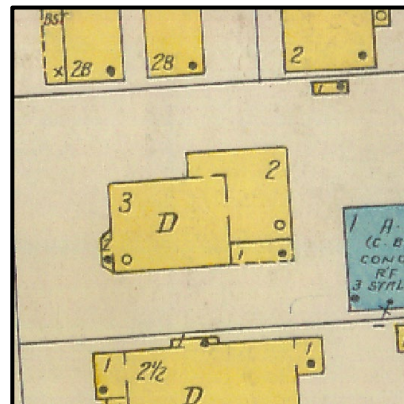
Fig 4

Figure 4: 1938 – 1959 Sanborn Map

- The porch at the right rear of the property appear to have expanded to meet the width of the front massing.

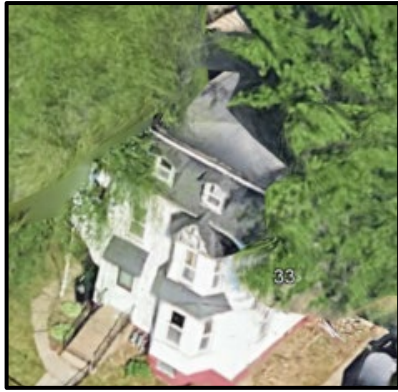
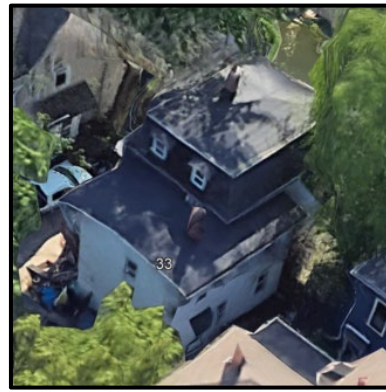
Figures 5 & 6: Satellite image of the property

- Addition: second story massing on the left front of the structure with a slanted shed roof.
- Addition: small hood roof over the front door.

Alterations: In addition to the changes in materials as noted in the Materials section above, the structure has seen an expansion of the rear porch and the addition of a second story projecting massing on the left side.
