**STEP 1: DETERMINATION OF SIGNIFICANCE**  
**STAFF REPORT**

**Site:** 33 Cedar Street

**Case:** HP24-000061

**Legal Ad:** *The Applicant seeks to demolish a principal structure 100 years ago.*

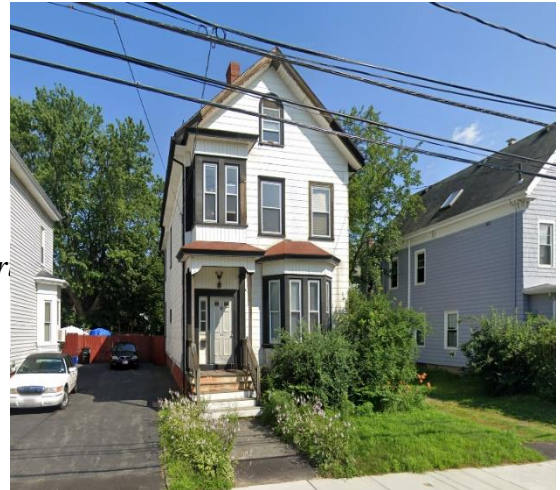
*Top: Front elevation*

- Front Elevation
    - Gable roof with deep eave
    - First floor: On the left of the front façade: covered stoop with main entry door flanked on its left by side lites. On the right of the front façade: one-story polygonal bay window on the.

- Second floor: Two evenly spaced window openings, and flat roofed square oriel.
    - Half-story: Arched window opening centered under gable peak.
  - Rear Elevation

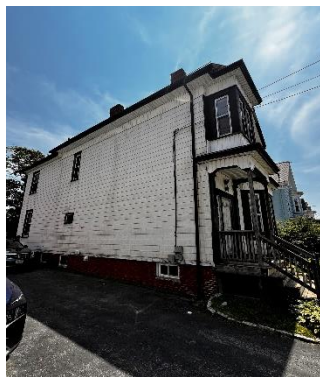
*Bottom, left: Left elevation*

- First floor: One window opening in original location.
    - Basement: Three standard basement/foundation windows.
    - Second floor: Two window openings in original location. Other original window openings have been covered up with siding.

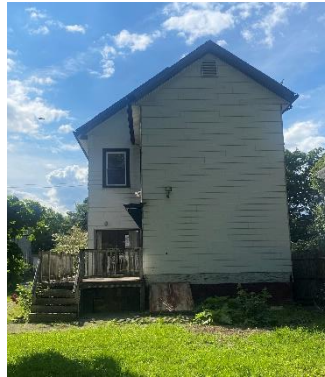
*Bottom, middle: Rear elevation*

- Rear addition stepped down, contemporary and subservient to main massing.
    - Main massing first floor: Sliding glass doors, rear deck and stairs.

- Second floor main massing: Window opening in original location.
    - Half-story main massing: Window opening in original location.
  - Left Elevation

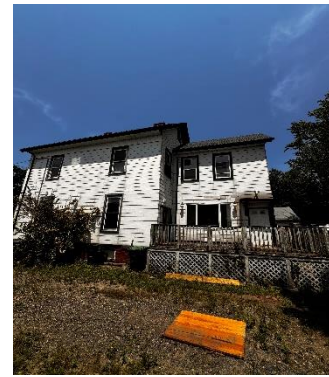
*Bottom, right: Right elevation*

- Right Elevation
    - Window openings in original location, evenly spaced and symmetrically spaced across two-floors.
    - Rear addition: Window openings original.

- First floor: late 20<sup>th</sup> century bay window with later alteration of entry door and overhang.
    - Basement: At least one standard basement/foundation window.

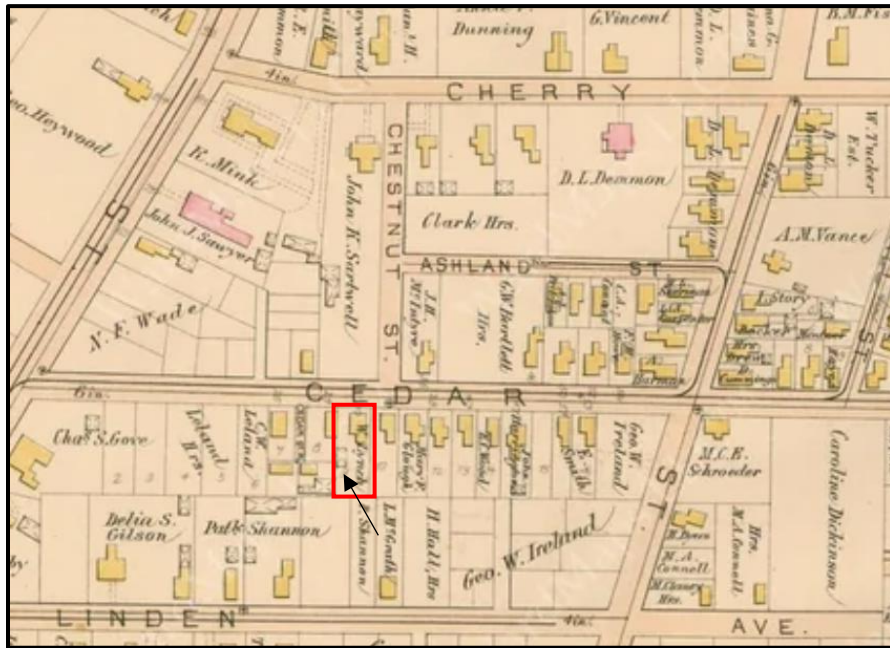
1884 Hopkins  
Map Plate 12,  
specifying  
location of 33  
Cedar Street.

The 1884 Hopkins map shows Cedar Street with established parcel numbers as they appear today. More development had happened in the immediate area in the 10 years between the publication of these maps, with many of the lots on Cedar Street having residential structures on them. As for 33 Cedar Street, along with the principle structure, a barn or stable had also been built on the property. Though Staff cannot determine exactly when the structure was built, it is presumed it was constructed when the principle structure was built or closely thereafter. Though a bit difficult to see on the image above, the black arrow points to where the barn or stable is located on the property.

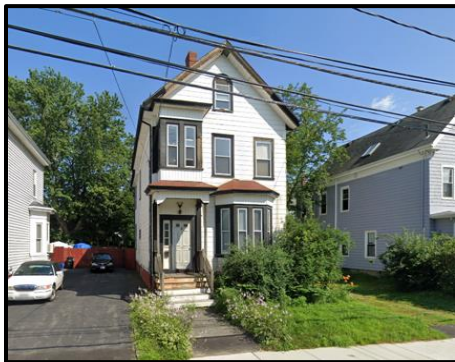
Above: Fig 3

Figure 3:

- Shows the later addition of what could possibly be painted aluminum trim around the first-floor bay window and windows on second floor oriel.

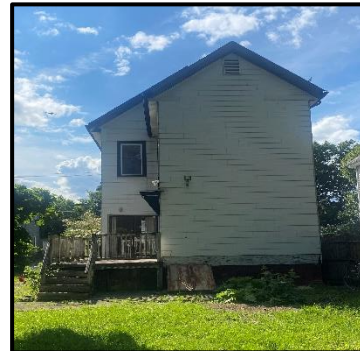
Above: Fig 4

Figure 4:

- Shows the addition of a rear deck and stairs.
