STEP 1: DETERMINATION OF SIGNIFICANCE
STAFF REPORT

Site: 80 Curtis Street

Case: HP24-000059

Legal Ad: *The Applicant seeks to demolish a building constructed a minimum of 75 years ago.*

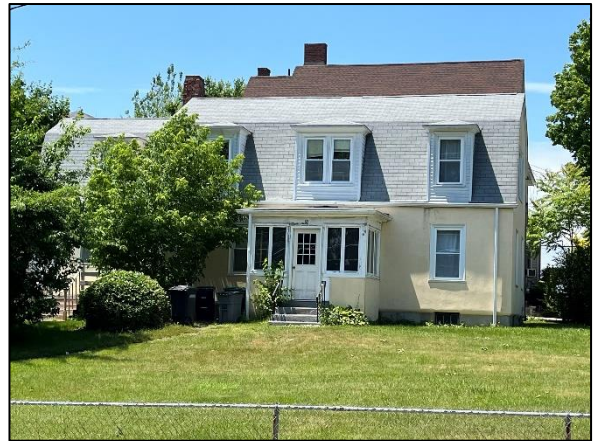
Top: Front elevation **Bottom, left:** Left elevation **Bottom, middle:** Rear elevation **Bottom, right:** Right elevation

- Front Elevation
 - The front elevation presents an asphalt-shingled gambrel roof with three hipped dormers – one centered double dormer and two single dormers; the front of the left rear massing also presents an asphalt-shingled gambrel roof and a single hipped dormer.

- There is also a covered front entryway in the center of the front massing, with steps leading thereto flanked by railings on both sides.
 - There is a porch at the front of the left rear massing with steps leading thereto flanked by railings on both sides.

- The fenestration includes one-over-one double hung windows on the bottom and top stories, and larger single-pane windows for the front entryway.
 - Right Elevation

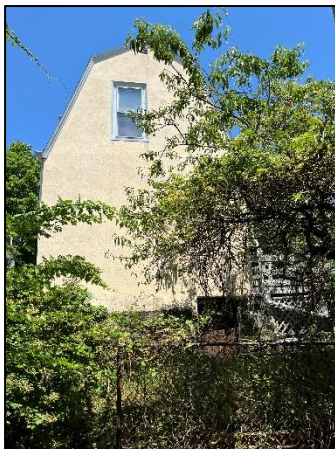
- Left Elevation
 - The right elevation presents the side of the gambrel-roofed left rear massing, smaller in width than the right elevation.
 - The fenestration includes no windows on the bottom story and a single one-over-one double hung window on the top story.

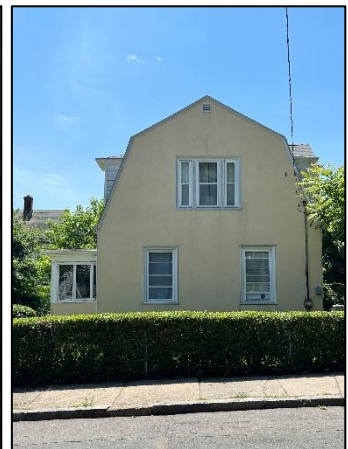
- The right elevation presents the side of the gambrel-roof.
 - The fenestration includes two symmetrical one-over-one double hung windows on the first floor, and a centered one-over-one double hung windows framed by thin double-hung flankers on either side.

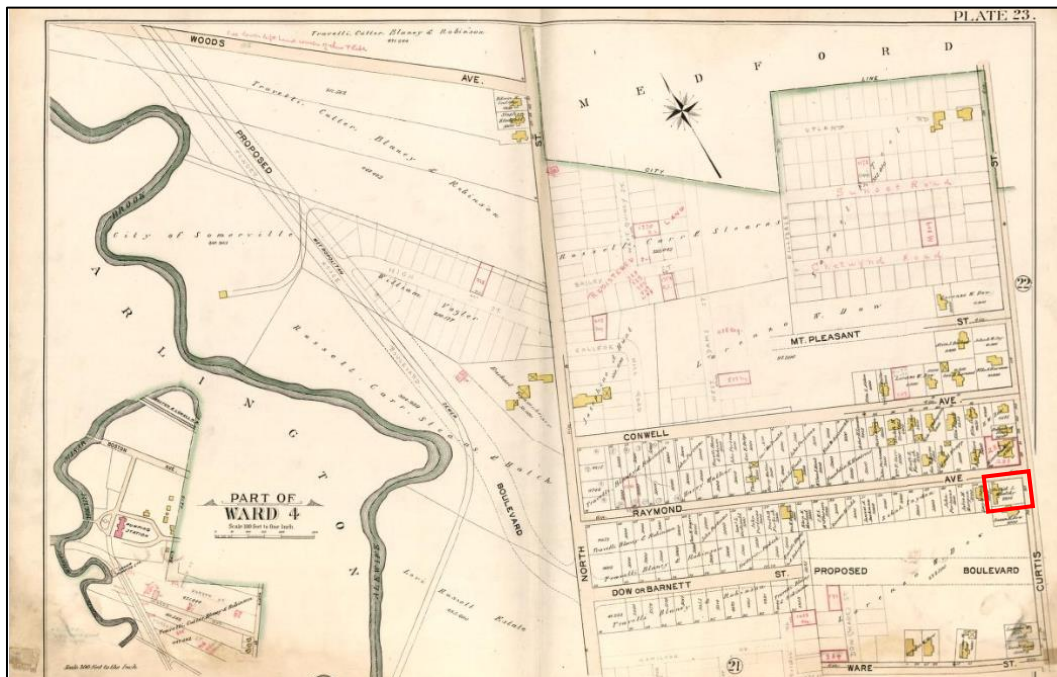
The structure at 80 Curtis Street first appears on historical maps on the 1895 Bromley map, indicating that it was built between 1889 and 1895 and was among the first cluster of houses built to the north of Teele Square.

Above: 1895 Bromley Map, Plate 23, specifying location of 80 Curtis St.

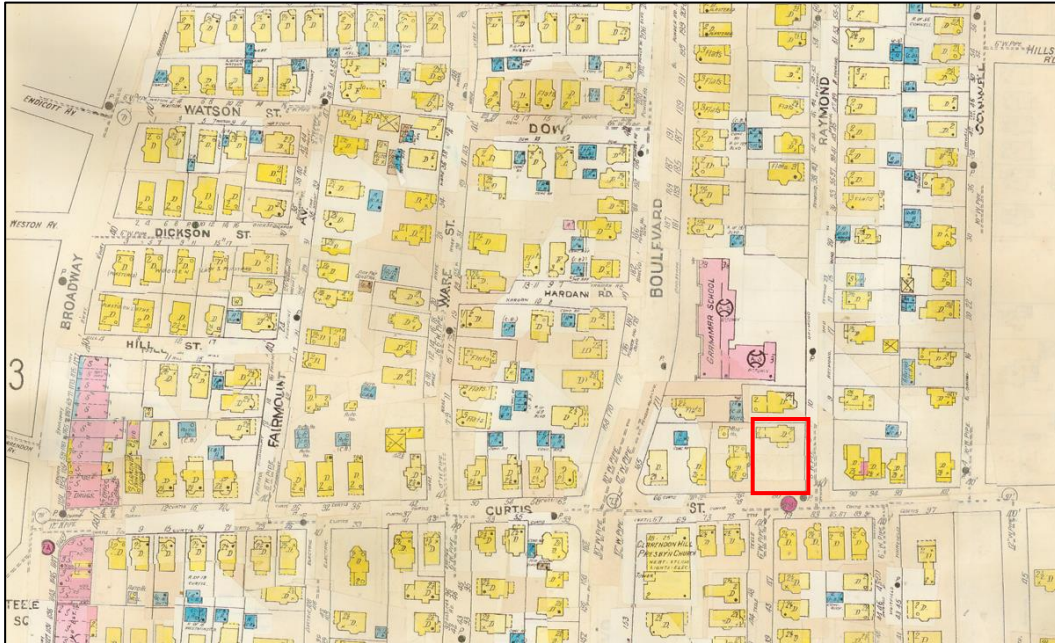
The structure, a gambrel-roofed cottage, was built at the beginning of a period of rapid growth for this area known as Clarendon Hill. Over the next 30 years, Powder House Boulevard would be completed, and all of the lots along Curtis Street and Conwell and Raymond Avenues would be built out, as demonstrated by the 1925 Sanborn map below. Development of the neighborhood also included the construction of a grammar school, now known as the West Somerville Neighborhood School.

Above: 1925 Sanborn Map, Plate 4, specifying location of 80 Curtis St.

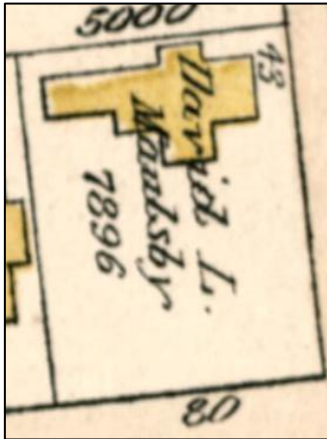
Fig 1

Fig 1: 1895 Bromley Map, close up of 80 Curtis Street

- Shows the original footprint of the structure.
- Gambrel roof 1¾-story main massing with dormers and a 2-story rear gable wing; gambrel roof 1¾-story rear left massing with dormers,

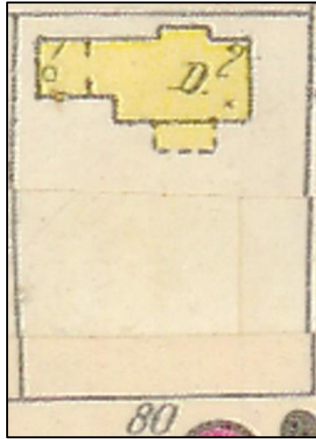
Fig 2

Fig 2: 1925 Sanford Map, close-up of 80 Curtis Street

- Shows the same footprint.

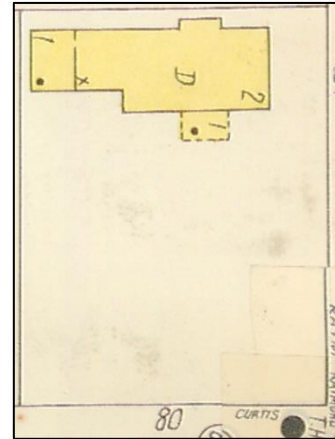
Fig 3

Fig 3: 1938-59 Sanborn Map, close-up of 80 Curtis Street

- Shows the same footprint.

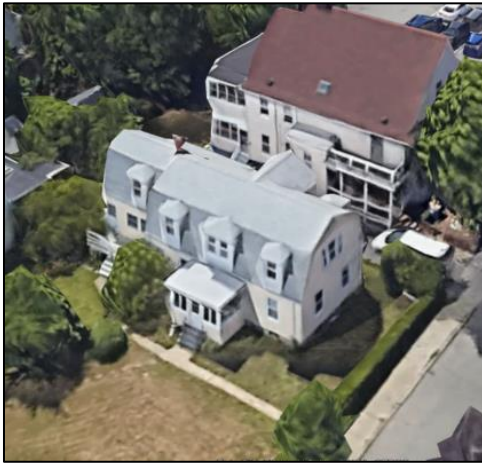
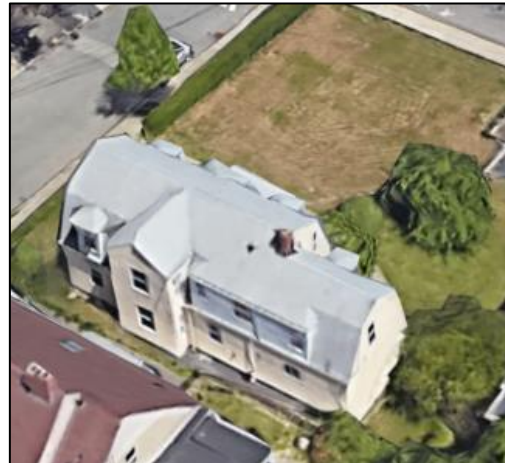
Fig 4 & 5: Satellite images of 80 Curtis Street

- Shows the same footprint.
- Dormers at the left rear massing may have been expanded.
- The front porch/entryway is covered, which may have been an alteration.
- A porch has been added at the front of the left rear massing.

- d. Alterations: Shed dormer appears to have has been added to the rear of the left rear massing; a front open porch has been added to the front of the left rear massing; the front centered entryway may have altered.

- e. *Evaluation of Integrity of 80 Curtis Street* Based on the observations of the building and a study of the historic maps, it is Staff's position that the building largely retains the integrity of its original form. Alterations have occurred to this structure which obscure some original architectural details; however, the original massing remains largely intact.
