STEP 1: DETERMINATION OF SIGNIFICANCE
STAFF REPORT

Site: 35 Cedar Street

Case: HP24-000076

Legal Ad: *The Applicant seeks to demolish a principal structure constructed a minimum of 75 years ago.*

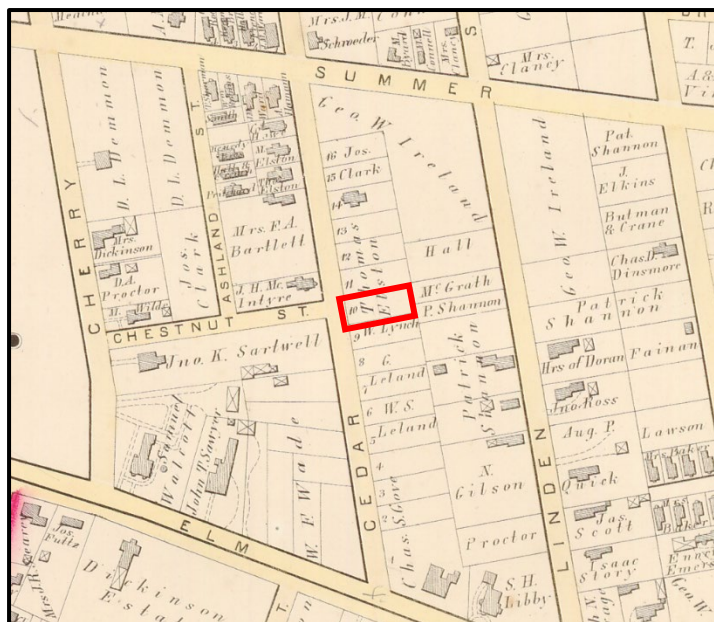
1874 Hopkins Map Plate J, specifying location of 35 Cedar Street.

The 1874 Hopkins Map shows that this section of Cedar Street the subject property is located had been both laid out and platted. The surrounding area was fast developing with residential buildings already constructed on many lots on nearby streets such as Linden, Cherry, Chestnut, and Ashland. The 1874 map shows the parcel was owned by a Thomas Elston. Information from City Directories and Census records indicate that

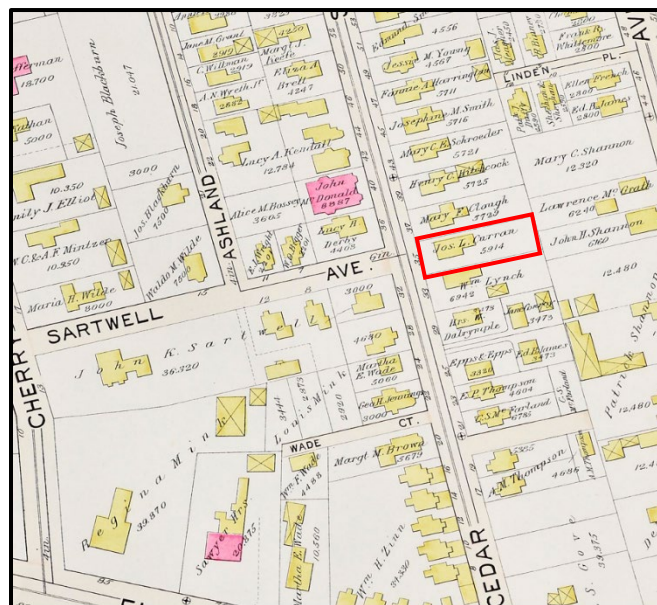
1885 Bromley
Map Plate 17,
specifying
location of 35
Cedar Street.

The 1895 Map shows that by this point in time, more of this area is developing residential structures. Nothing significant has changed to 35 Cedar Street, as the map shows the structure remains the same from

the 1884 Hopkins Map. One notable change in the neighborhood is that Chestnut Street was renamed to Sartwell Avenue.

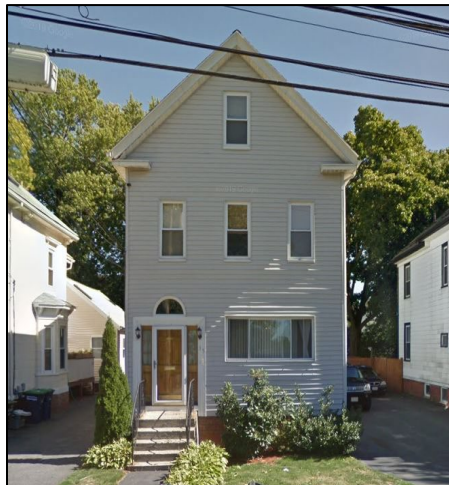
Above: Figure 3

Figure 3: Front Elevation

- Shows original window openings on the second floor and original window opening on half-story.
- Shows the addition of modern window and front door.

- Front Elevation
 - Gable roof with deep eave
 - First floor: On the right side of the front façade: Stoop with main entry door flanked on its left and right by side lites and top crescent window. On the left of the front façade: Modern window.

- Second floor: Three evenly spaced window openings.
 - Half-Story: One window opening centered under gable peak.
 - Rear Elevation
 - Rear addition stepped down, contemporary and subservient to main massing.

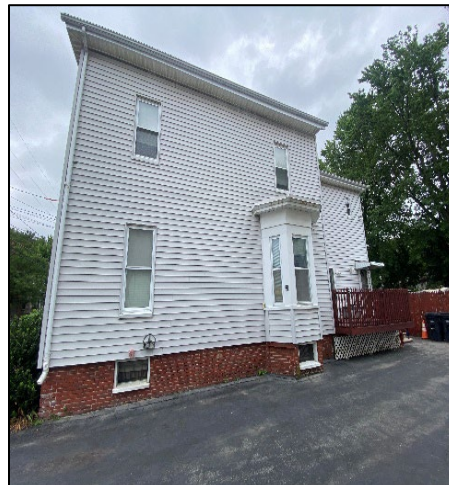
Above: Figure 4

Figure 4: Right Elevation

- Shows the addition of the bay window on the first floor.
- Shows the addition of a side deck on the rear addition and covering over side entrance.

- Right Elevation
 - Window openings in original location, evenly spaced and symmetrically space across two-floors.
 - First floor: Early 20th century bay window.

- Basement: Two standard basement/foundation windows.
 - Rear addition: Window openings likely covered up with siding and addition of smaller modern windows.

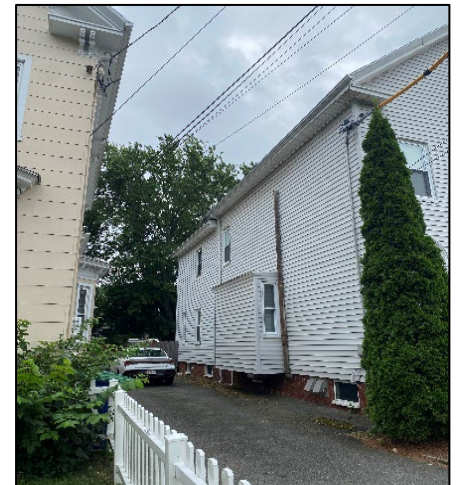
Above: Figure 5

Figure 5: Left Elevation

- Shows the addition of the squared bay window.

- Left Elevation
 - Some original window openings on second floor. Other original window openings likely covered up by siding.
 - First floor: Early 20th century squared bay window.

- Basement: Four standard basement/foundation windows.
- c. Materials:
 - Foundation: Brick
 - Windows: Modern vinyl trim windows
 - Entry door: Later addition modern door with side lites and crescent window
