STEP 1: DETERMINATION OF HISTORIC SIGNIFICANCE
STAFF REPORT

Site: 128 Central Street

Case: HP24-000122

Legal Ad: *The Applicant seeks to demolish a building constructed a minimum of 75 years ago.*

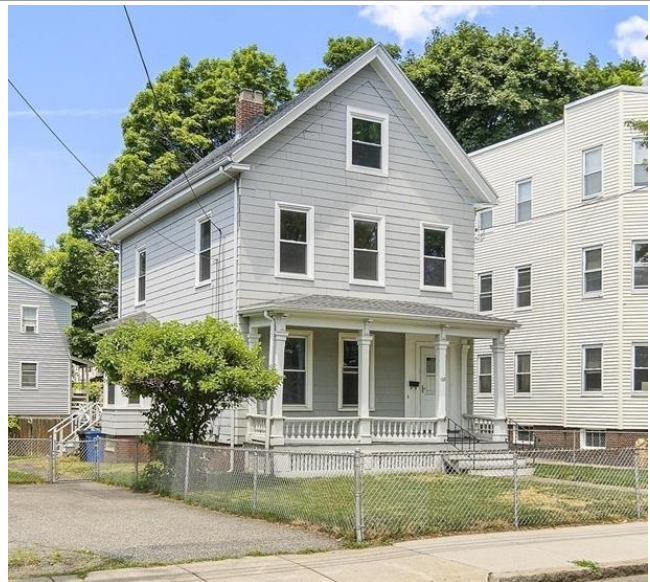
Above: 128 Central Street front elevation

There are several other gable front residential buildings Italianate architectural features in the neighborhood including 125 & 127 Central Street. The subject residence, contrary to similarly styled homes in the neighborhood, is predominately in its original form. The subject residence has a full-width one-story porch with square columns, a wide eave, and classic bracketed cornice.

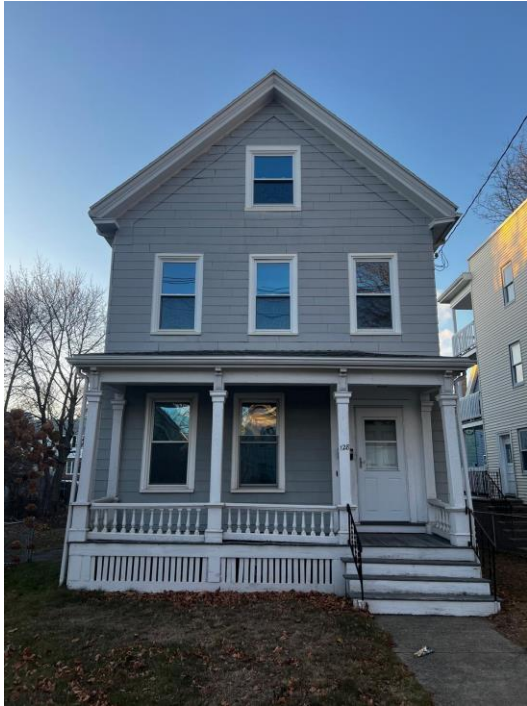
Below: 128 Central Street, front elevation

Front elevation: three bays wide with three bays presented on the first and second stories. Single window centered under gable peak. Covered front porch running width of façade and accessed by three steps.

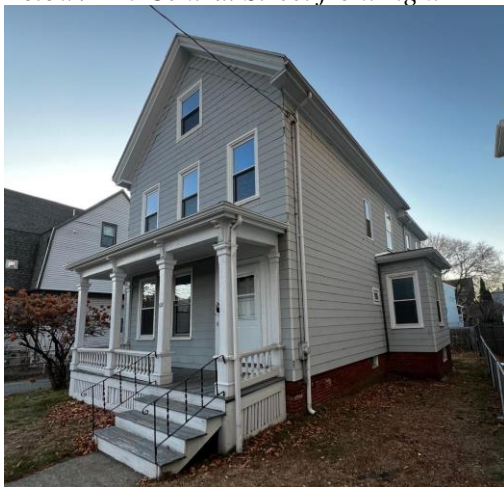
Below: 128 Central Street front right

Right elevation: largely windowless façade except for the second story rear of the main massing. Square bay at rear of first story.

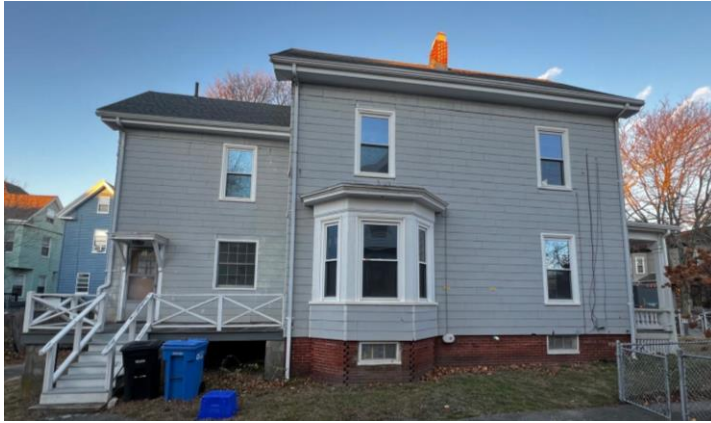
Below: 128 Central Street left elevation

Left elevation: two bays deep, windows symmetrically placed across façade. Polygonal bay on first story at rear of elevation.

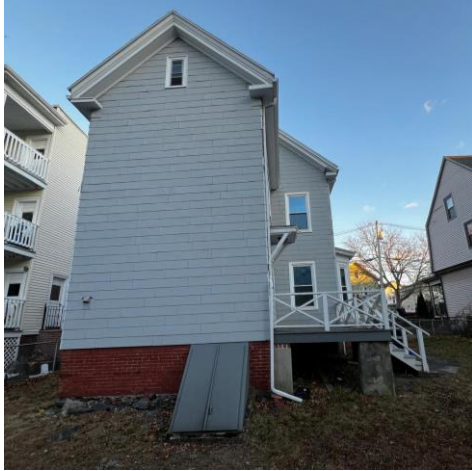
Below: 128 Central Street rear elevation

Rear elevation: First and second story of main massing present one window each. Two-story rear addition presents windowless backside, but a right elevation with an open deck accessed by a set of steps, two windows and access door.

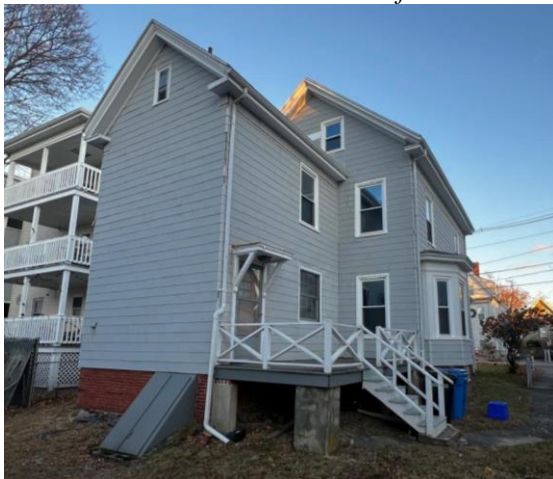
Below: 128 Central Street rear left

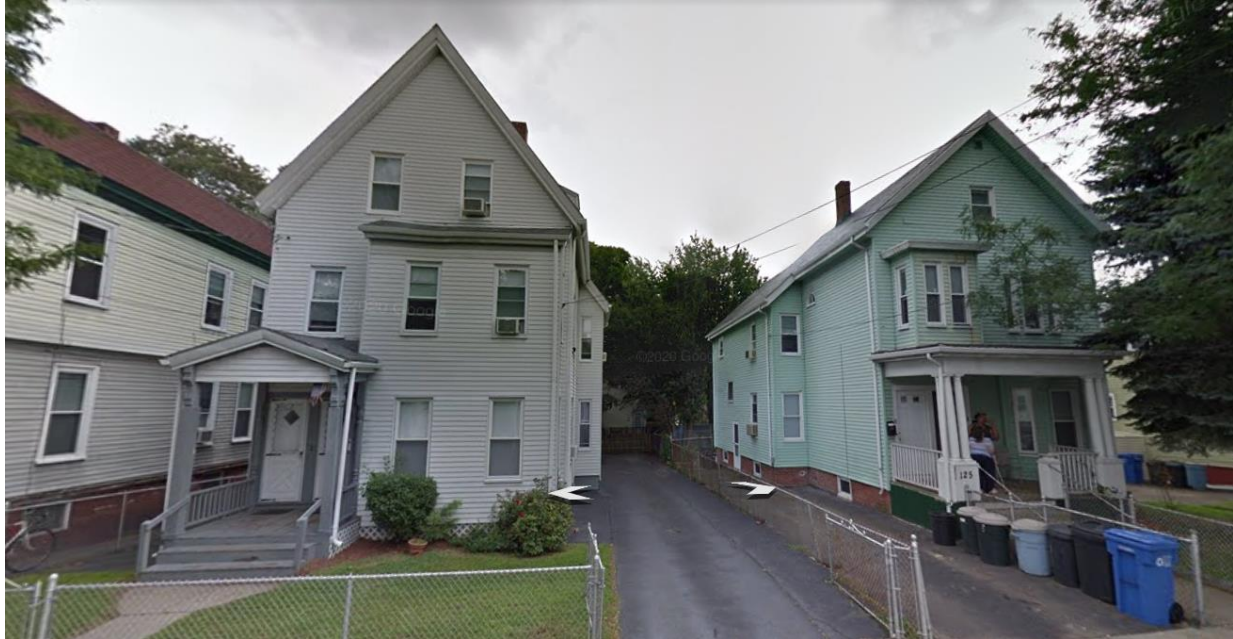
The images below are of two properties directly opposite from 128 Central Street and are provided for comparison. Though built a few years apart from 128 Central, 125 Central (below, right) and 127 Central (below, left), are also gable-fronted. All three structures share similar

form and massing and Italianate style details (steeply pitched gabled roofs, three-bay wide construction, deep eave and one or windows under the front gable peak, rear ells. 125 Central presents a front bay and front oriel (second story, front). 127 likely had at least a first story bay to the right of the (now double) entry hall.)

Below: 127 Central St. (right) and 125 Central St. (Left)

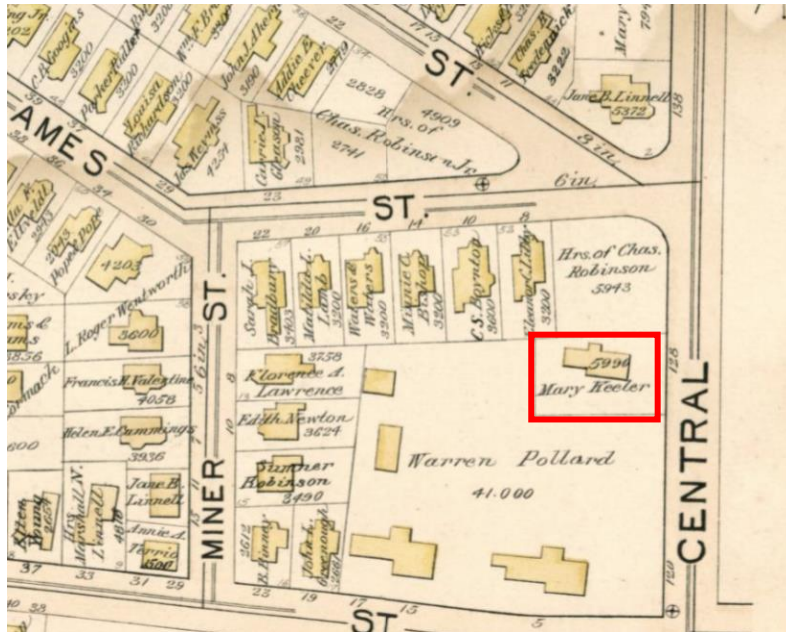
On the 1895 Bromley Map, Mary Keeler, was listed as the owner of 128 Central Street. According to Somerville City Directories, it appears that Mary and her family were living at the residence and her husband, Charles Keeler, was operating his bookkeeping business at the residence as well. The subject property is highlighted in red below.

Below: Portion of the 1895 Bromley map
