STEP 1: DETERMINATION OF SIGNIFICANCE
STAFF REPORT

Site: 199 Elm St

Case: HP24-000120

Legal Ad: *The Applicant seeks to demolish a principal structure constructed a minimum of 75 years ago.*

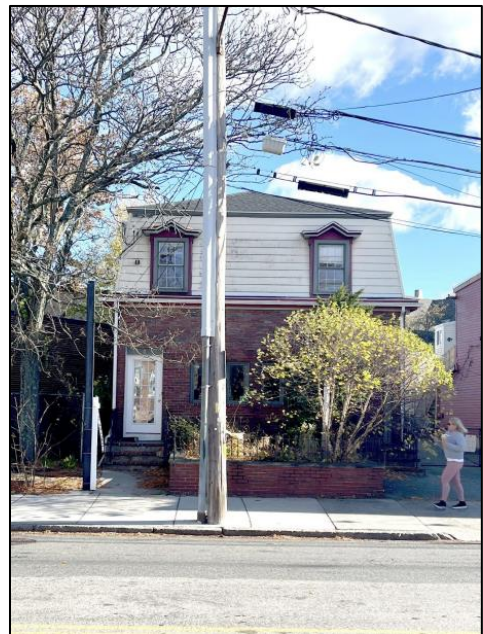
Top: *Front elevation*

- a. Location: It is likely that this structure is in its original location and built on-site.
- b. Design: The house is a two-story mansard. The front elevation shows two front entryways on the right and left side of the building with a large window flush to the façade between the two doorways. The front elevation is brick faced and vinyl siding on the second story. There are two six over six double hung windows on the second story, with a wall dormer. The right elevation has five (5) six over six double hung windows and vinyl siding. The rear elevation has a two-story addition, back entryway and shed-type structure with door. The left elevation is largely siding, with one six over six double hung window, a one over one double hung, and a small window on the first story. The second story windows have a gothic gable-style dormer roof.

- c. Materials: Wood framing, brick façade, vinyl siding, brick foundation, asphalt roof. The front steps are a brick with a concrete foundation and metal rails. Metal fence in front of structure, back ramp and entryway steps constructed of wood. Windows and doors appear to have been replaced.

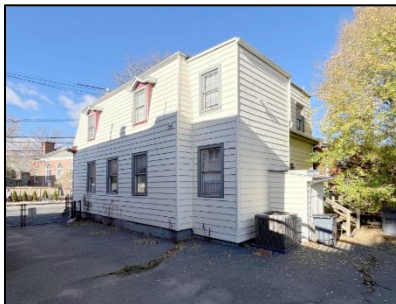
Bottom, middle: *Rear elevation*

- d. Alterations: A two-story addition has been added to the rear of the building. The original bay windows on the front and side of the building have been removed. A second entryway has been added to the front façade.

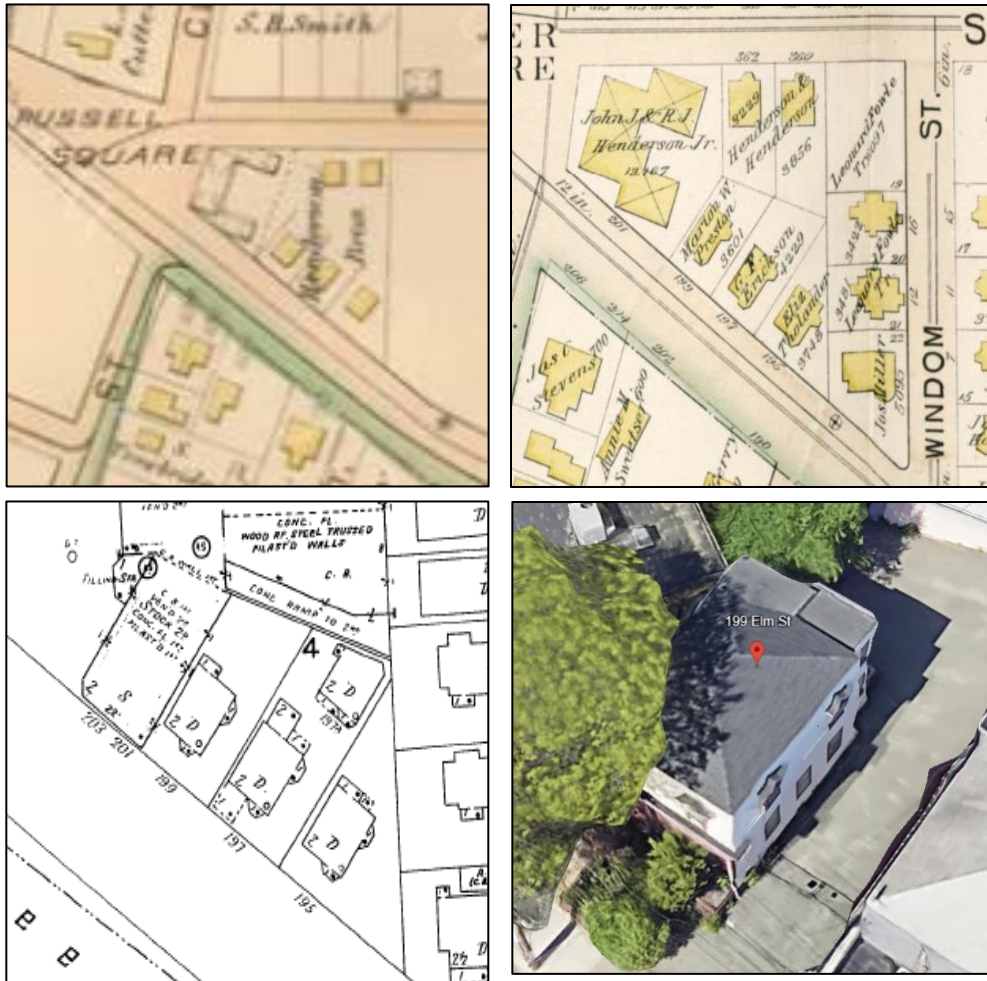
Top Left: 1884 Hopkins Map

- This is the first time the structure appears on a historic map. It is depicted as a wood framed square building.

Top Right: 1895 Bromley Map

- A bay has been added to the side and front of the structure.

Bottom Left: 1925 Sanborn Map

- A one-story rear addition has been added to the structure.

Bottom Right: Google Earth View, present day 199 Elm St

- A second story has been added to the existing one-story rear addition
- A second two-story addition has been added to the rear of the structure.
- The bay windows at the front and side have been removed
