Hardship Variance Narrative Section SZO 3.1.13.I.i.a

Project: 8 - 8a Melvin Street Renovations

8 – 8a Melvin Street
Somerville, MA

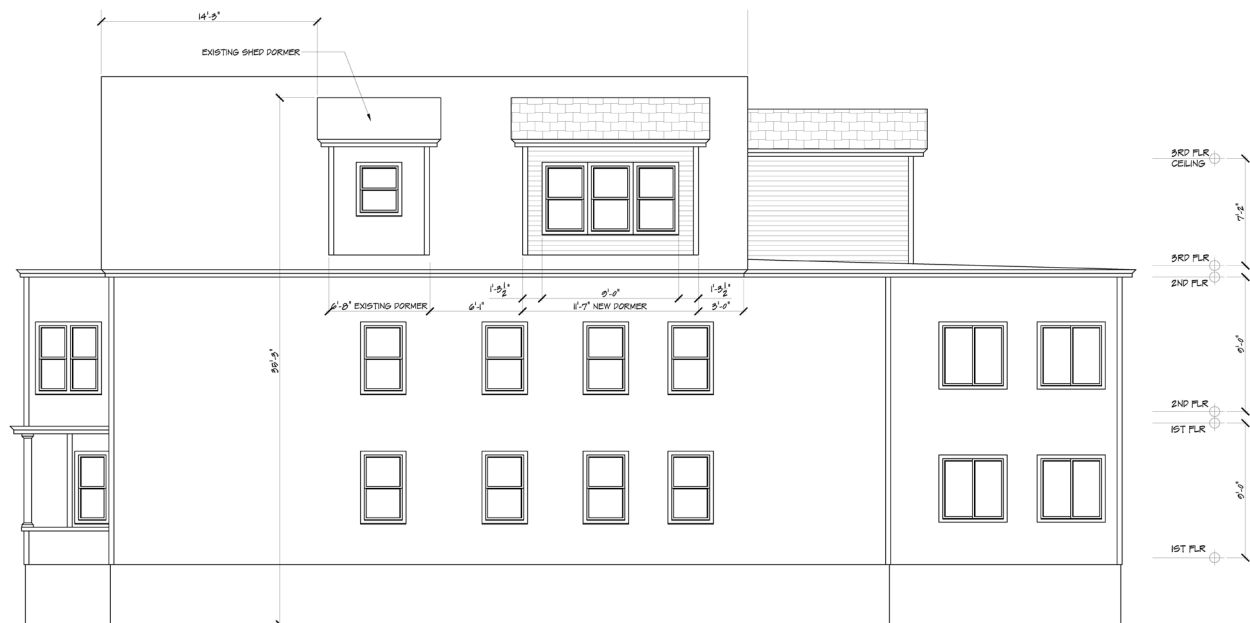
Right Side Elevation – Approved Permit Drawing

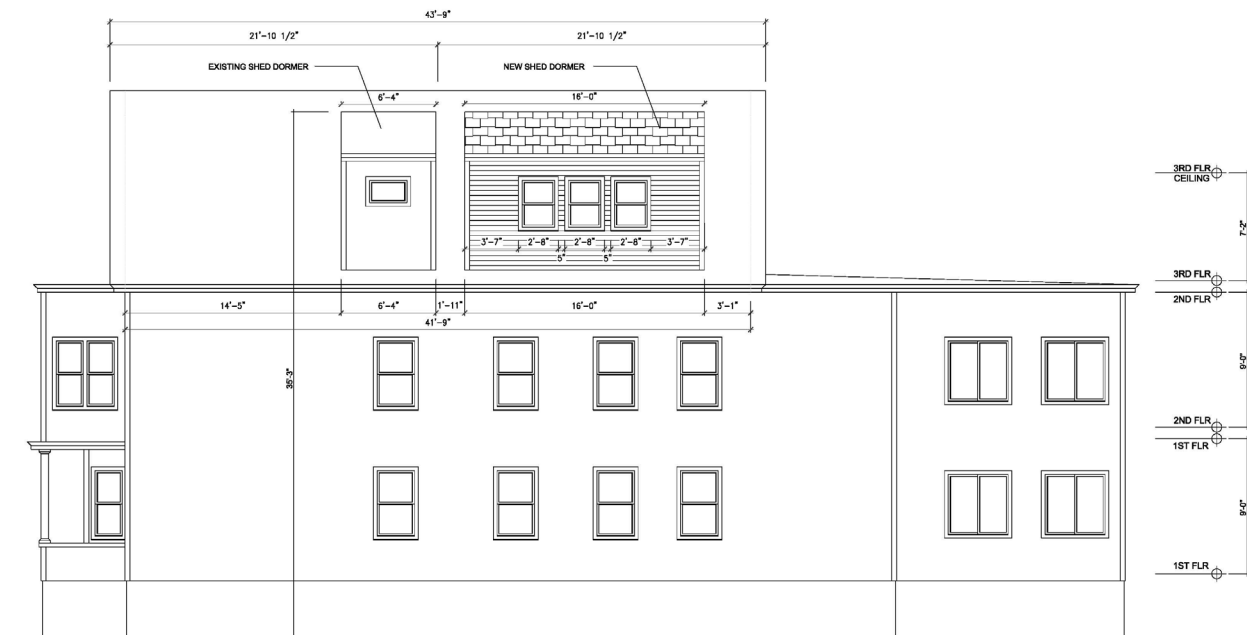
Right Side Elevation – As-built Condition

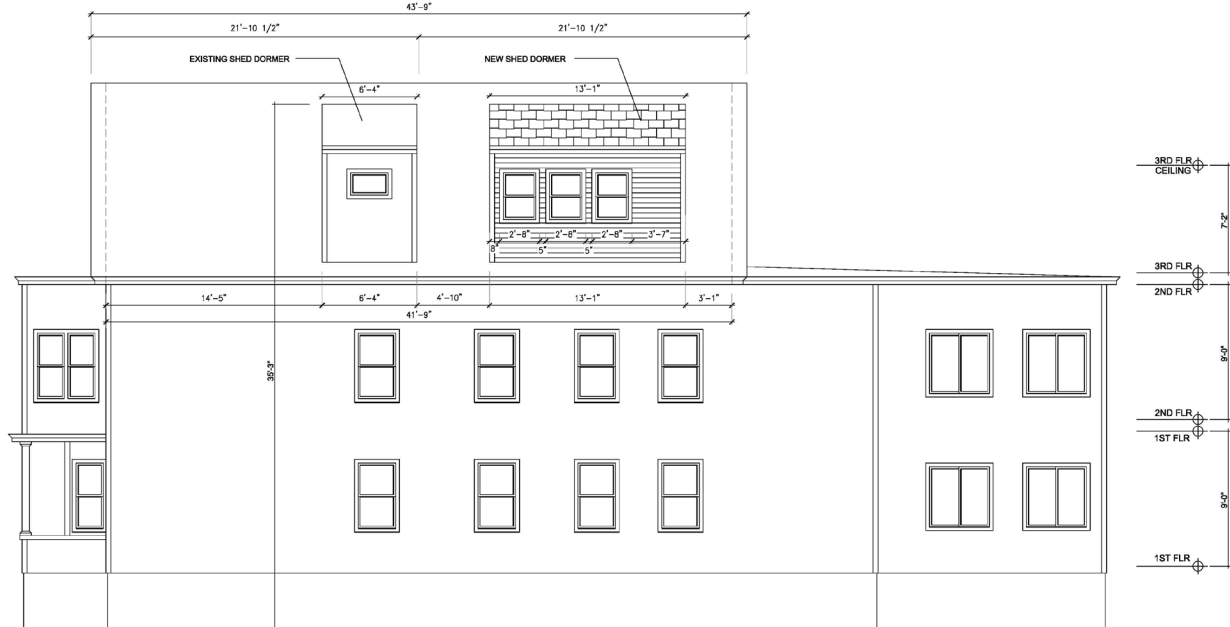
Right Side Elevation – Proposed Revised Dormer

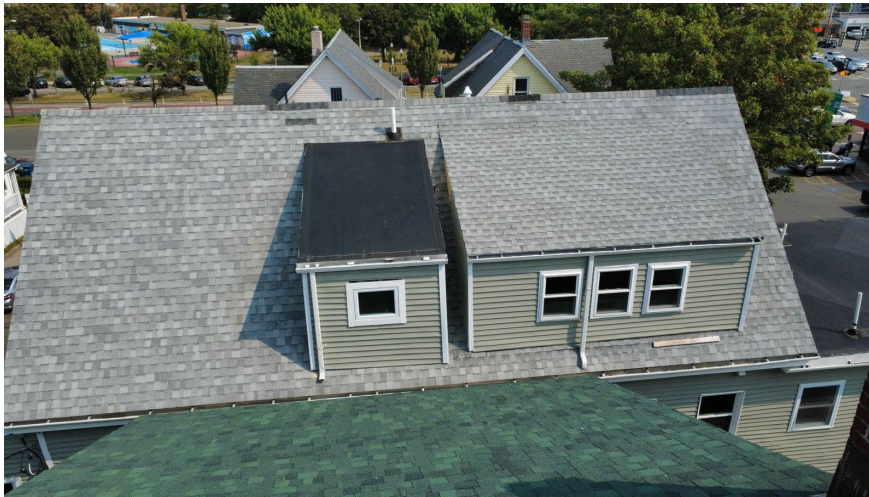
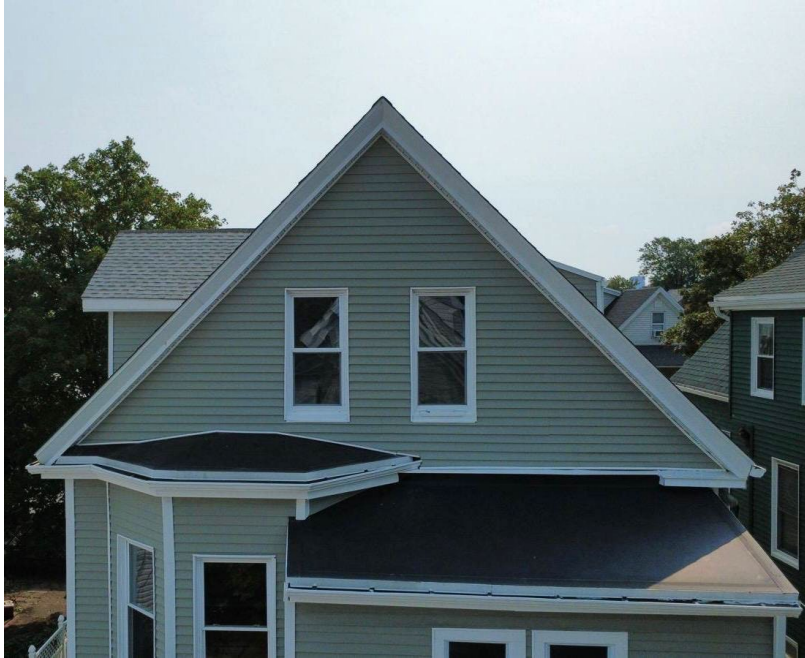
Photos of Existing Roof Condition and Dormer Configuration

As noted above, the change in the dormer during construction and subsequent completion of the project did not meet the SZO 3.1.13.I.i.a dormer zoning requirements unbeknownst to the applicant. As such, they are seeking a hardship variance for the conditions listed under that section as the project has already been completed and it would be a significant financial cost for the applicant to modify the construction at this point in the project.
