STEP 1: DETERMINATION OF SIGNIFICANCE
STAFF REPORT

Site: 62 Elmwood Street

Case: HP25-000077

Legal Ad: *The Applicant seeks to demolish a principal structure constructed a minimum of 75 years ago.*

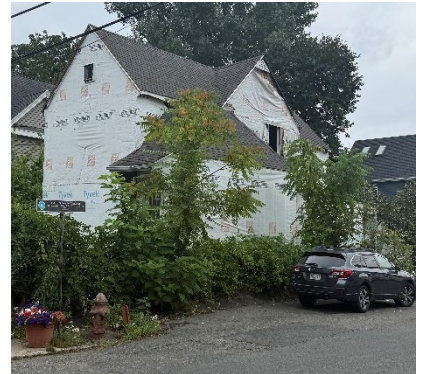
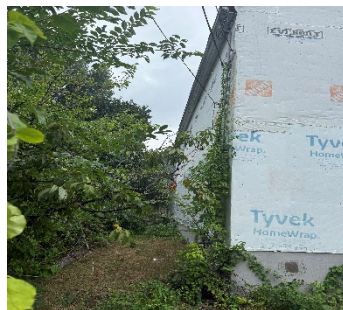
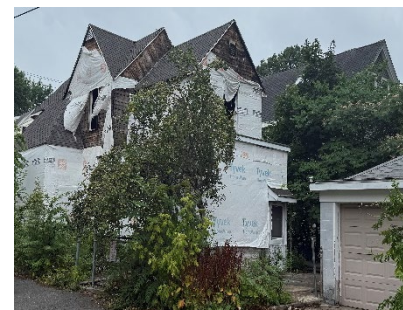
Top: Front elevation

Bottom, left: Left elevation

Bottom, middle: Rear elevation

Bottom, right: Right elevation

- c. Materials:
 - Foundation: Main massing: likely concrete-parged brick or stone. Right elevation additions are likely concrete or concrete block.
 - Windows: Not currently identifiable, but windows seen on the 2020 Google street view were replacement windows.

- Chimney: Brick single stack chimney
- d. Alterations: Alterations include replacement of siding, windows (locations and type) front entry door doors. Hip-roofed right elevation entry, single-story right elevation addition with louvered windows; front steps

- e. *Evaluation of Integrity of 62 Elmwood:* Based on the observations of the building and a study of the historic maps, it is staff's position that the original massing, scale remain, however exterior components of the building have clearly been altered over time through the removal and replacement of original materials and through later additions.

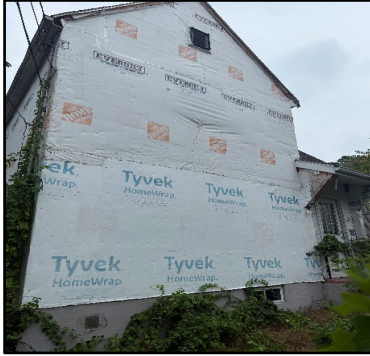
Top Left: Current front facade of locus facing Elmwood Street

- Front Elevation
 - Gable roof
 - Entry located in the right side from Elmwood St., with steps leading to entryway with railing in the side
 - Small vent above the second-floor window

- Prior to the ongoing renovation this side of the building showed:
 - Two double-hung windows are symmetrically positioned one above the other.
 - Right elevation

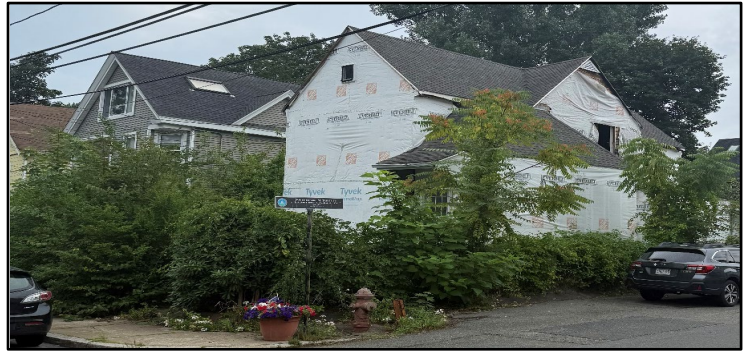
Top Right: Current side view of the building at the intersection of Elmwood and Harrison Streets.

- Gable roof plane
 - Hip-roofed side entry.
 - Prior to ongoing renovation:
 - Hip-roofed entryway connected to cross gable on the main massing.
 - The addition behind the entryway showed a series of 6 louvered windows with a side entrance and steps leading to this entryway.

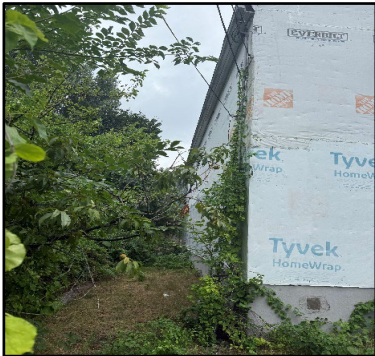
Middle Left: Current view of left side of locus from Elmwood Street.

- Left elevation
 - Siding removed and sheathing temporarily covered while under renovation.
 - Prior ongoing renovation:
 - 7 various sizes of double-hung windows asymmetrically distributed on the left elevation on the main massing

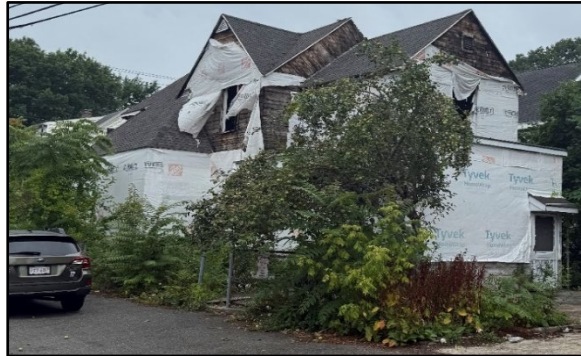
Middle: Side/Back view of building from Harrison Street.

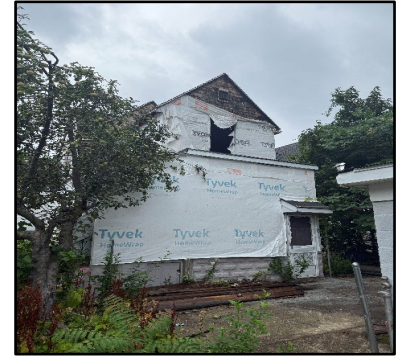
Middle Right: Full view of the rear entrance of the building.

- Anything on the left elevation of the rear addition?
 - Rear elevation
 - Gable roof with an entryway at street level
 - One opening of a window on the second floor. (Not picture prior ongoing renovation to note any other details).

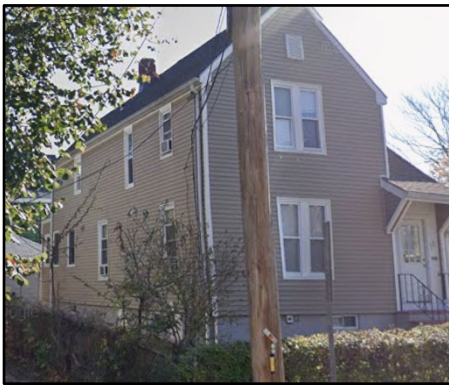
Bottom left: Google map image from 2020 showing left elevation of from Elmwood St. perspective

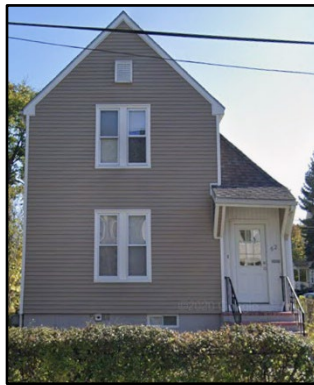
Bottom Middle: Google map image from 2020 showing front elevation from Elmwood St. perspective

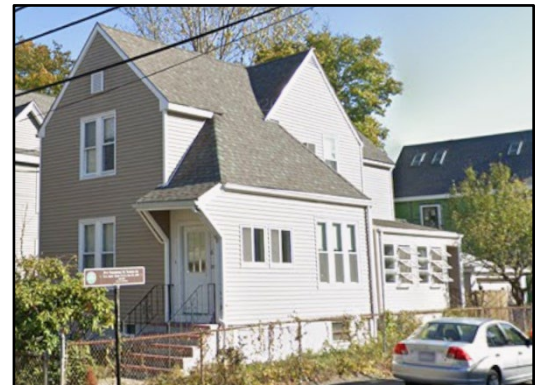
Bottom Right: Google map image from 2020 showing right elevation from Elmwood St. perspective
