STEP 1: DETERMINATION OF HISTORIC SIGNIFICANCE
STAFF REPORT

Site: 21 Avon Street

Case: HP25-000080 & HP25-000081

Legal Ad: *The Applicant seeks to demolish a principal structure constructed a minimum of 75 years ago*

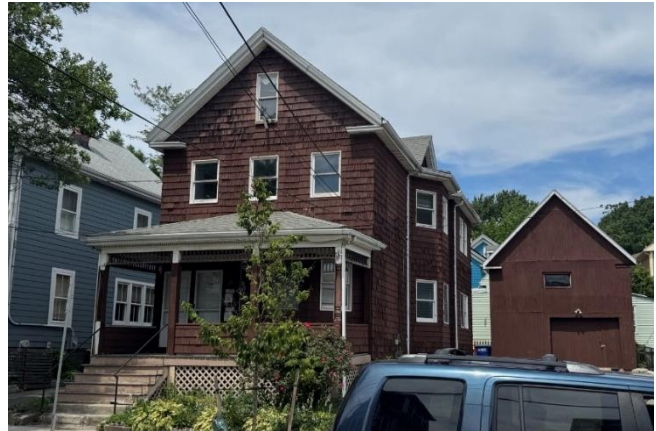
Front Elevation of the Home & Barn at 21 Avon St.

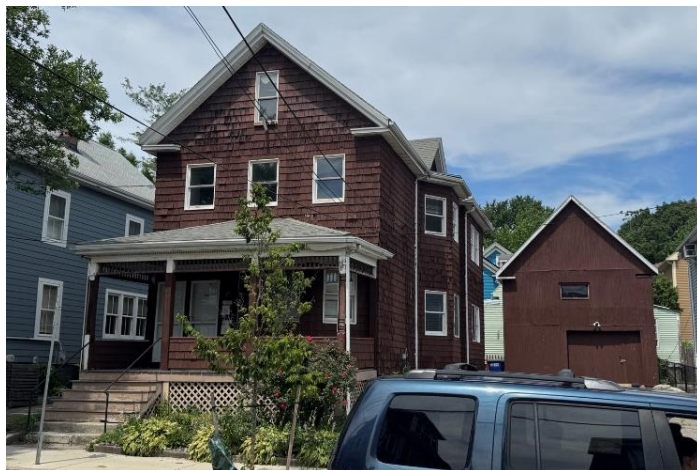
Above: Front elevation

Front Elevation

First Story:

- front porch with hipped roof, cornice with dental molding and spindrals
- Tuscan columns on either sides of front porch
- bay window on right side and 2 front doors on the left

Second Story:

- three fixed double-paned windows
- wide eave overhang, boxed without brackets
- front gabled roof with a steep pitch

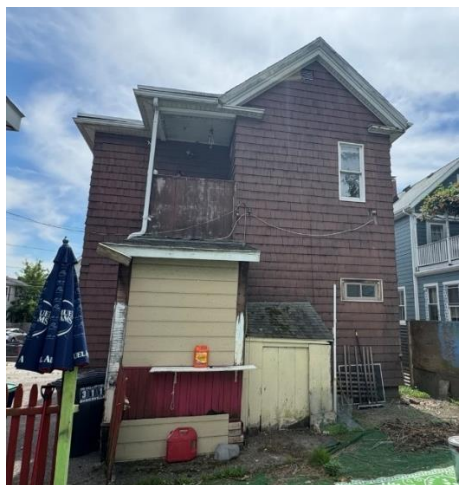
Above: Rear elevation

Rear Elevation

First Story:

- horizontal sliding window on right side
- cellar access with a shed roof
- shed roof beneath second-story porch above addition

Second Story:

- wide eave overhang, boxed without brackets
- second-story porch on left side of addition

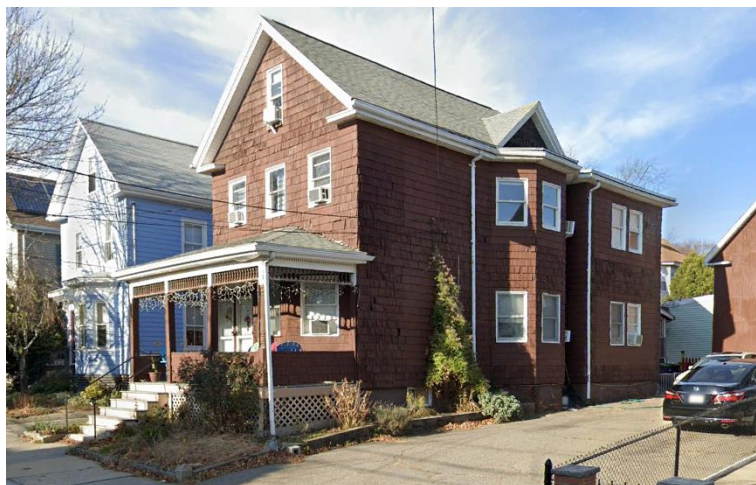
Above: Front/ right elevation

Right Elevation

First Story:

- asymmetrical
- bay window; double hung windows
- rear addition with double-hung windows

Second Story:

- bay window with gabled roof dormer
- double hung windows
- wide eave overhang

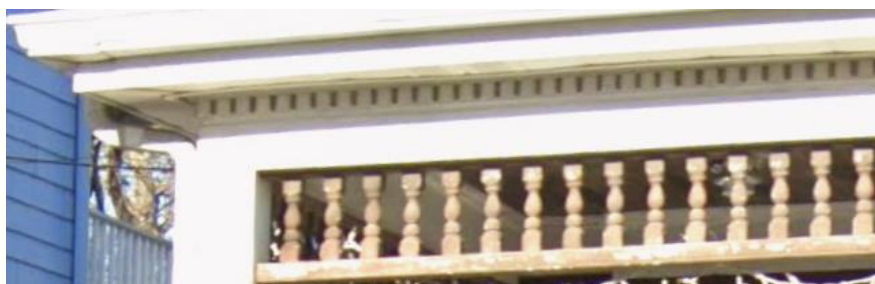
Above: ~~Spindles~~, Spindles dentals, cornice molding above front porch

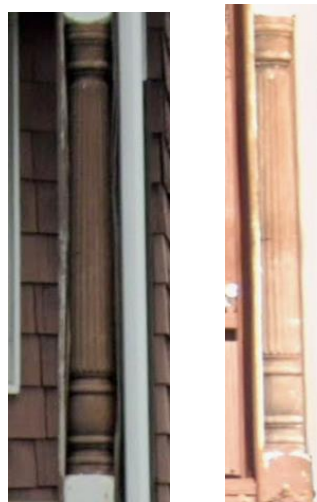
Above: 2 photos of the Tuscan column on right side of front porch

c. Alterations: There has been a 2 two-story addition, constructed prior to 1900. A small rear porch was added to the second story of that addition. Doors and windows appear to have been replaced. The shingles appear to have been replaced or repaired. Portions of the Tuscan columns supporting the first story front porch have been partially covered with wood and shingles. It is likely porch balusters have been covered/ replaced by this similar material mimicking the siding/ shingles that cover the structure.

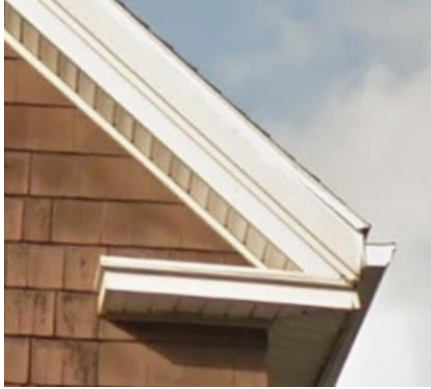
Above: Boxed cornice on eave of 21 Avon House

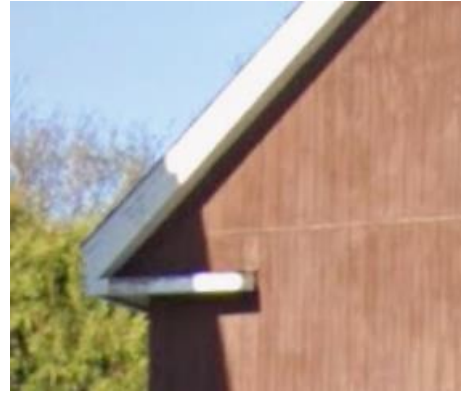
Above: Boxed cornice on eave of 21 Avon Barn

Design: The barn at 21 Avon Street is a front gabled roof structure, with a single picture window on the front, and a moderate eave overhang, boxed without brackets.

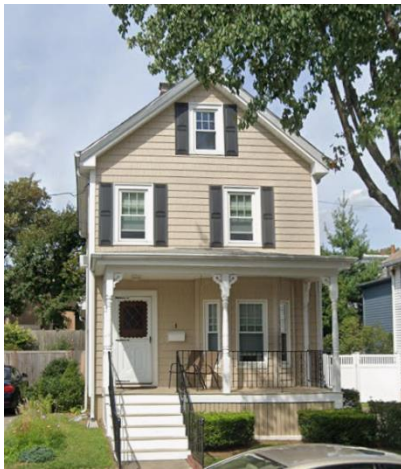
The images below are of neighboring properties and are provided for comparison. These structures were built during the same time period as the subject property and are in the same architectural style. These structures are of the Italianate style (front-facing gabled roofs, moderate to widely overhanging eaves boxed without brackets, single-story entry porches, bay windows). These front-facing gabled, Italianate dwellings are common throughout the neighborhood. A majority of these structures were present by the time of the 1874 Hopkins map, shown later in this memo.

Above: 5 Avon St.

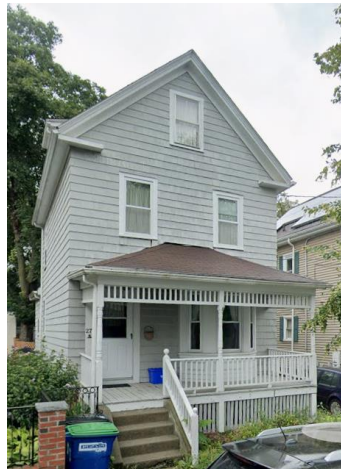
Above: 27 Avon St.

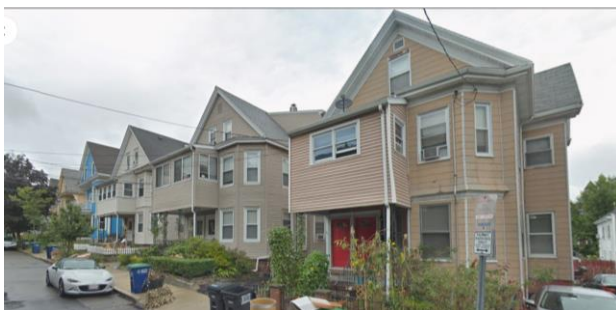
Below are other neighboring properties of a similar style to the subject property, but with heavily altered facades. Few homes on Avon Street have their original façade form or Italianate details. Many have infilled porches, replaced materials, and front additions.

Above: 41 to 51 Avon St.

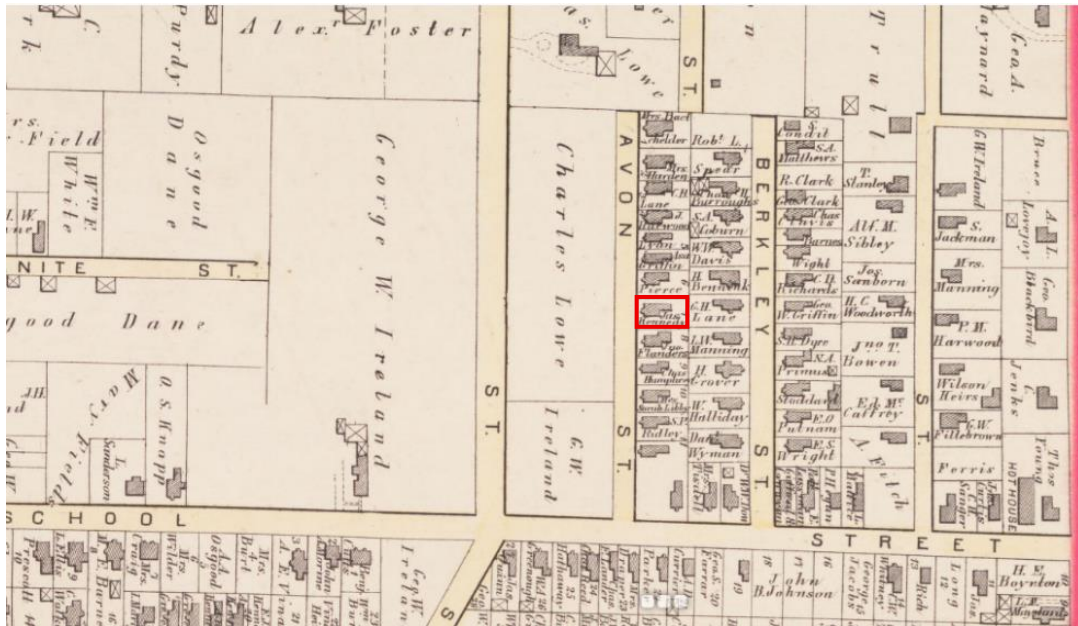
Above: 1874 Hopkins Map of 21 Avon St.

1874 Hopkins Map

- Original footprint of the structure.

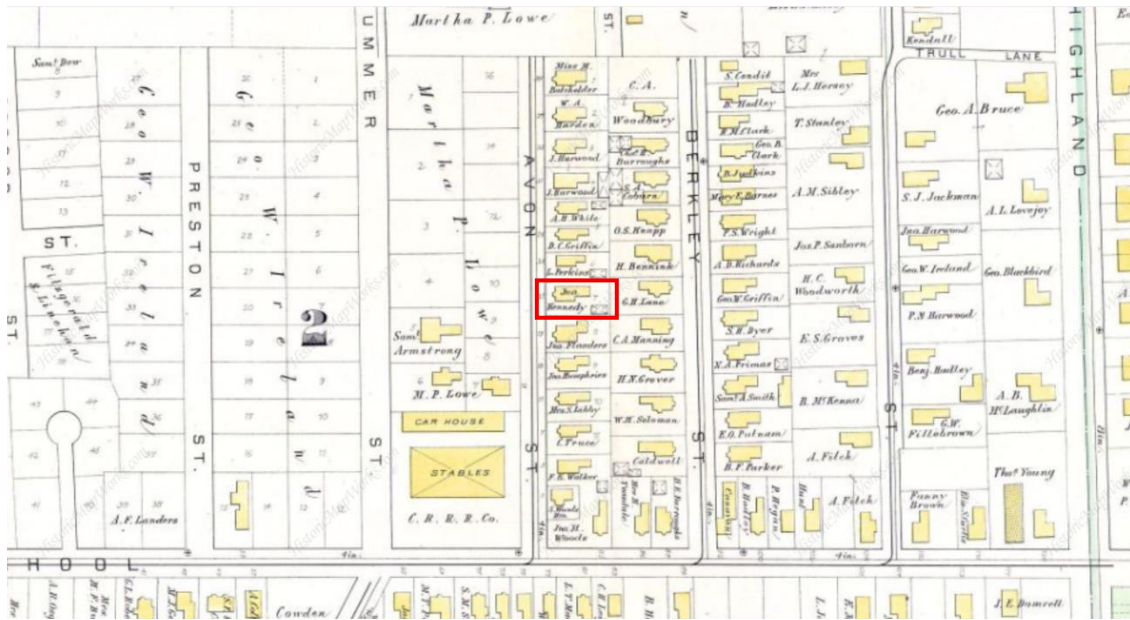
Above: 1884 Hopkins Map of 21 Avon St.

The 1884 Hopkins map shows the presence of several barns, carriage houses, and stables in the neighborhood. The barn at 21 Avon was built sometime between 1885 and 1895, according to historic maps. This barn was likely built by John Kennedy, an early resident and owner of the property. John Kennedy was born in 1834 in Maine. He was married to Eliza A. Kennedy, a housekeeper, who was born in Maine in 1830.

1884 Hopkins Map

- Barn shown in rear of the property.
