Somerville Historic Commission

The property at 396–398 Broadway is a six-unit historic condominium building located in Somerville, Massachusetts. The building currently suffers from extensive water damage to the exterior, which has compromised the integrity of the wooden siding and window trim. To address the root cause of this deterioration, a full gutter replacement is required prior to commencing any exterior restoration work.

Replacement Plan – 396–398 Broadway, Somerville, MA

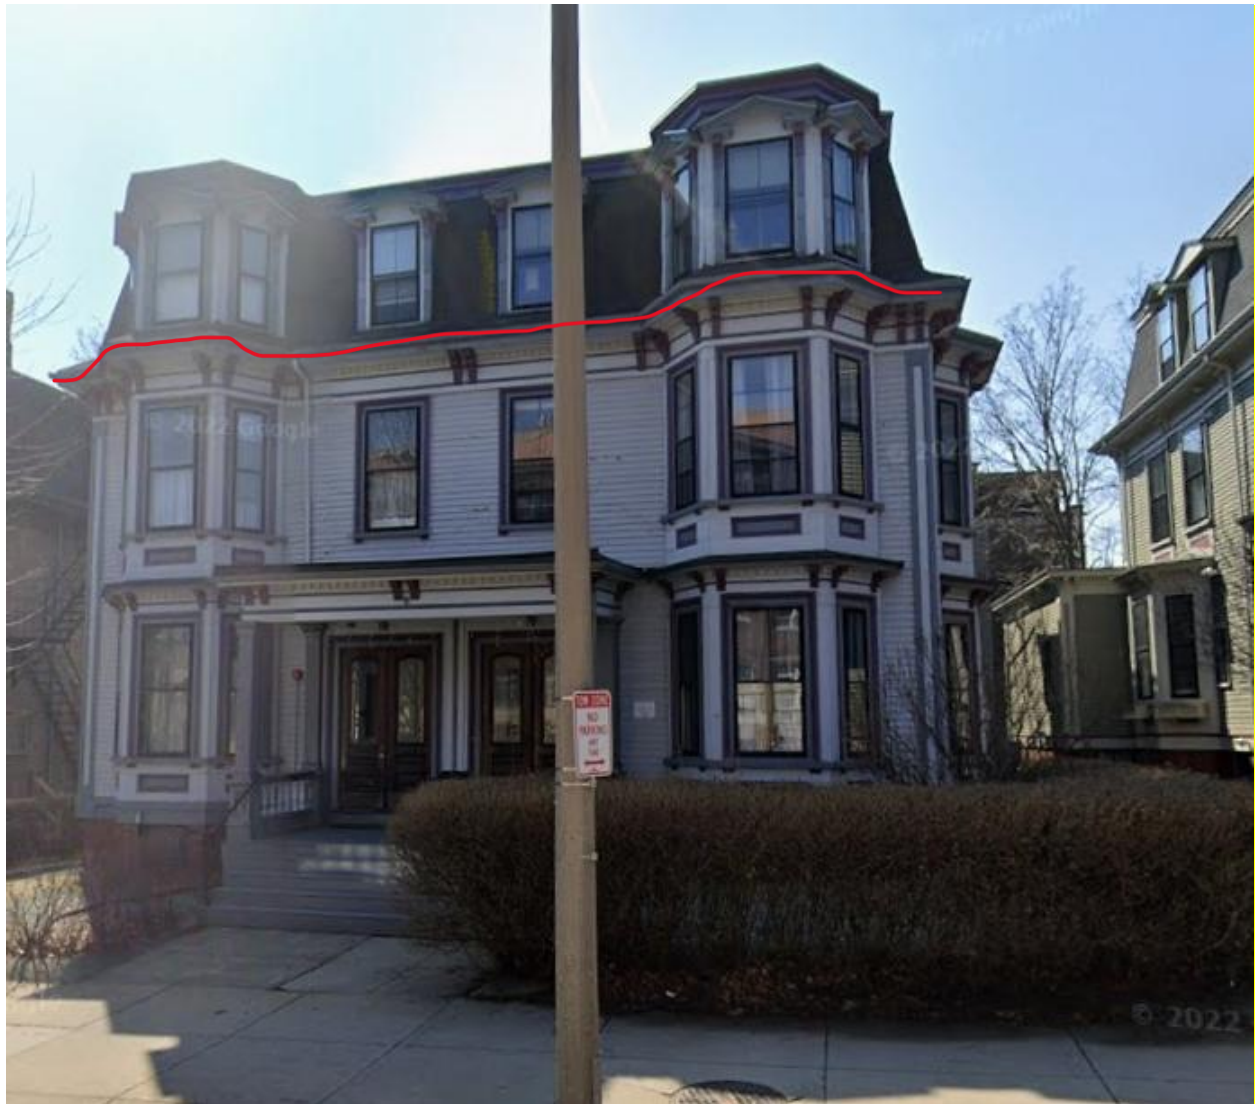
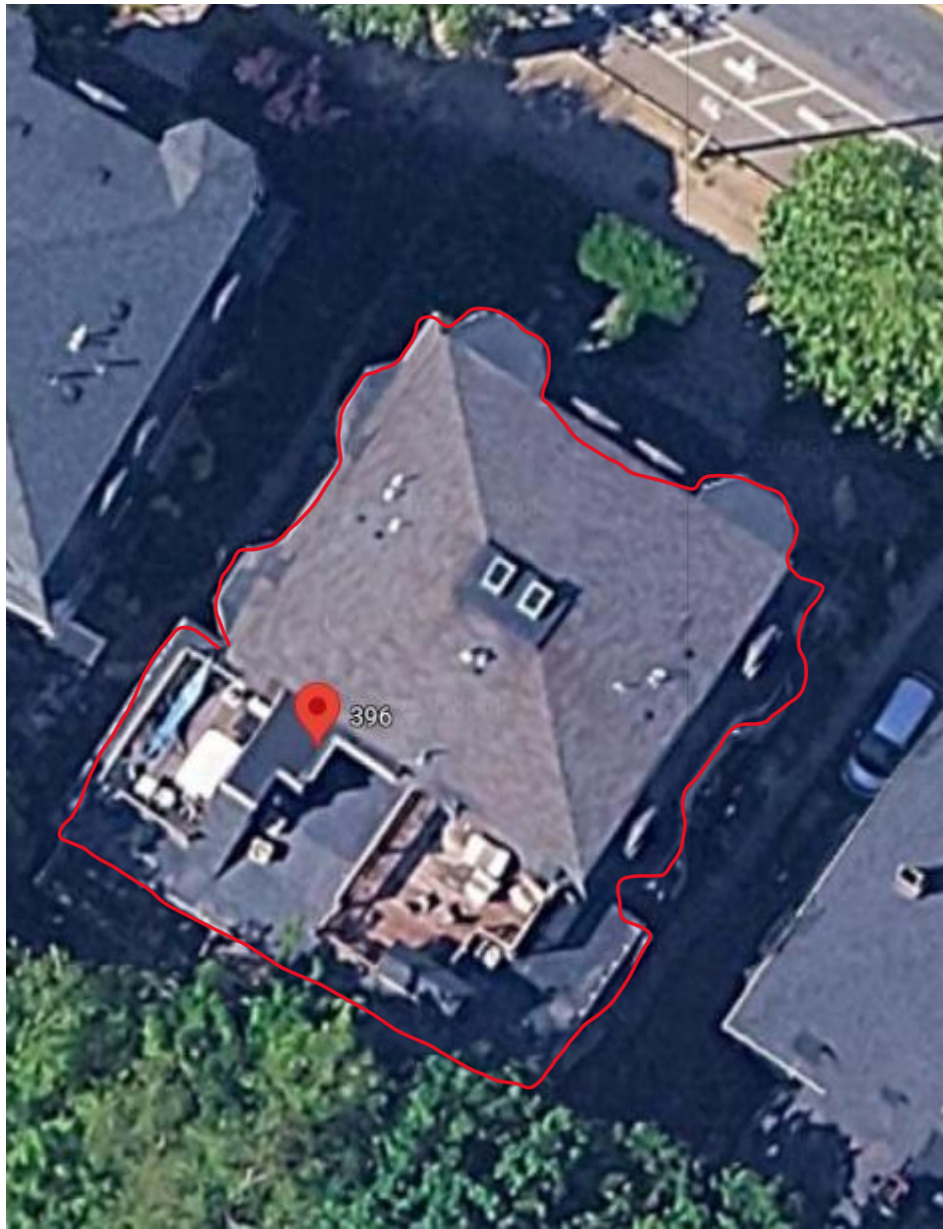
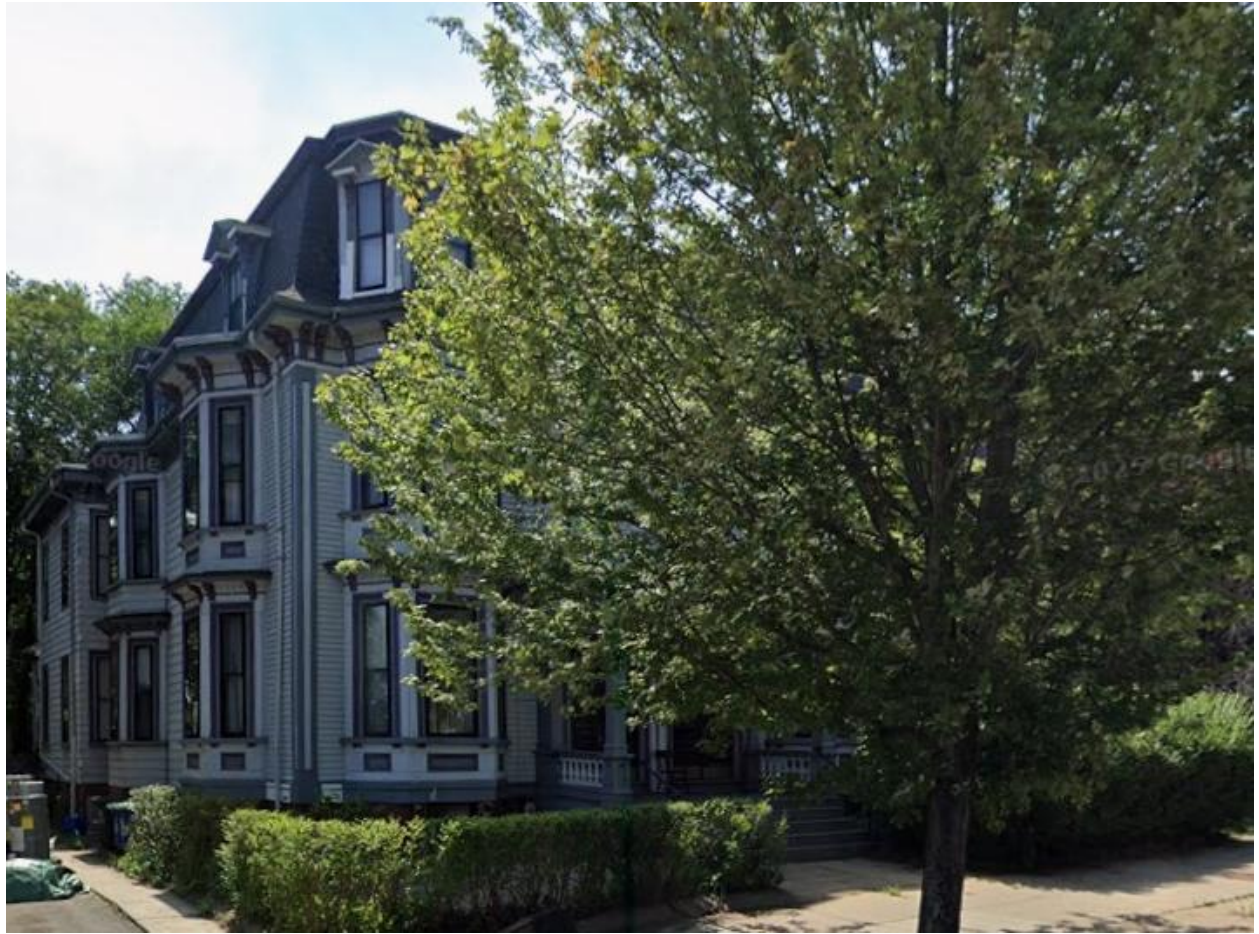
The existing wooden gutters and the fascia behind them exhibit widespread rot, with several sections having decayed completely. In some areas, this deterioration has created holes in the gutter system, and vegetation such as weeds is growing between joints, particularly near the upper edges of the structure.

The proposed scope of work involves replacing the deteriorated wooden gutters with seamless 5" K-style gray aluminum gutters (0.032", 20 gauge), as detailed in the attached contractor quote. The replacement gutters will replicate the profile and color of the original system to ensure compatibility with the building's historic character.

The scope of work includes the removal of the existing wooden gutters located along the front and sides of the property, as well as the removal of the existing metal gutters at the rear of the building. During this process, any fascia boards found to be deteriorated or structurally compromised will be replaced. Fascia boards that are in good condition will remain in place.

Once removal and necessary repairs are complete, new gray seamless aluminum gutters and downspouts will be installed around the entire perimeter of the building. The new gutters will match the existing profile and color to maintain visual continuity with the building's current appearance and surrounding streetscape.
