STEP 1: DETERMINATION OF SIGNIFICANCE
STAFF REPORT

Site: 58 Main Street

Case: HP25-000078

Legal Ad: *The Applicant seeks to demolish a building constructed a minimum of 75 years ago.*

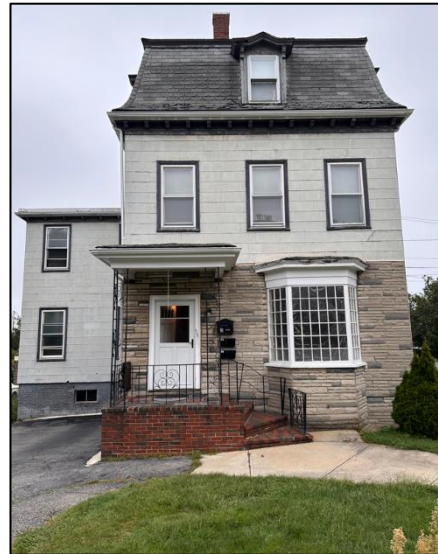
Top: Front elevation

- a. Location: This structure is in its original location. The building was constructed on-site sometime prior to 1874.
- b. Design: The house is a 3-story mansard colonial home with a mansard roof. The exterior consists of vinyl siding and concrete material over a wood frame, with masonry on the exterior near the porch on the first floor. Entry is through the front vinyl door.
 - Front Elevation
 - The front elevation presents a mansard roof
 - There is a brick front porch on the first-story with metal railing

- The first floor has masonry on the front elevation
- The front door is possibly wood

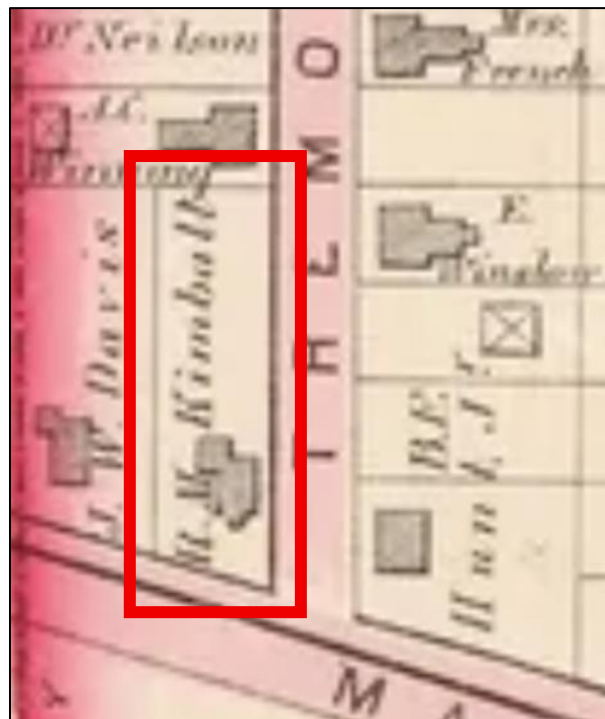
Above: 1874 Hopkins Map, Plate 36&37, 58 Main St highlighted, and a close-up of the lot

Zooming in on the 58 Main Street lot, we can see that R. M. Kimball is listed as the owner. It's possible that the initials on this map are a misprint, as a 1898 Boston Evening Transcript lists someone named Fred M. Kimball as residing there.

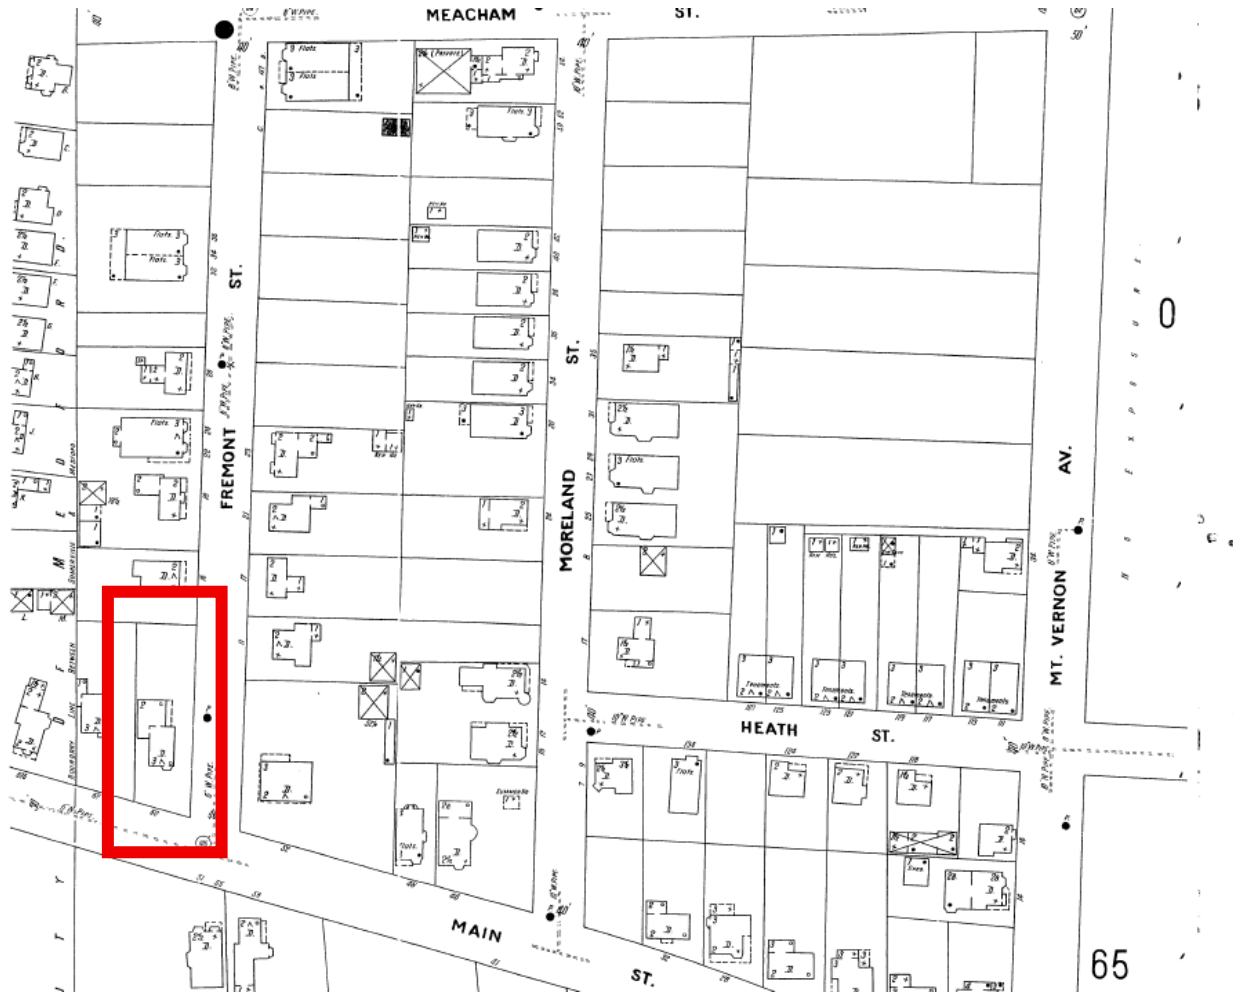
On the 1900 Map below, we can see the surrounding area in a similar state as 1895 and the building footprint of 58 Main Street remaining the same.

Above: 1900 Sanborn Map, Plate 51, with 58 Main Street lot highlighted

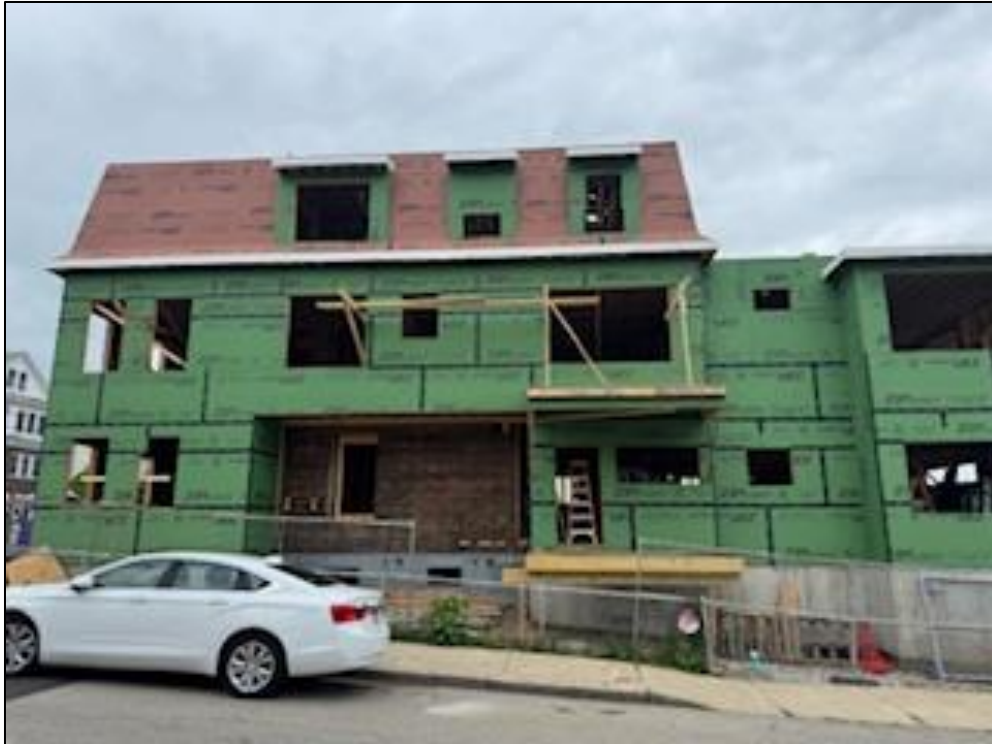
Staff Note: This property has already begun demolition, as they have demolished more than fifty percent of the building while repairing the roof. A Stop Work Order has been placed on the property by the Inspectional Services Department (ISD). A determination from the HPC is needed to see if the house is historically significant and the work can continue.

Above: current state of the building taken from the right elevation
