36 Beacon – Below Steps Outline and Intent

2025.07.28

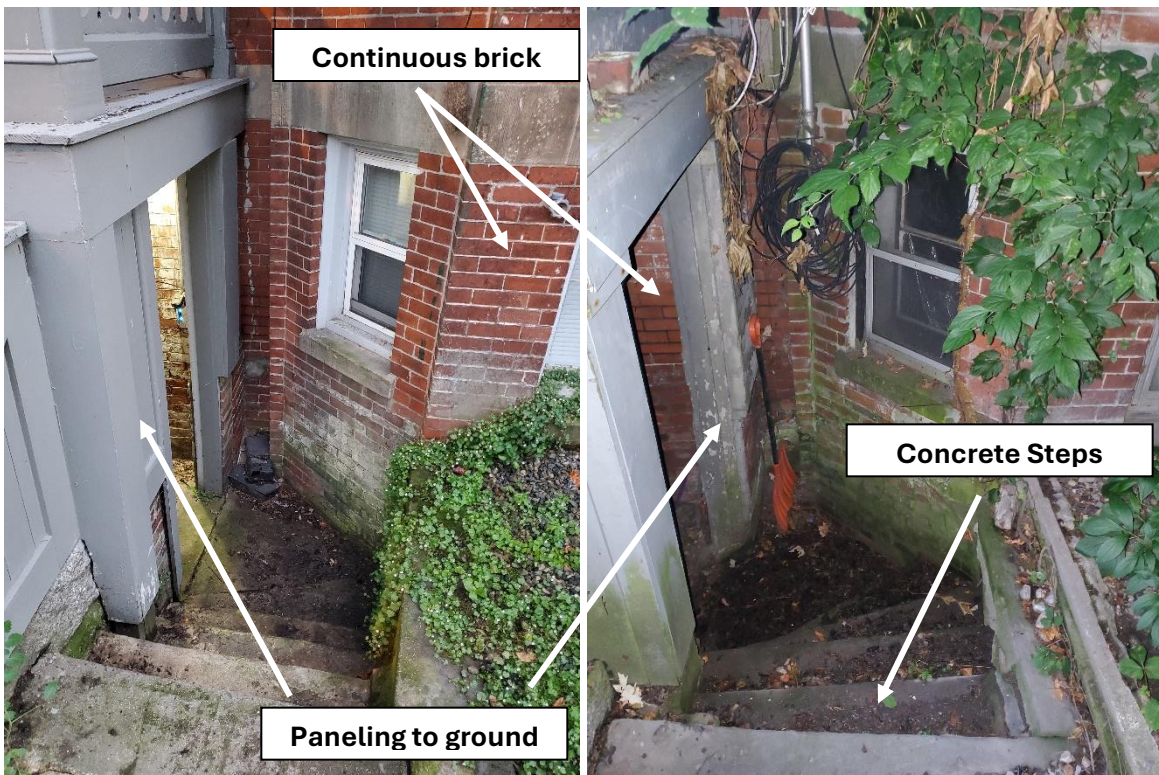
- Grey wood paneling to be rebuilt to extend down to ground to match that found in three of the neighboring rowhouses. Most similar to photo on the left below.

Property 1

Property 2
