STEP 1: DETERMINATION OF HISTORIC SIGNIFICANCE
STAFF REPORT

Site: 184 Broadway

Case: HP25-000102

Legal Ad: *The Applicant seeks to demolish a principal structure constructed a minimum of 75 years ago*

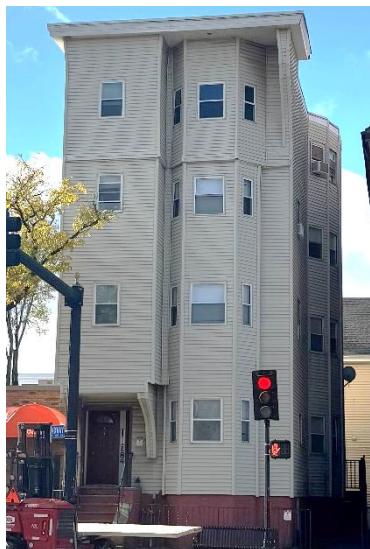
Front Elevation of 184 Broadway

Front Elevation

First Story:

- Raised foundation beneath first floor
- Concrete staircase flush with sidewalk
- Recessed covered entryway framed by large brackets
- 3, 1-over-1 modern sash windows on bay
- Projecting polygonal bay rising from basement

Second Story:

- Continued vertical stacked bay
- 3, 1-over-1 modern sash windows on bay
- Continued projecting upper floor above entryway with 1 modern 1-over-1 sash window

Third Story:

Fourth Story:

- Continued vertical stacked bay
- 3, 1-over-1 modern sash windows on bay
- Continued projecting upper floor above entryway with 1 modern 1-over-1 sash window
- Large bracket on the right side connected to eave
- Wide eave overhang topped with cornice bordering a small parapet

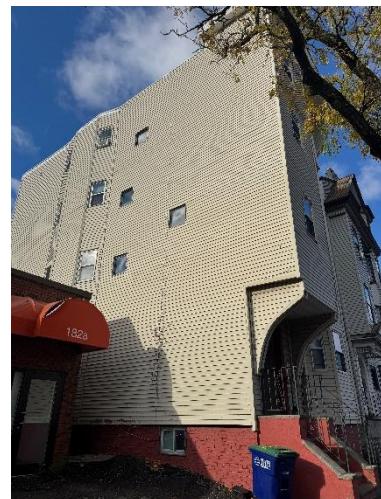
Left side Elevation of 184 Broadway

Left Elevation

First Story:

- Raised foundation beneath first floor
- Horizontal sash basement window
- Staircase railings and enclosure projecting from entryway
- Large bracket on the right-side projecting from front elevation slightly recessed from left elevation
- Projecting subtle polygonal bay rising from basement

Second Story:

- Continued subtle stacked bay
- 1 or 2 square picture windows asymmetrically arranged
- 2 1-over-1 modern sash windows on sides of bay

Third Story:

Fourth Story:

- Wide eave overhang topped with cornice bordering a small parapet

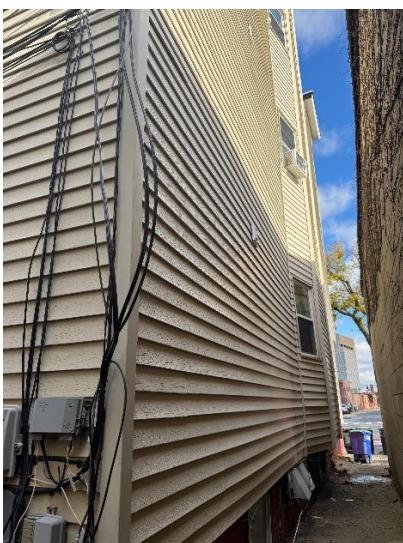
Rear Elevation of 184 Broadway

Rear Elevation (not fully visible)

First Story:

- Raised foundation beneath first floor
- Horizontal sash basement window

Second Story:

- Unknown fenestration
- Little to no architectural detailing

Third Story:

Fourth Story:

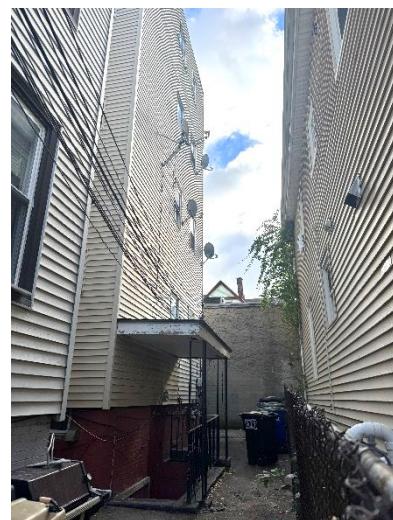
Right Side Elevation of 184 Broadway

Right Elevation

First Story:

- Raised foundation beneath first floor
- 3 to 4 1-over-1 modern vinyl sash windows asymmetrically arranged
- Projecting rear floors rising from basement
- Sunken basement entryway with steps descending from ground level side yard

- Flat roofed hood over basement entryway supported by metal posts

Second Story:

- Continued projecting rear upper floors
- 3 to 4 1-over-1 modern vinyl sash windows asymmetrically arranged

Third Story:

Fourth Story:

- Continued projecting rear upper floors
- 3 to 4 1-over-1 modern vinyl sash windows asymmetrically arranged
- Large bracket on the left side projecting from front elevation
- Small parapet topped with cornice with a slight overhang

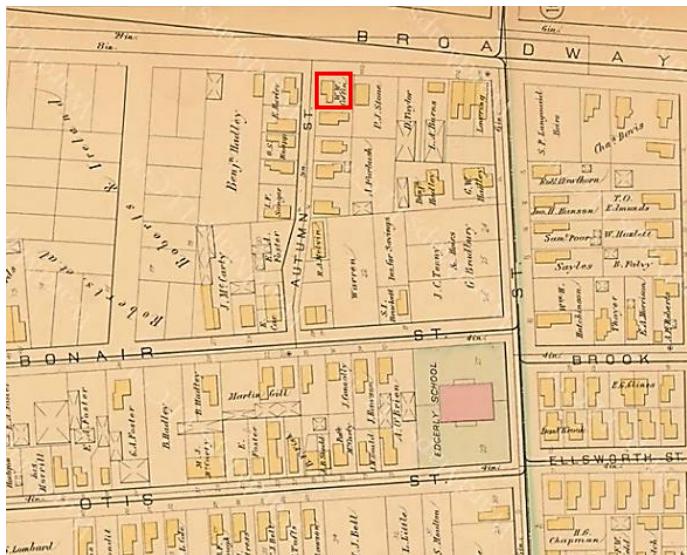
1884 Bromley Map:

184 and 186 Broadway are one lot, the structure at 184 Broadway has not been built yet, and the owner is listed as W. W. Coffin.

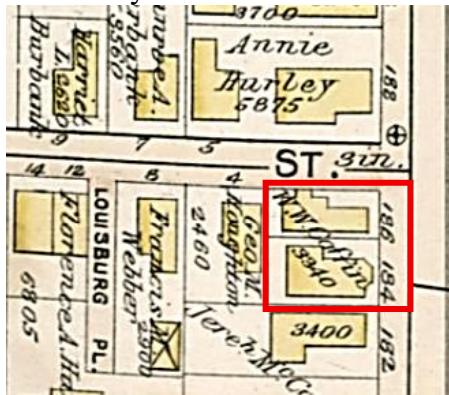
1895 Bromley Map

In 1875, Winslow and Florence Coffin had their only child, a daughter, Fanny Ethel Coffin. By 1895, the residential structure at 184 Broadway had been fully constructed. On the 1895 Bromley map shown below, W. W. Coffin is listed as the owner for both 184 and 186 Broadway.
