STEP 1: DETERMINATION OF HISTORIC SIGNIFICANCE
STAFF REPORT

Site: 143 Walnut Street

Case: HP25-000114

Legal Ad: *The Applicant seeks to demolish an accessory structure constructed a minimum of 75 years ago.*

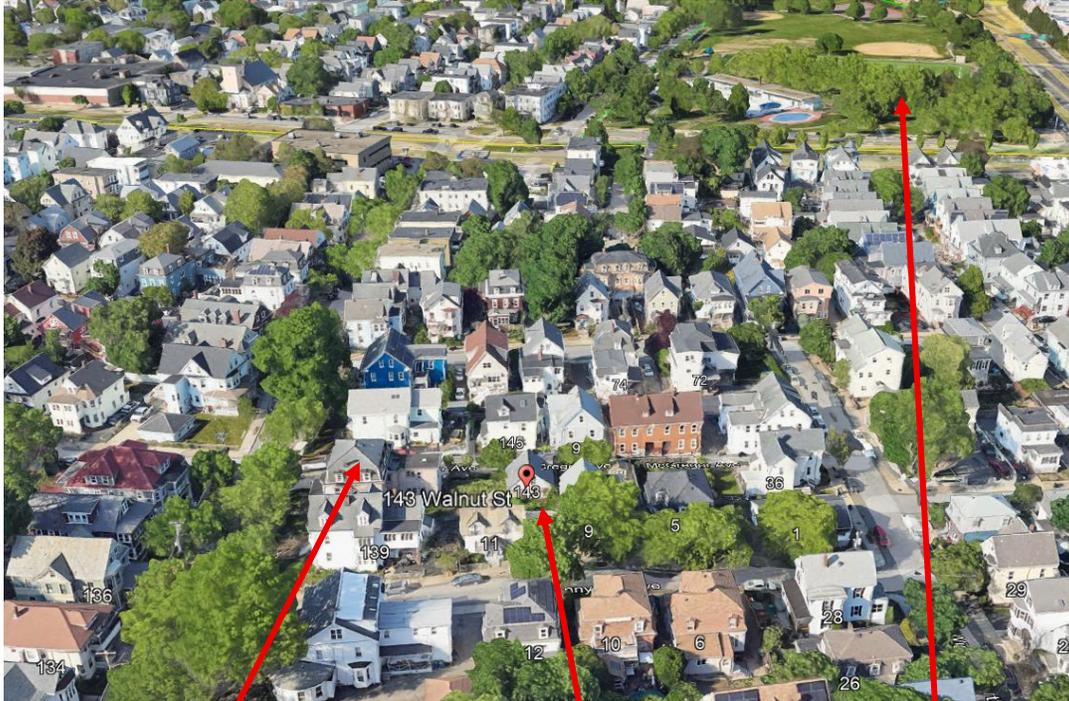
Context Map:

Principle Structure
141 Walnut:
John Ayre House

Subject Property:
Accessory Structure
at 143 Walnut St

Foss Park

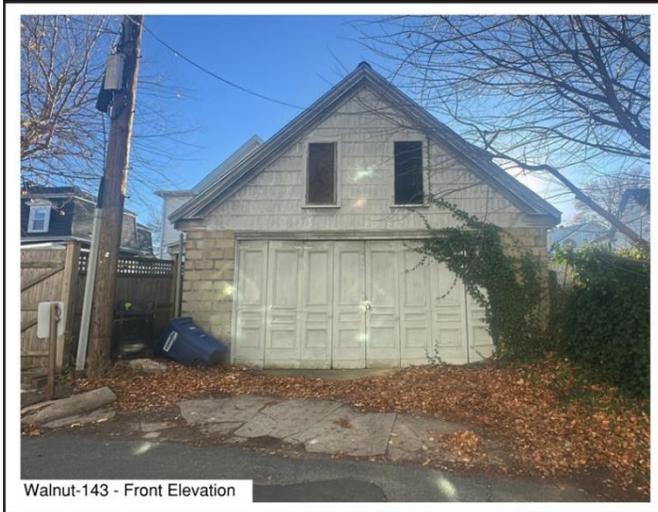
Walnut-143 - Front Elevation

- Large multi- panel garage door system with recessed vertical detailing.

- Two evenly spaced boarded up windows
- Moderate eave overhang, boxed without brackets
- Front gabled roof with a steep pitch

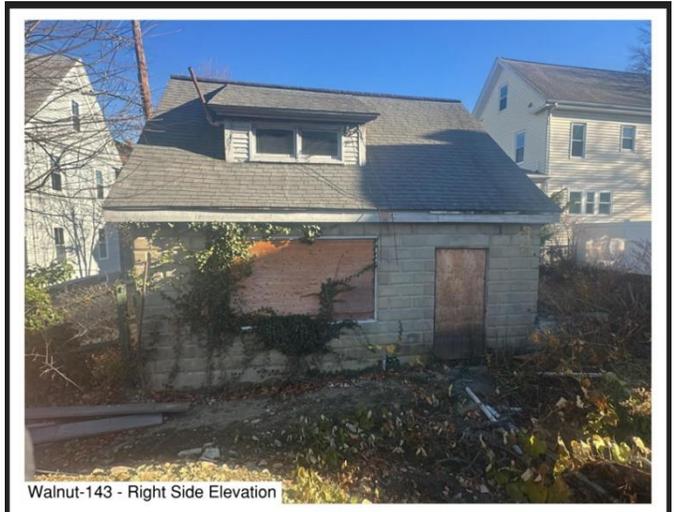
Walnut-143 - Right Side Elevation

- asymmetrical boarded up window and door opening

- moderate eave overhang
- asymmetrical shed dormer

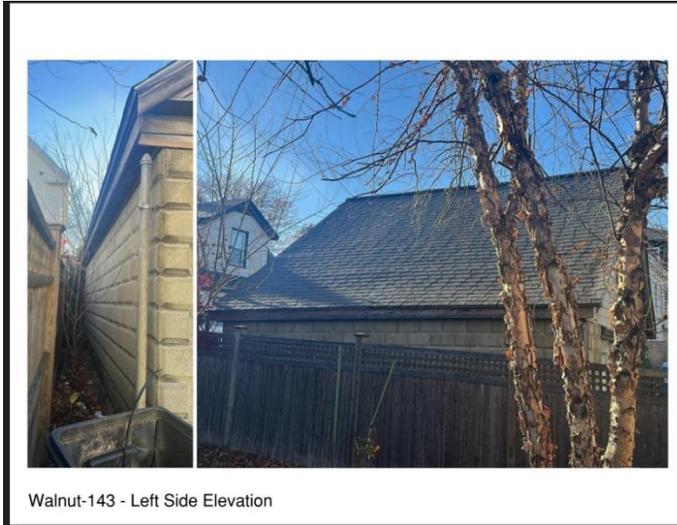
Walnut-143 - Left Side Elevation

- moderate eave overhang
- no windows or doors

- steep pitched gable roof

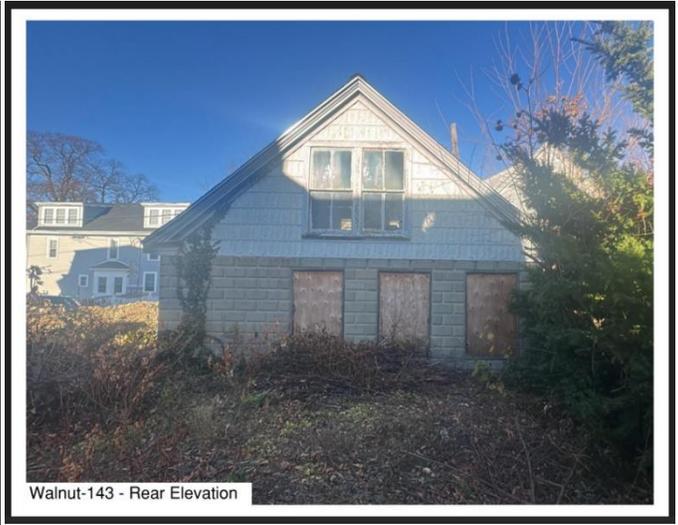
Walnut-143 - Rear Elevation

- three evenly spaced rectangular openings boarded up; were likely windows

- moderate eave overhang, boxed without brackets
- steep pitched gable roof
- symmetrical fenestration beneath gable
- double hung wood sash windows
