**STEP 1: DETERMINATION OF SIGNIFICANCE
STAFF REPORT**

Site: 5 Wilton Street

Case: HP26-000021

Legal Ad: *The Applicant seeks to demolish a principal structure constructed a minimum of 75 years ago.*

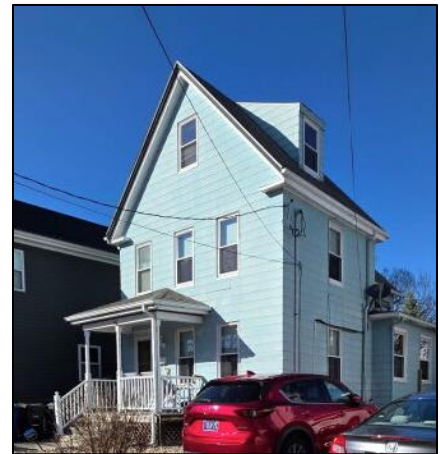
Top: Front elevation

- a) Location: This structure is in its original location.
- b) Design: The house is a two and a half story front gabled Italianate style home.
 - Front Elevation

- Front gable
 - Door with stoop/porch structure (appears composite material)
 - White railings
 - Stone Steps
 - Six one-over-one windows (likely replacement)

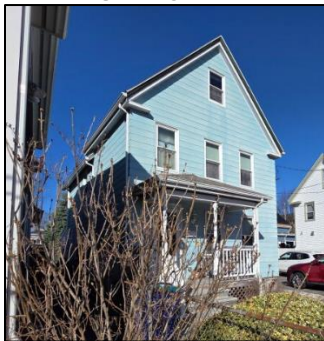
Bottom, left: Left elevation

- Basement window
 - Left Elevation (hard to see due to proximity to abutting structure)
 - Three one-over-one windows
 - Right Elevation
 - Dormer with one one-over-one window

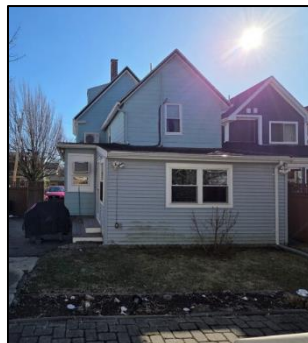
Bottom, middle: Rear elevation

- Siding: Asbestos shingles
 - Trim: Wood
 - Steps: Stone
 - Roof: Asphalt
- d) Alterations: The structure appears to a rear addition that does not appear on the historic maps.

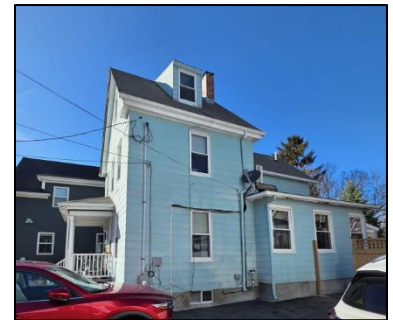
Bottom, right: Right elevation

- Chimney
 - Eight one-over-one windows
 - Rear door
- c) Materials
 - Foundation: Concrete
 - Windows: Likely aluminum
 - Entry Door: Aluminum outer door, wooden door
