**STEP 1: DETERMINATION OF SIGNIFICANCE**  
**STAFF REPORT**

**Site:** 60 Medford

**Case:** HP26-000037

**Legal Ad:** *The Applicant seeks to demolish a principal structure constructed a minimum of 75 years ago.*

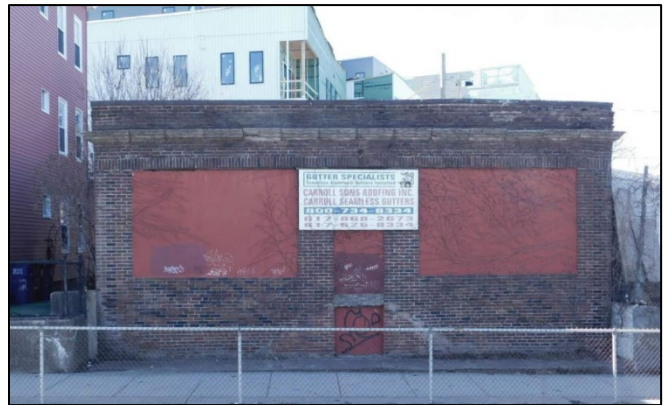
*Top: Front elevation*

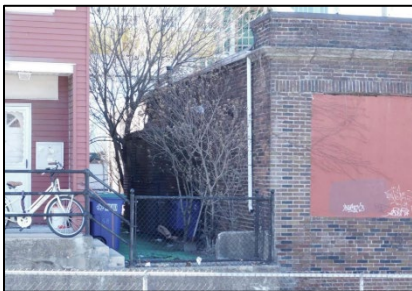
*Bottom, left: Left elevation*

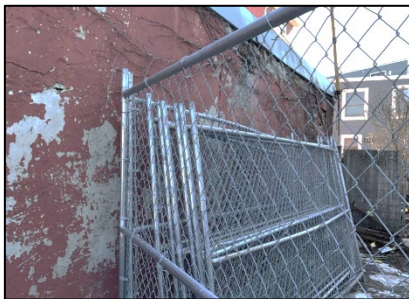
*Bottom, middle: Rear elevation*

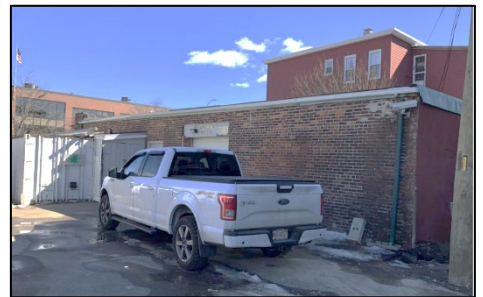
*Bottom, right: Right elevation*

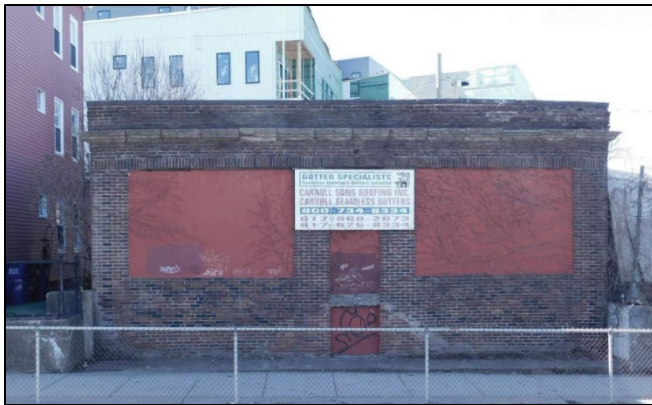
Top Left: front elevation of building  
Top Right: left elevation of building  
Bottom Left: right elevation of building  
Bottom Right: rear elevation of building

- Front Elevation
    - Flat roof with elevated bordering walls
    - Street facing brick commercial storefront
    - Two large storefront-sized window openings on front faced and center entry door, currently boarded up

- Running bond brickwork with soldier course above each window opening. Concrete cornice line below roofline.
  - Right Elevation
    - Brick façade with side entries and doors. Running bond brickwork below roofline.

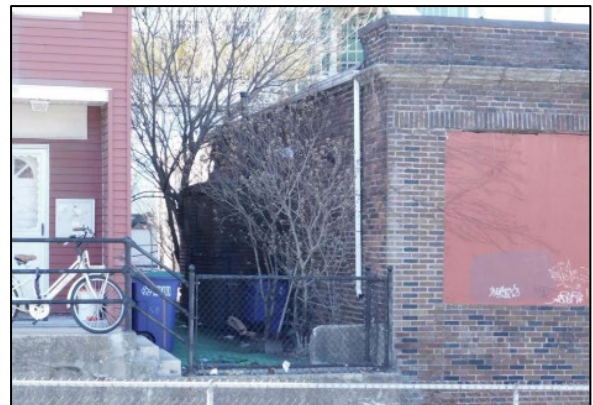
- Left Elevation
    - Brick façade. Running bond brickwork below roofline.
  - Rear Elevation
    - Painted concrete
- c. Materials:
  - Foundation: likely concrete or brick foundation
