**STEP 1: DETERMINATION OF SIGNIFICANCE**  
**STAFF REPORT**

**Site:** 64 Medford St

**Case:** HP26-000038

**Legal Ad:** *The Applicant seeks to demolish a  
principal structure constructed a minimum of 75 years ago.*

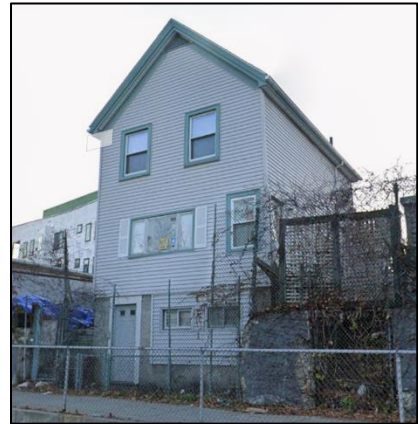
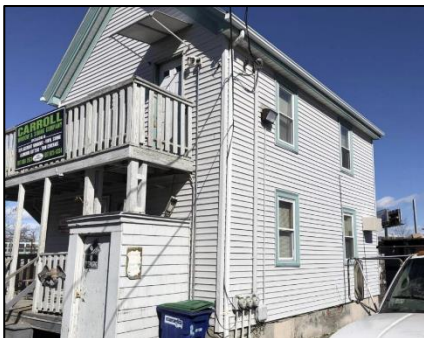
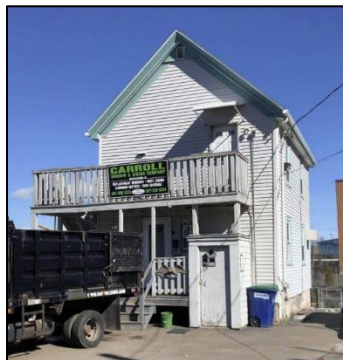
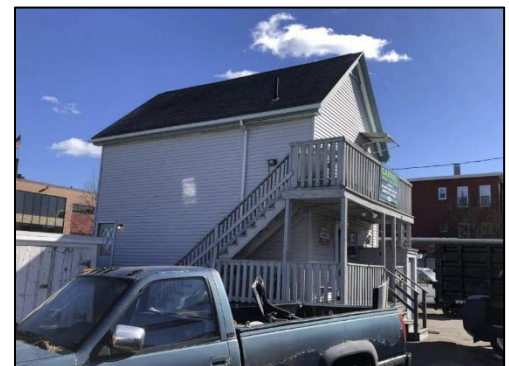
*Top: Front elevation*

*Bottom, left: Left elevation*

*Bottom, middle: Rear elevation*

*Bottom, right: Right elevation*

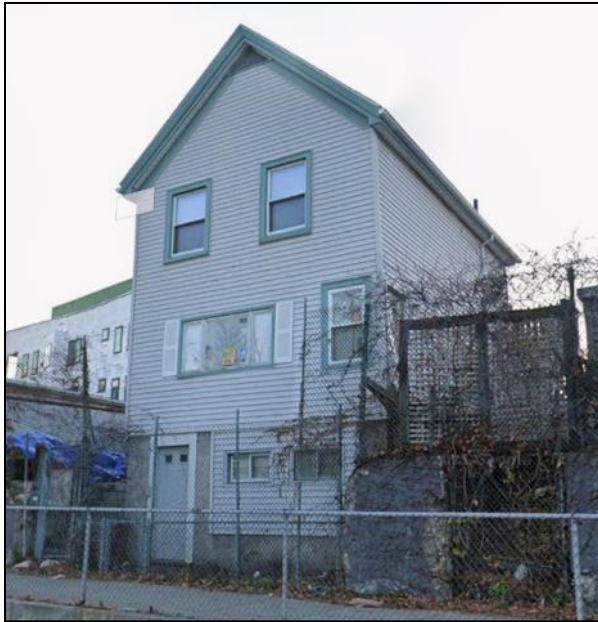
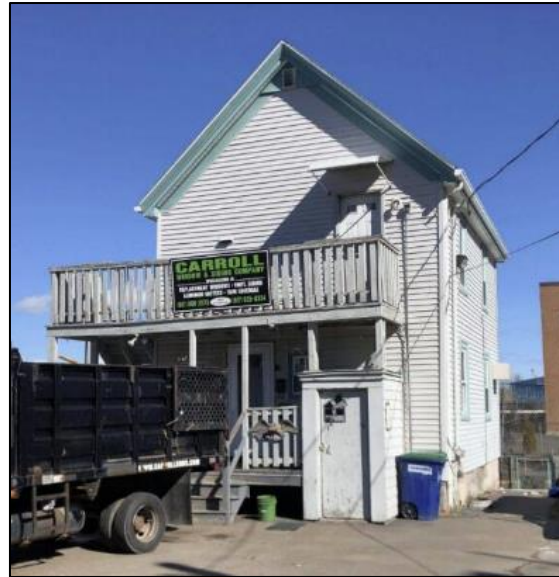
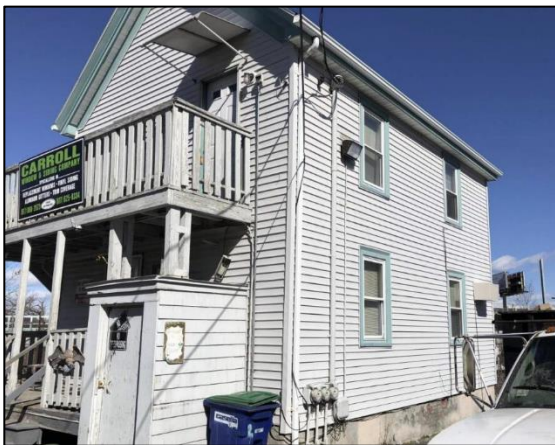
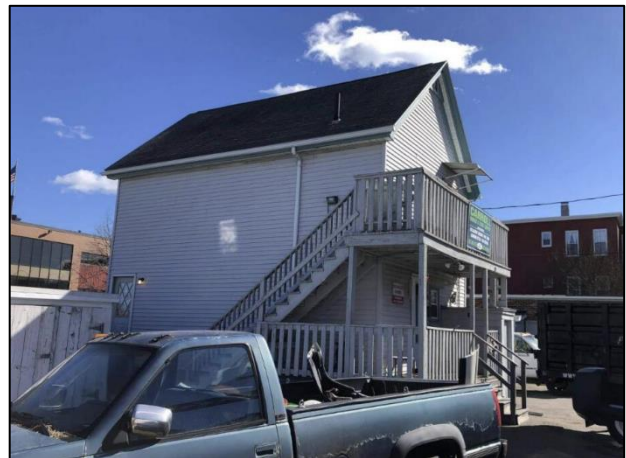
Top left : front elevation of the building  
Top right: rear elevation of the building  
Bottom left: left elevation of the building  
Bottom right: right elevation of the building

- a. Location: It is believed that the structure is in its original location. The building was constructed on-site sometime between 1884-1895
- b. Design: The building is a 2.5 story vernacular gable-front workers cottage with a covered porch on the rear elevation

- Front Elevation
    - Symmetrical front elevation
    - 2.5 story vernacular gable-front frame
  - Right Elevation
    - Asbestos siding with 4 windows

- Left Elevation
    - First floor side entrance
    - Steps to second floor porch
  - Rear Elevation
    - Covered first floor porch with rear steps
    - Second floor porch

- Entrance likely to basement level
- c. Materials:
  - Foundation: Likely concrete or brick
  - Windows: Likely aluminum
  - Entry door: Modern with storm door

- Siding: Vinyl shingle
  - Trim: Wood & likely aluminum
  - Steps: Wood
  - Roof: Gable and asphalt shingles
- d. Alterations: Modern replacement of doors and windows on the front elevation. Replacement of siding to vinyl shingle.

- e. Evaluation of Integrity of 64 Medford Street: Based on the observations of the building and a study of the historic maps, it is Staff's position that the building retains most of the integrity of its original form. Alterations have occurred to this structure which obscure some original details; however, the original massing and key architectural details such as the gable roof feature remain intact.
