**STEP 1: DETERMINATION OF SIGNIFICANCE**  
**STAFF REPORT**

**Site:** 3 Cameron Ave

**Case:** HP26-000042

**Legal Ad:** *The Applicant seeks to demolish a building constructed a minimum of 75 years ago.*

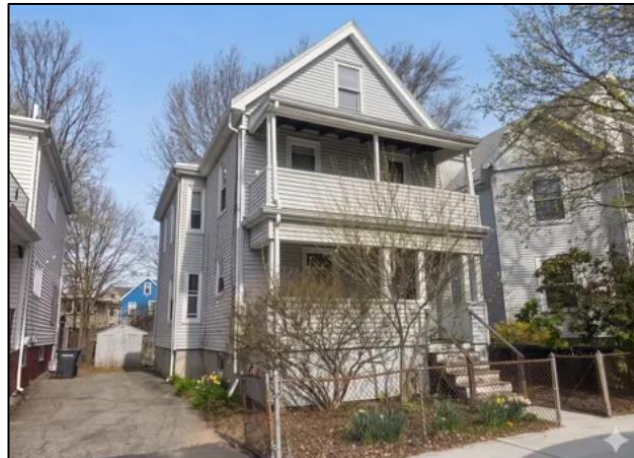
*Top: Front elevation*

- The front elevation presents a gable
- There was a front porch, likely made of concrete and wood, with a railing that was possibly made of vinyl
- The front door was possibly vinyl
- Six one-over-one windows are visible that were likely not original

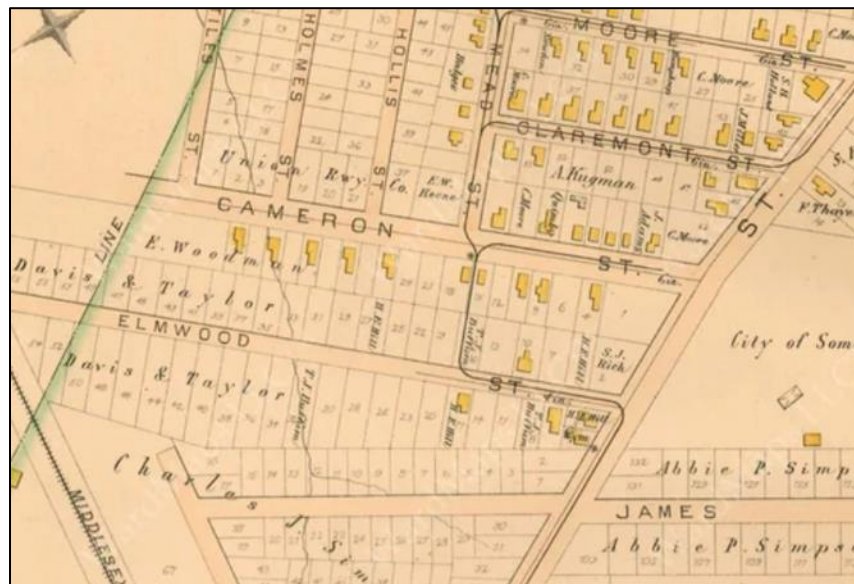
*Above: 1884 Hopkins map with location of 3 Camerone Ave Highlighted*

The maps of 1884 and 1895 below effectively illustrate the steady transformation of the area between Holland Avenue and the Lexington–Arlington rail line from agricultural to developed.

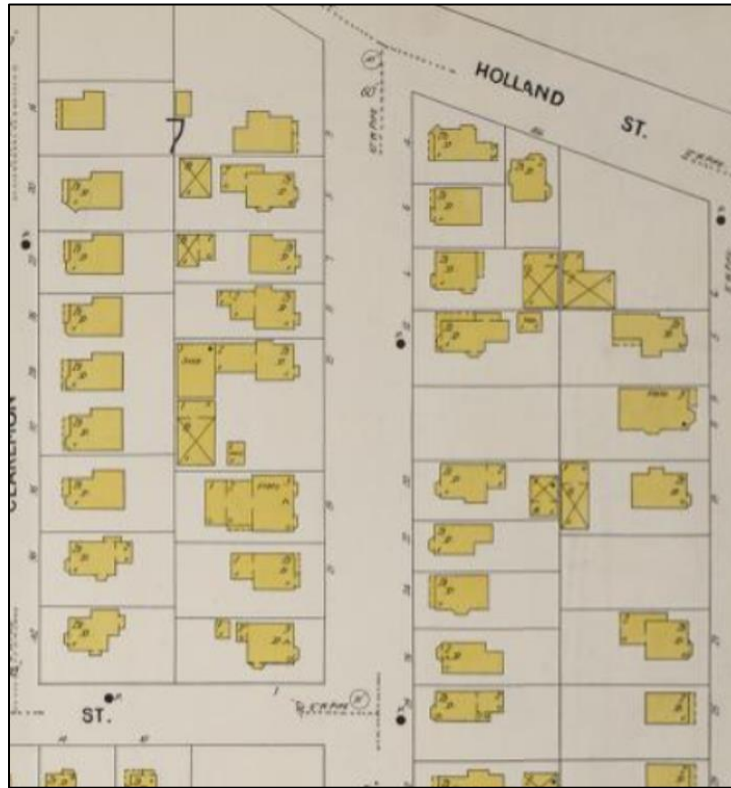
*Above: 1900 Sanborn map with location of 3 Camerone Ave Highlighted*

On the 1900 Map below, we can see the surrounding area in a similar state as 1895 and the building footprint of 3 Cameron Ave remaining the same. We can also see that a garage pops up on the property by this time. This garage remained on the site until it was approved for demolition in 2025.

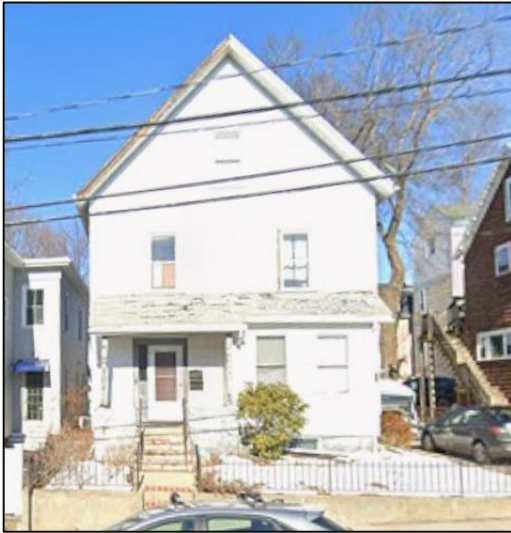
*Above: front façade in 2022, prior to construction*

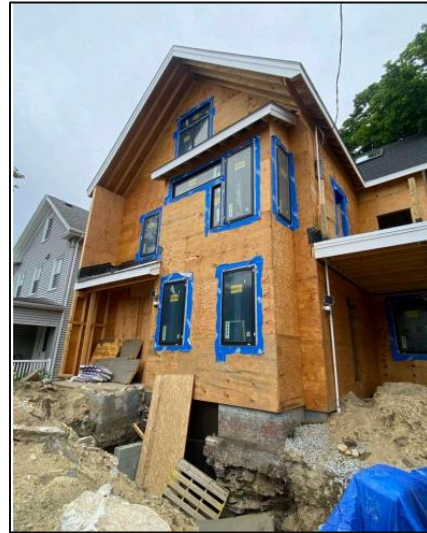
**Staff Note:** This property has already begun demolition, as they have demolished more than fifty percent of the building while removing sheathing. A Stop Work Order has been placed on the property by the Inspection Services Department (ISD). A determination from the HPC is needed to see if the house is historically significant and the work can continue.

*Above: current front facade*

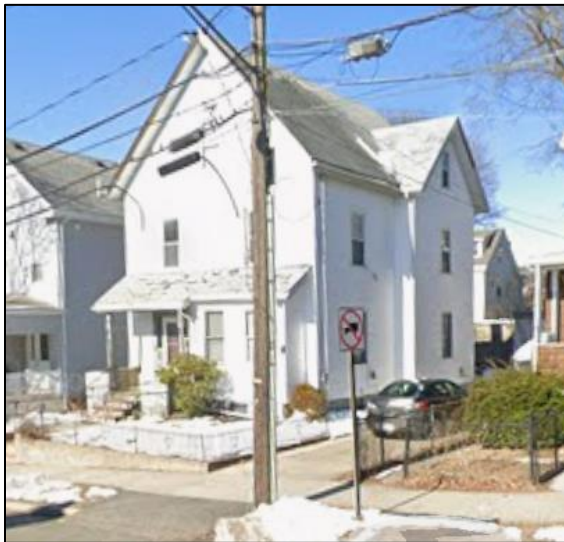
*Above: Right façade in 2022, prior to construction*

- The right elevation presented formerly vinyl siding over a wood and concrete base
- There are five one-over-one windows that were likely vinyl and likely not original

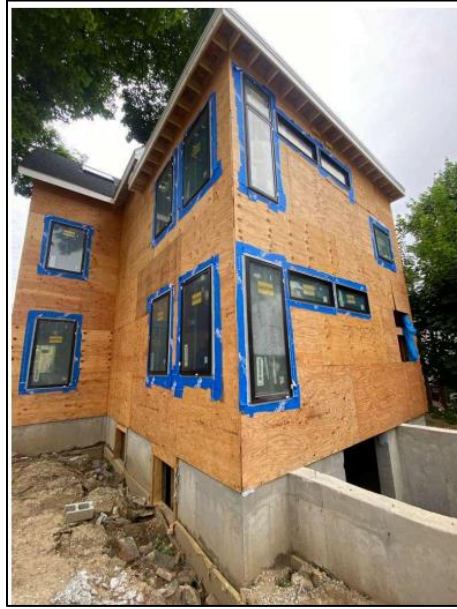
*Above: current rear facade*

- The applicant did not present images of the rear prior to construction, but it can be inferred that it likely contained vinyl siding and one-over-one vinyl windows like the rest of the house
- The roof appears hipped from the rear
