**STEP 1: DETERMINATION OF HISTORIC SIGNIFICANCE**  
**STAFF REPORT**

**Site:** 83 Wallace Street

**Case:** HP26-000053

**Proposal:** *Demolish principal structure.*

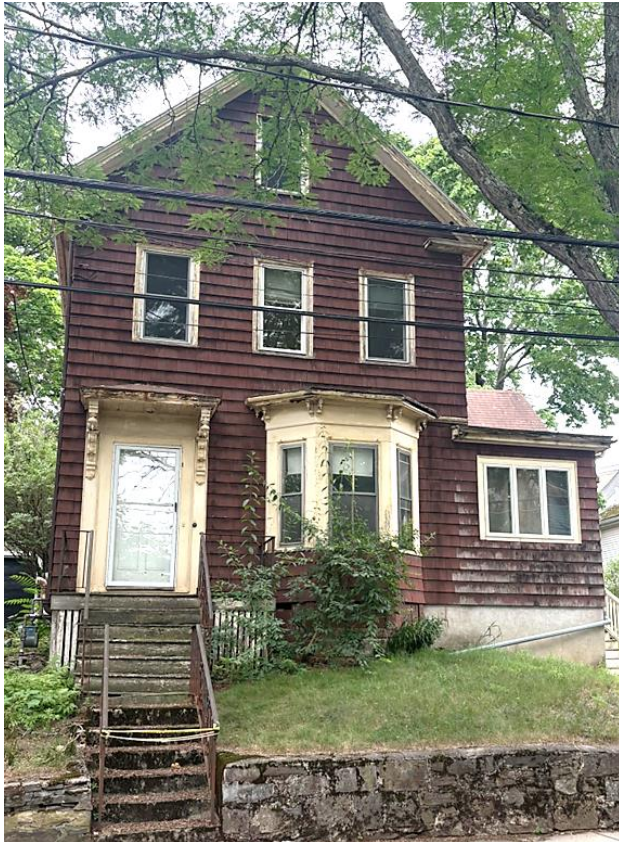
*Above: Front elevation of 83 Wallace St*

- a. Location: The structure is in its original location.
- b. Design: Two and a half story Italianate with a steep front facing gable and shingle cladding on the exterior. Steeply pitched gable roof, ornamental, bracketed surrounds at principle first floor openings, and a three-sided projecting bay with detailed brackets. Ornamental window surrounds, projecting bays on both the front and right sides, bracketed cornices, and vertical emphasis are qualities of the Italianate style particularly found in New England during the 1880s.

Principle entrance on the left side of the front façade with an open, covered portico supported by decorative brackets and a coordinating surround. Double-hung windows with symmetrical arrangement on the front façade. There appears to be a period doorbell or entry bell to the right of the open portico.

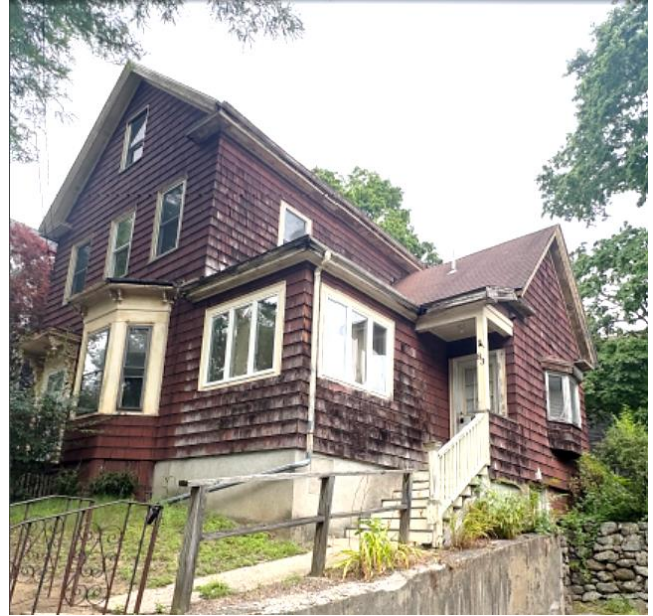
*Above: Right side elevation of 83 Wallace St*

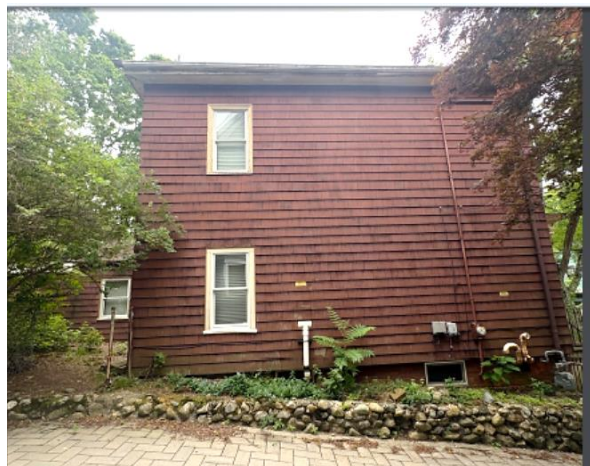
*Above: Left side elevation of 83 Wallace St*

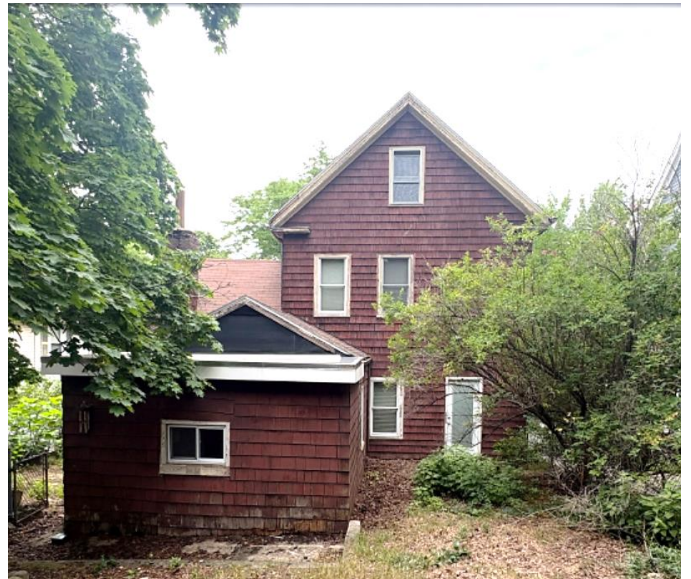
*Above: Rear elevation of 83 Wallace St*

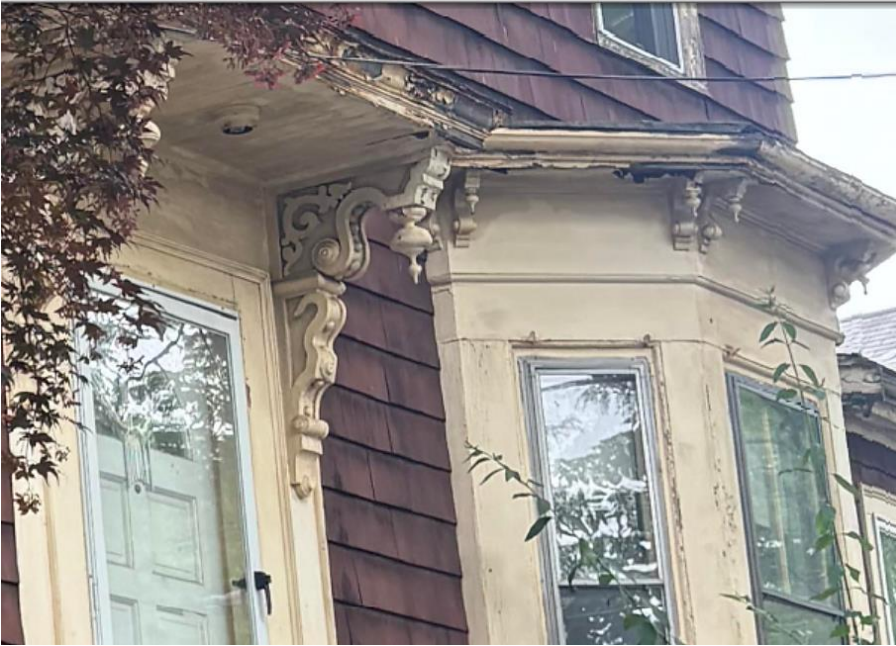
*Above: Details of front entrance and bay window Italianate brackets on 83 Wallace St*

- c. Materials: Shingle siding, stone front steps with metal rails; asphalt shingling on roof; brick and concrete foundation; wood decking on front portico; wood door; wood bracket details flanking front door and front bay window; window material unknown; brick chimney stack; wood detailing (molding & cornices).
- d. Alterations: Windows appear to have been replaced with vinyl, but surrounds and mostly intact. Exterior doors are not original. Unknown if the right side was extended with an addition at some point.

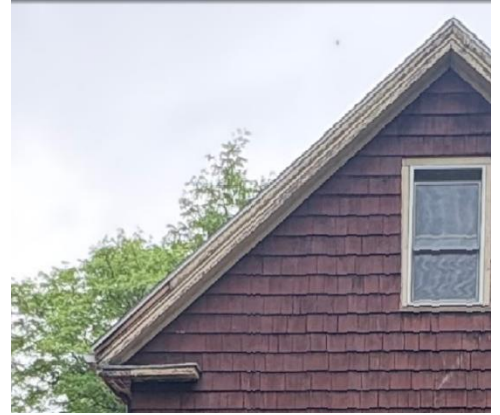
*Above: Details of rear boxed cornice on 83 Wallace St*

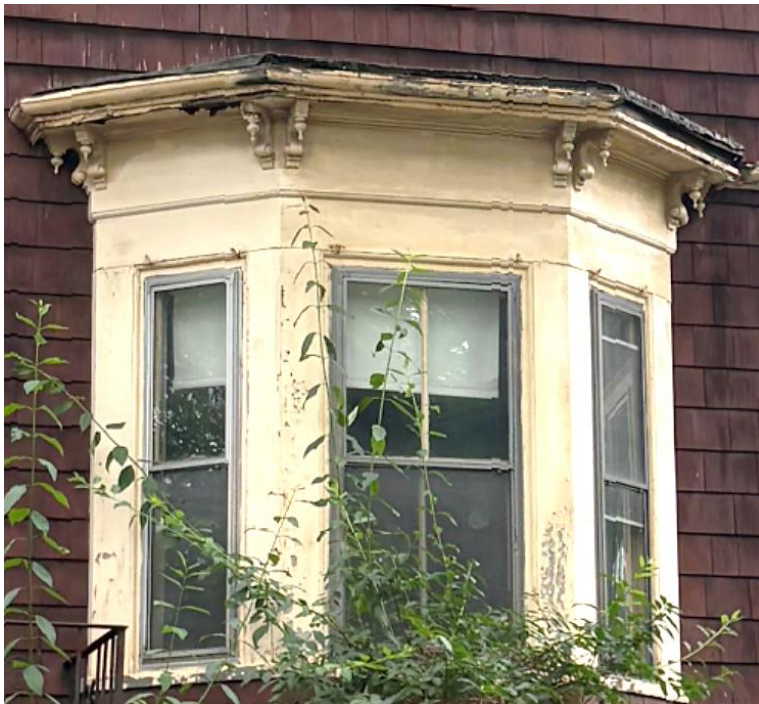
*Above: Details of projecting bay window with Italianate brackets on 83 Wallace St*

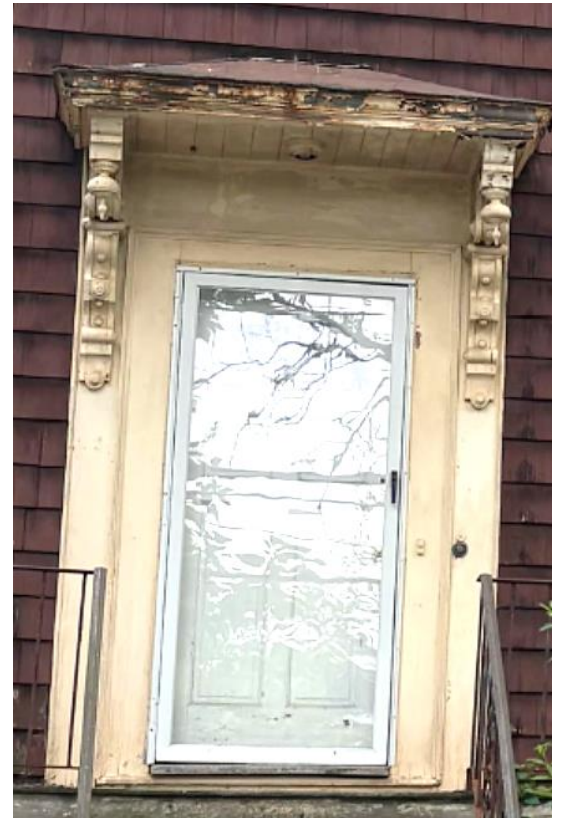
*Above: Principal entrance on 83 Wallace St*

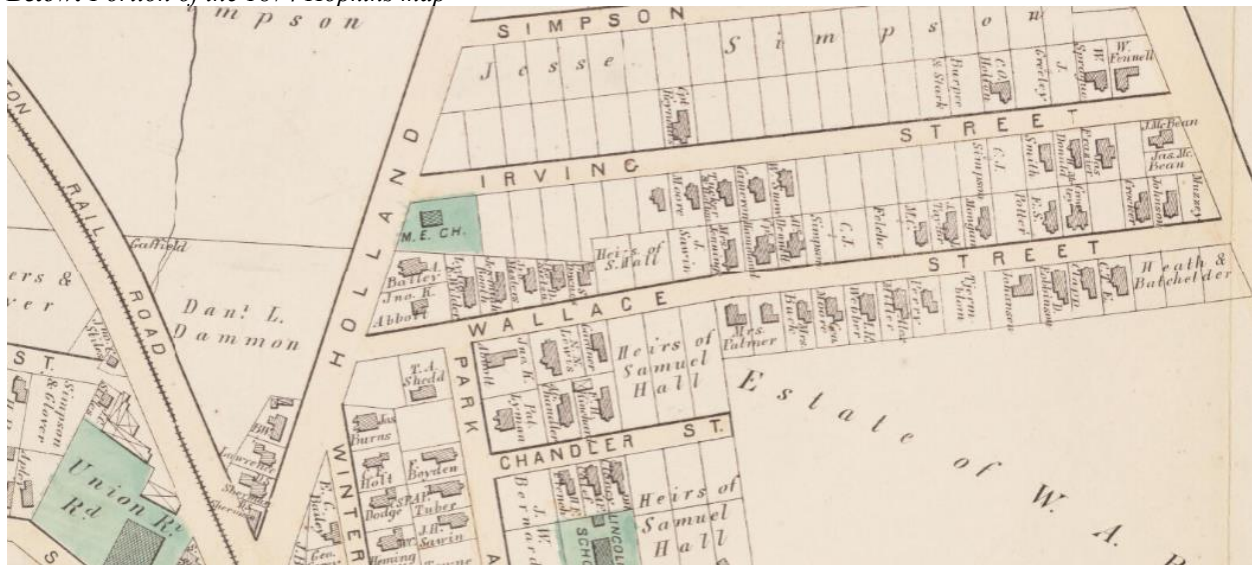
*Below: Portion of the 1874 Hopkins map*

The Davis Square neighborhood had a rapid increase in density due to the expansion of the Boston & Lowell Railroad reaching Somerville in the 1830s, and Fitchburg Railroad in the 1840s. A branch through what became known as Davis Square opened in 1870. Following these railway expansions, Somerville experienced an influx of suburban growth. At that time, farmers and their heirs began subdividing their land into residential tracts. (as shown on the 1874 Hopkins Map below)

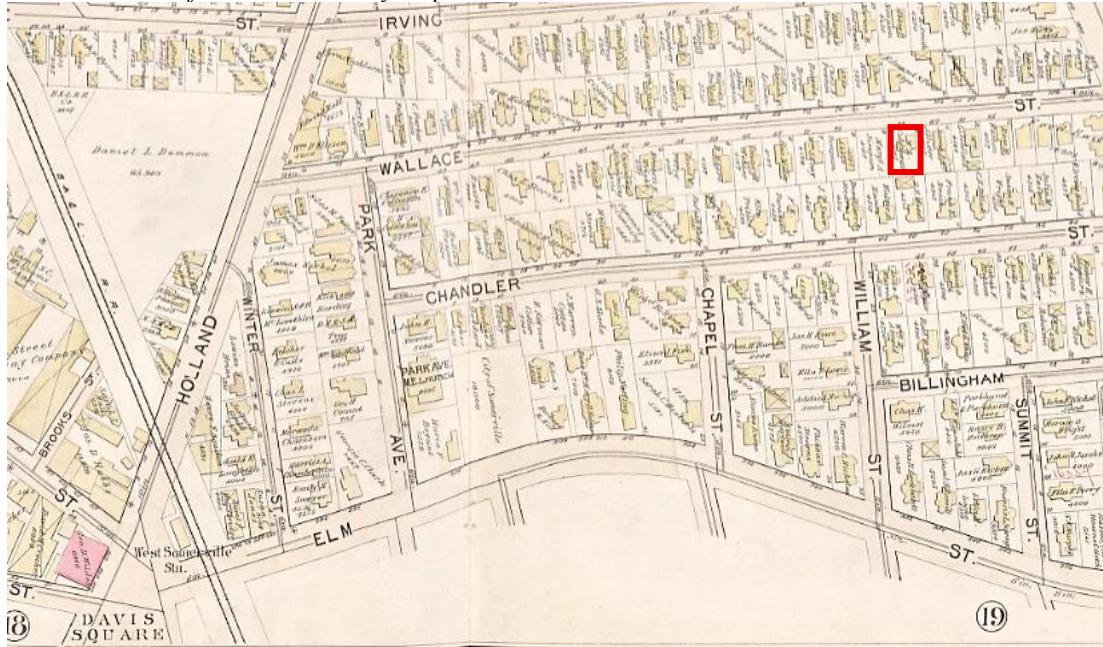
*Below: Portion of the 1895 Bromley map*

Historic map research indicates that this portion of Wallace Street and the surrounding neighborhood had dense development patterns by the 1880s. The 1895 Bromley map is the first time the house at 83 Wallace St was recorded. By this time, most blocks in the subject property's vicinity had been fully subdivided and developed.

On the 1895 Bromly map, the owner is listed as M. L. Goldthwaite.
