**Case #:** HPC 2018.051  
**Date:** June 19, 2018

**PRESERVATION STAFF REPORT**

**Site:** 27 Columbus Avenue

**Petition:** Peter Sisk, Owner, seeks permission from the Somerville Historic Preservation Commission (HPC) to alter the gutters and repair fascia and brackets

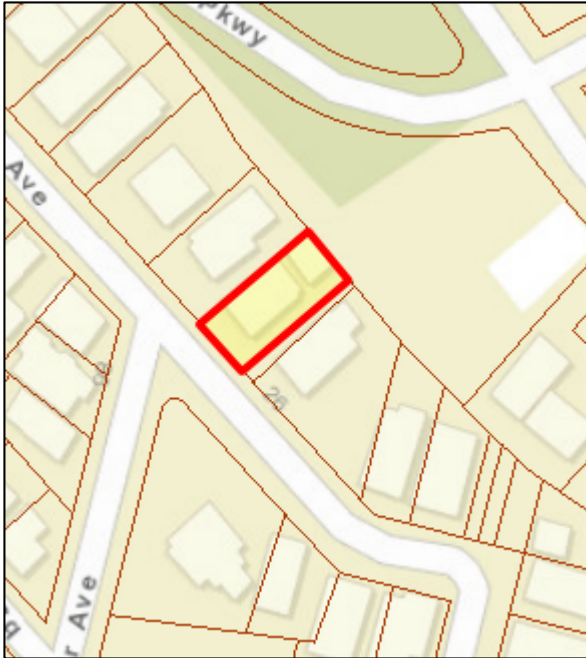
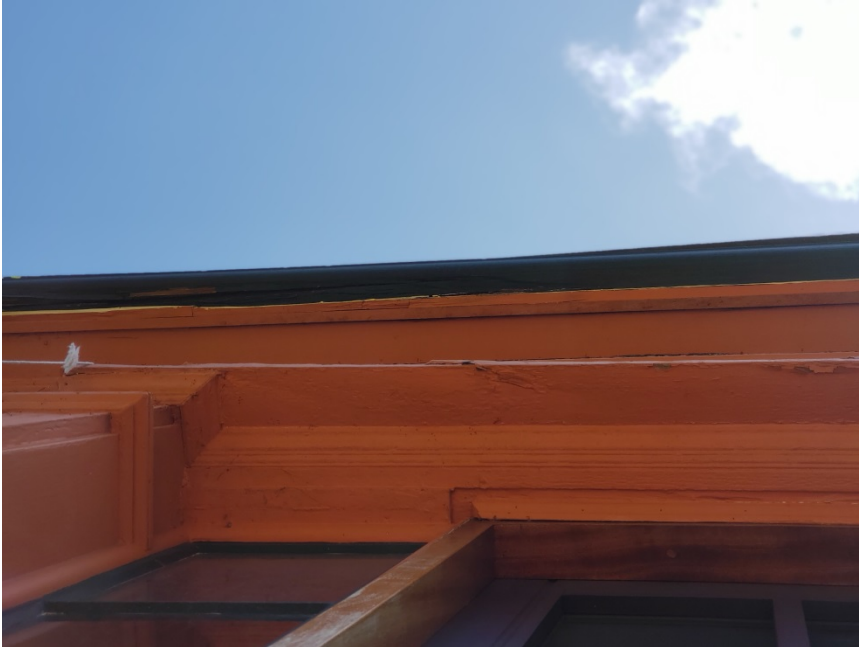
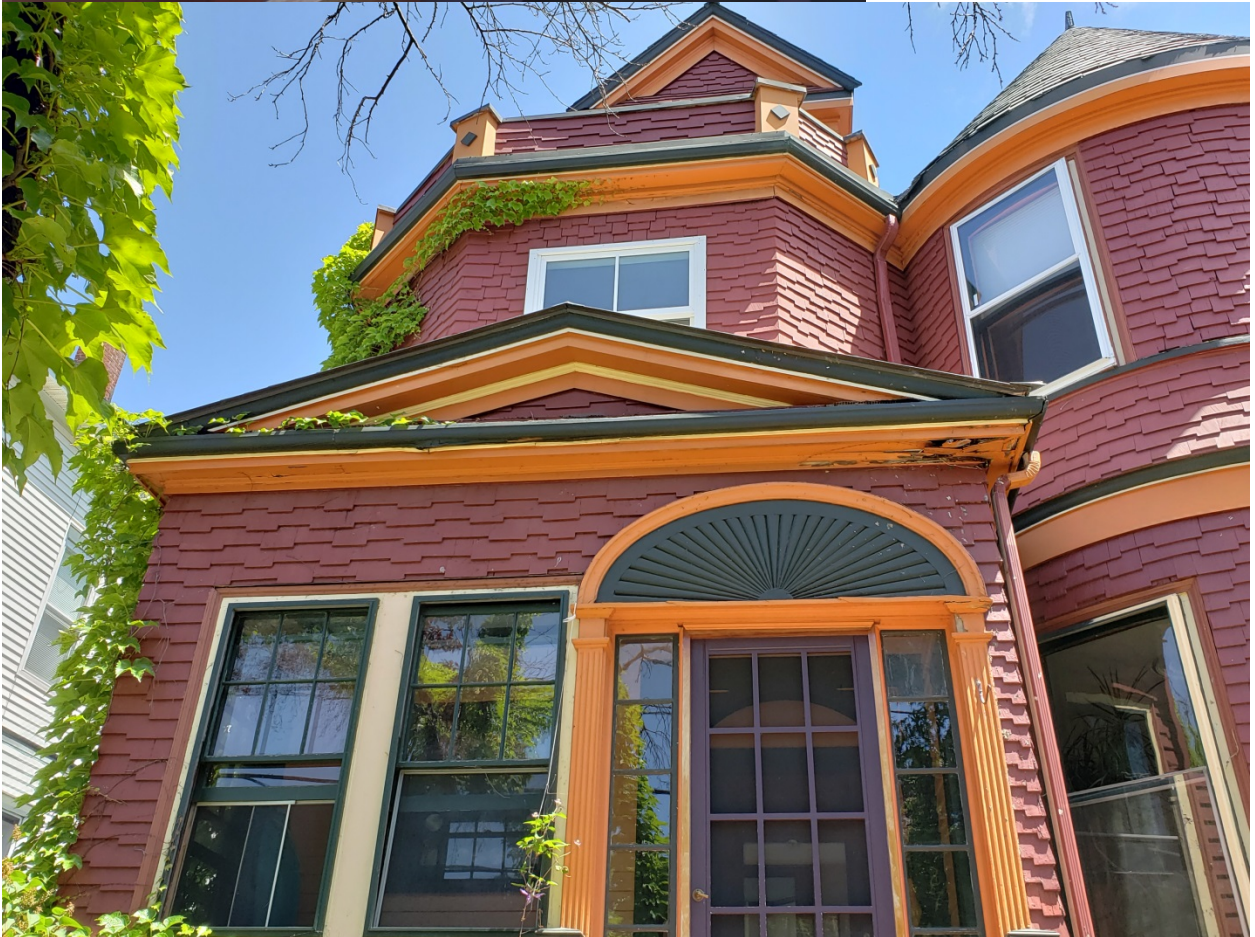
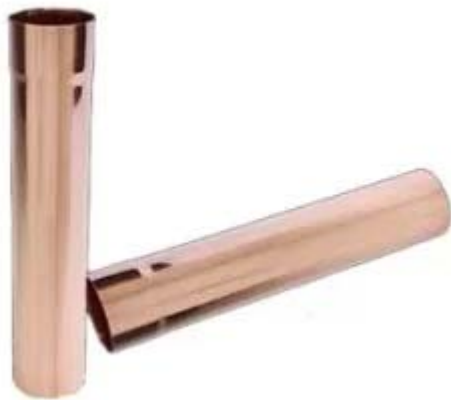
**Staff Findings:** No report from a wood gutter specialist was requested regarding the condition and feasibility of retaining the existing gutters. It should be noted that the proposed gutter is not inappropriate for the time period. There simply is no evidence that this house ever had copper gutters.

The existing wood gutters complement the curves and moldings of the elaborate Queen Anne massing. They blend with the rake moldings and cornices. The proposed ½ round copper gutter, while historically appropriate for the time period, does not continue the elaboration but rather is seen as an addition.

Staff finds that in all probability the use of wood gutters is original to the building and therefore more appropriate than the proposed copper ½ round gutters and therefore recommends repair or replacement in kind of the wood gutters. They further recommend that the Applicant devise a regular maintenance schedule for the wood gutters.

1. All appropriate building permits shall be obtained prior to the start of any work.
2. The rotted and damaged wood gutters shall be replaced in-kind to match the existing.
3. Historic Staff shall issue a sign-off upon completion of the project that this was done in accordance with the Certificate and approved plans.
