CITY OF SOMERVILLE, MASSACHUSETTS
MAYOR'S OFFICE OF STRATEGIC PLANNING & COMMUNITY DEVELOPMENT

HISTORIC PRESERVATION COMMISSION

PRESERVATION STAFF REPORT

Site: 46 Atherton Street

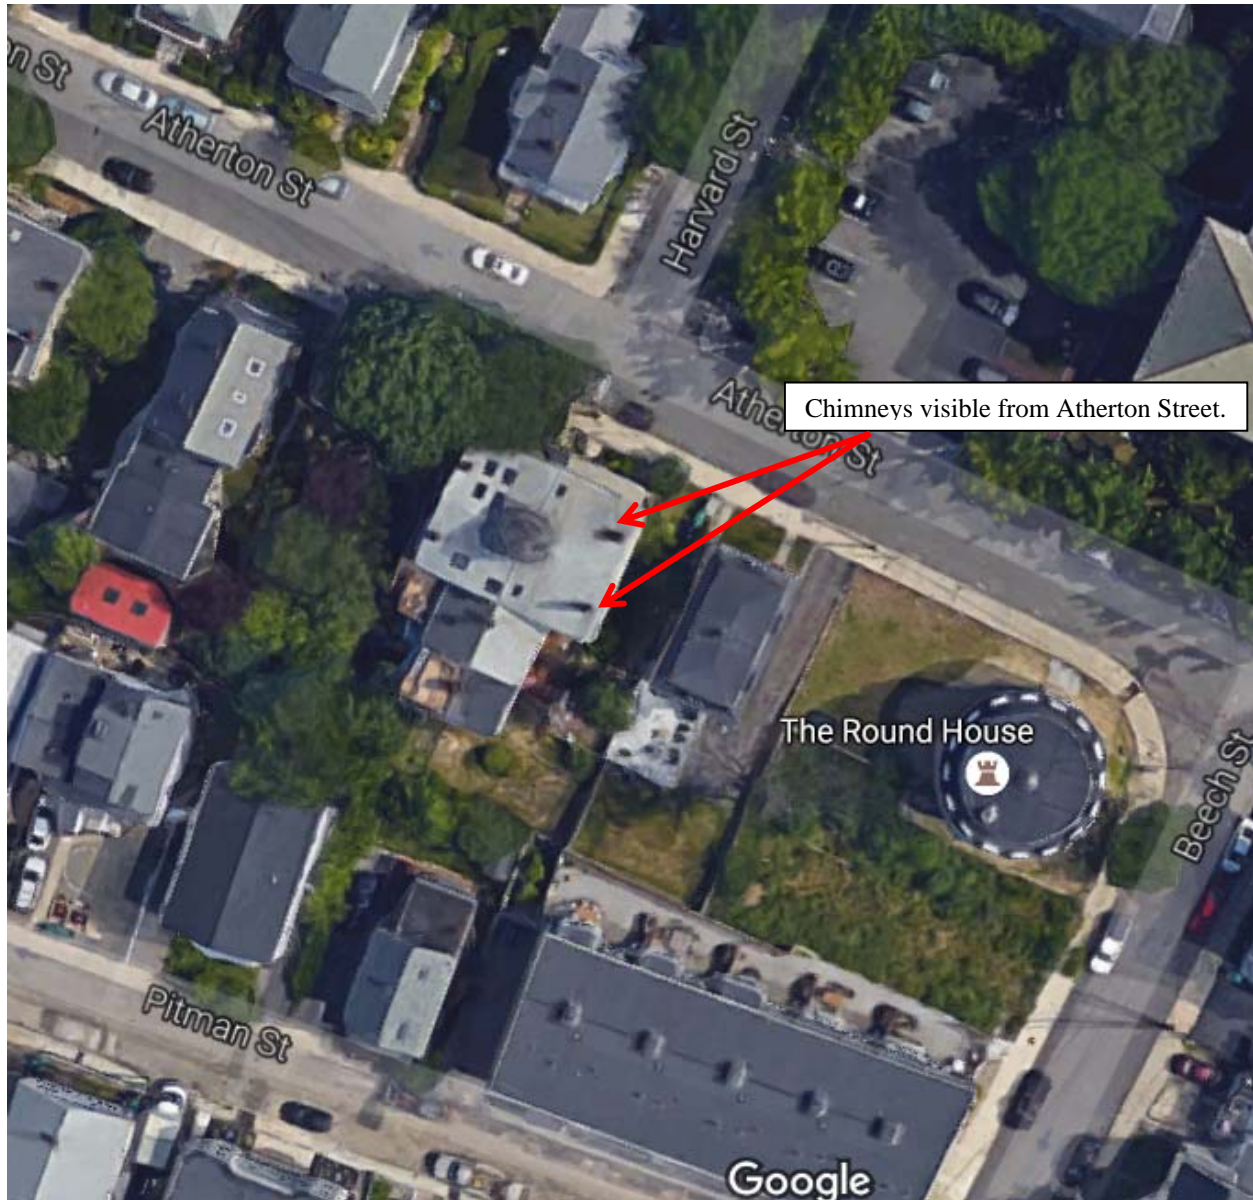
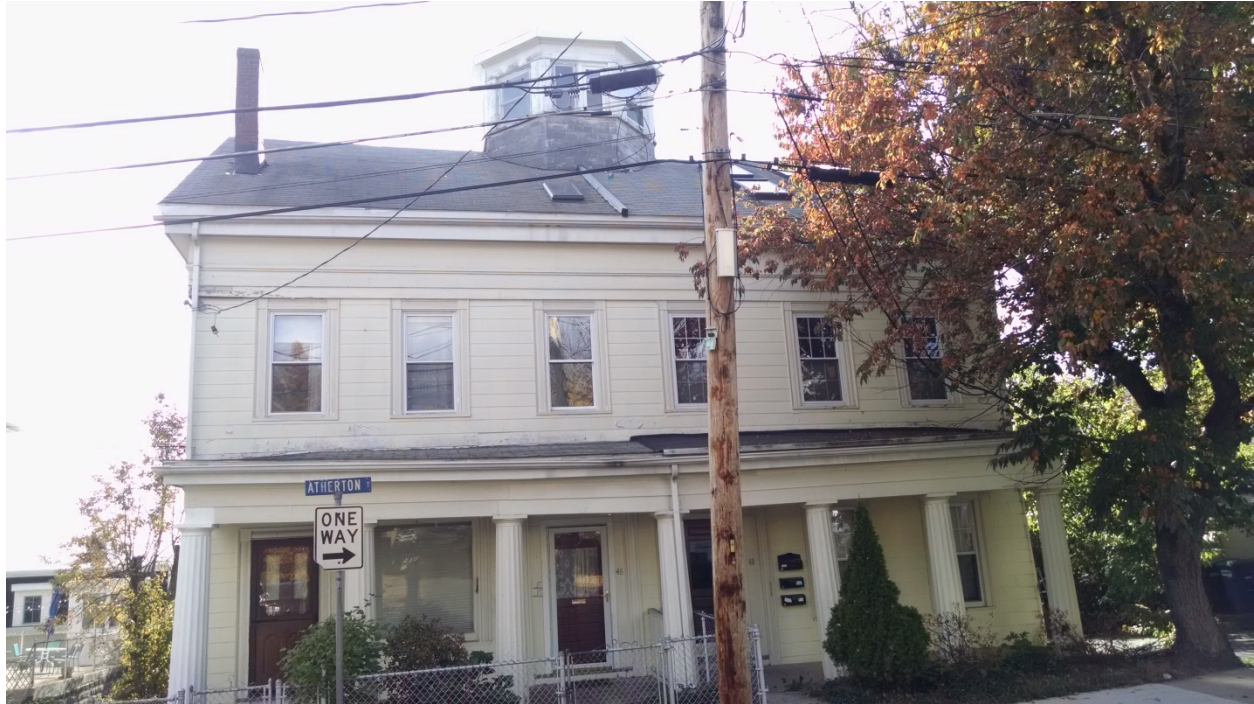
Proposal: The Applicant would like to remove the existing chimneys due to their interior condition. The Applicants agreed that the front-most chimney adds to the aesthetics of the house, however, rebuilding it is not in their budget at this time due to the ongoing work on the rest of the house. They would like to either add a faux chimney box, or rebuild it at a later date. The Applicant believes that neither chimney is original, and neither have any significant historical value. Both chimneys are in very poor condition, and in danger of falling through the floor. See attached photos.

Front chimney and basement photo

Staff finds that if the chimneys at 46 Atherton Street are demonstrably un-sound, they should be reconstructed. Rebuilding chimneys from attic beams up or constructing boxes with veneer brick often the leads to leaks and further damage due to differential expansion and contraction of the various components. The traditional method of building chimneys from the ground up and surrounding them with a timber frame gives the greatest stability to the entire system. Flashing should be of sufficient size to form a seal between the materials and the elements.

A Certificate of Non-Applicability shall be issued for the reconstruction of the chimneys in-kind.

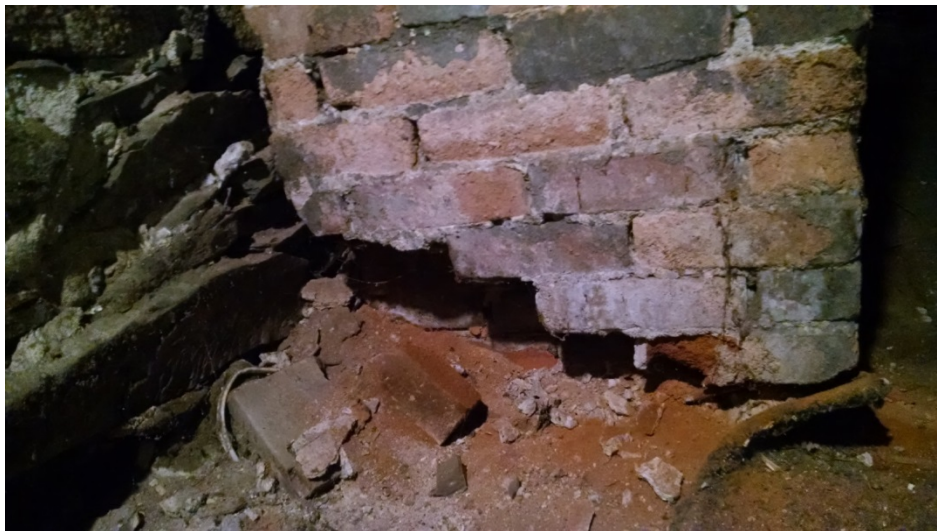
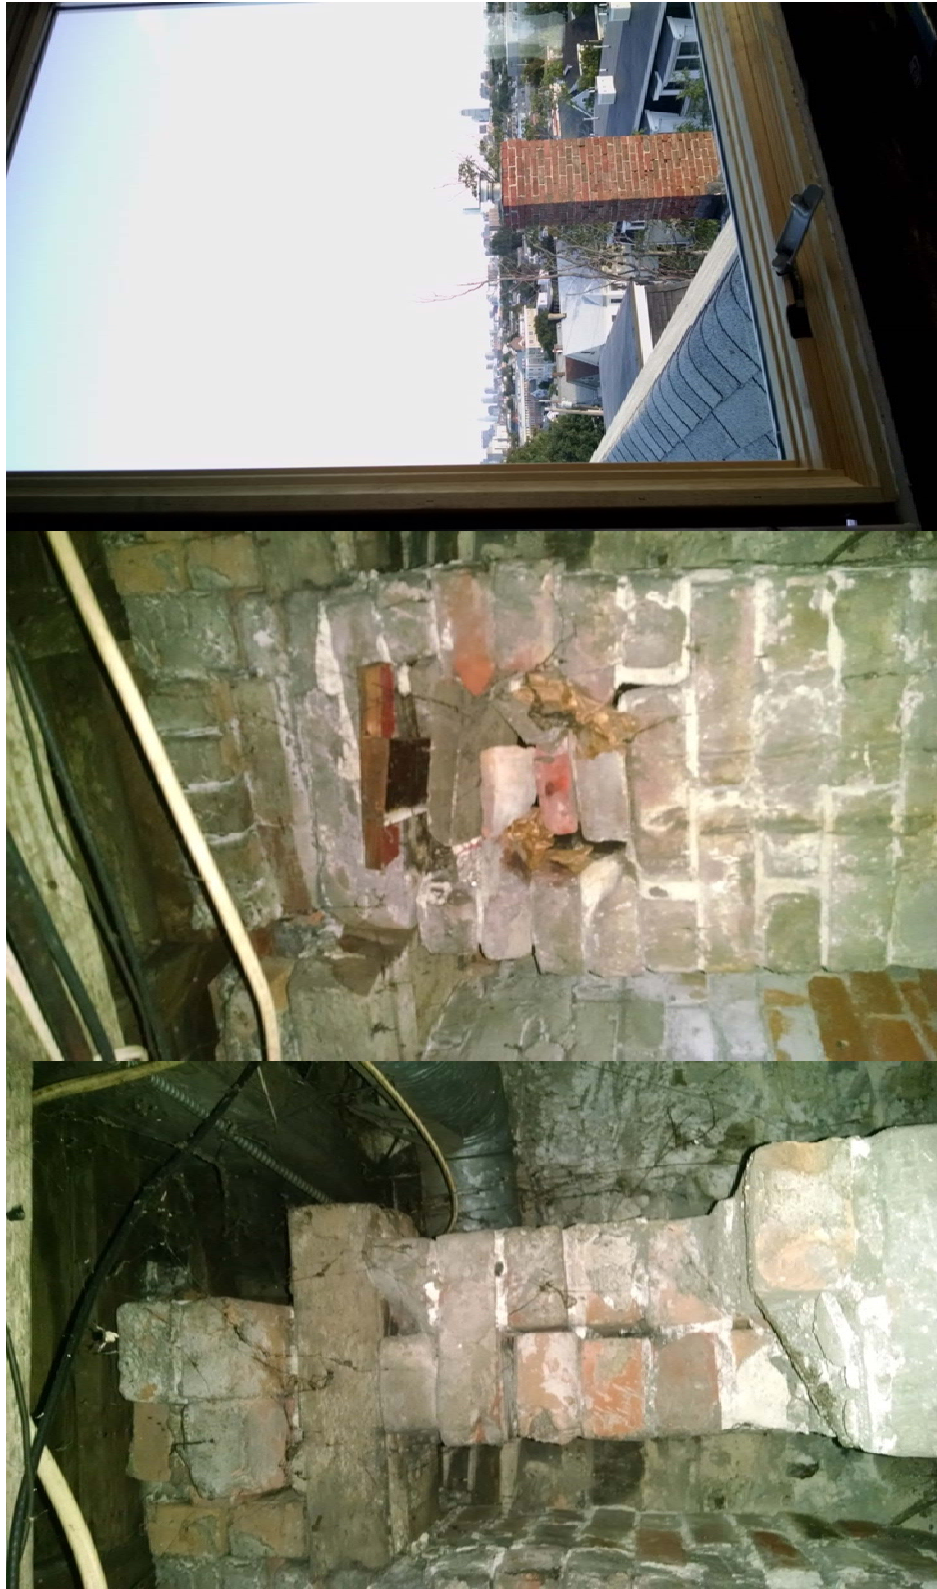
Rear chimney and basement photos

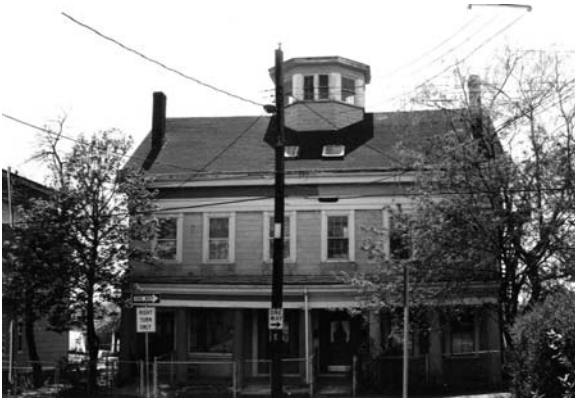
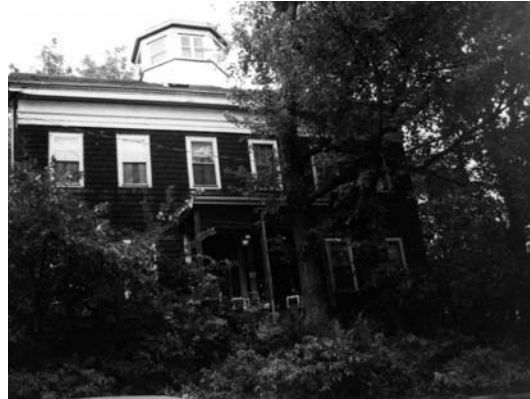
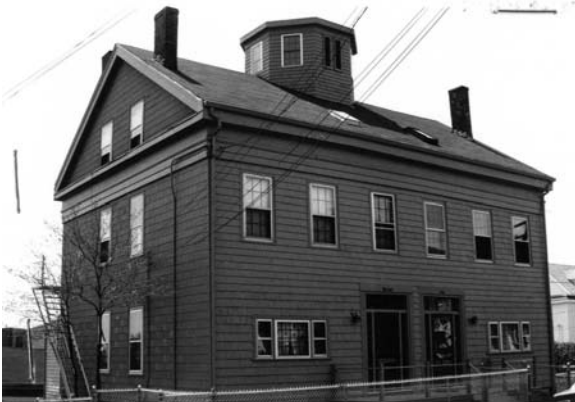
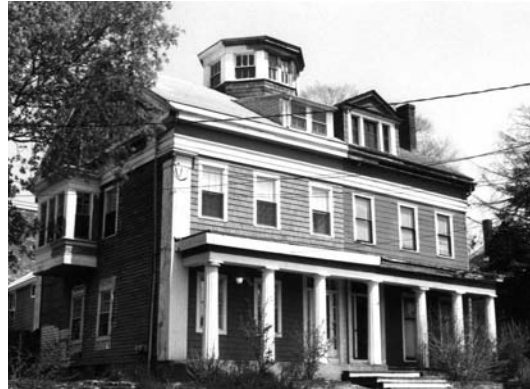
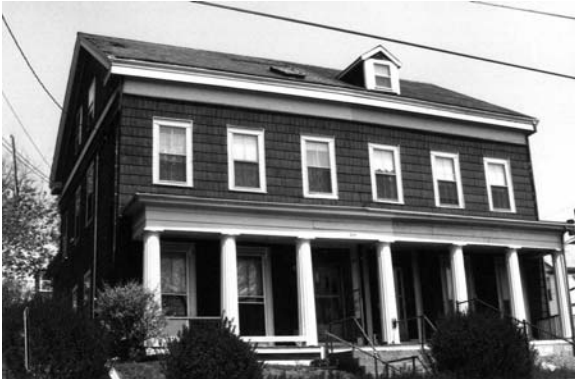
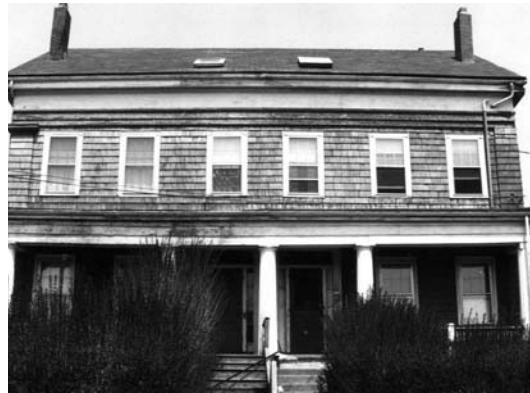
Staff Findings: There are two chimneys located on the east end of the building visible from the street. These are the chimneys proposed for demolition. Staff finds that the front chimney is of historic proportions, and that both chimneys may have been rebuilt more than once given the age of the building. Chimneys are often re-built as the mortar is softer than the brick and needs to be replaced periodically. The rear chimney was not rebuilt to the historic size and shape. Staff finds that chimneys are character-defining features. The other double Greek Revivals on Spring Hill also had chimneys constructed in the same locations and of similar dimensions. Staff found that chimneys had been removed from three of the buildings prior to designation in 1985. (See photos below from 1985).

All photos taken prior to designation in 1985

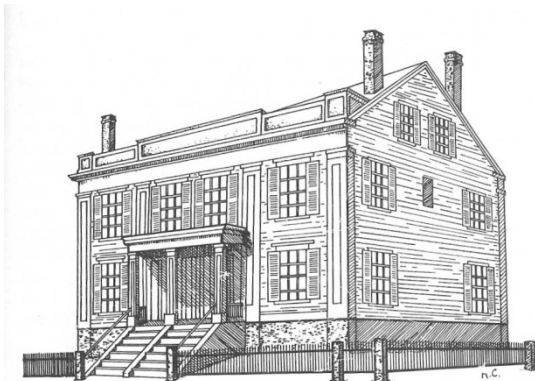
Style book examples of Greek Revival houses with side gables showing chimney placement and shapes.
