STEP 1: DETERMINATION OF SIGNIFICANCE
STAFF REPORT

Site: 13 Allen Street

Case: HPC.DMO 2021.01

Proposal: *Demolish principal structure.*

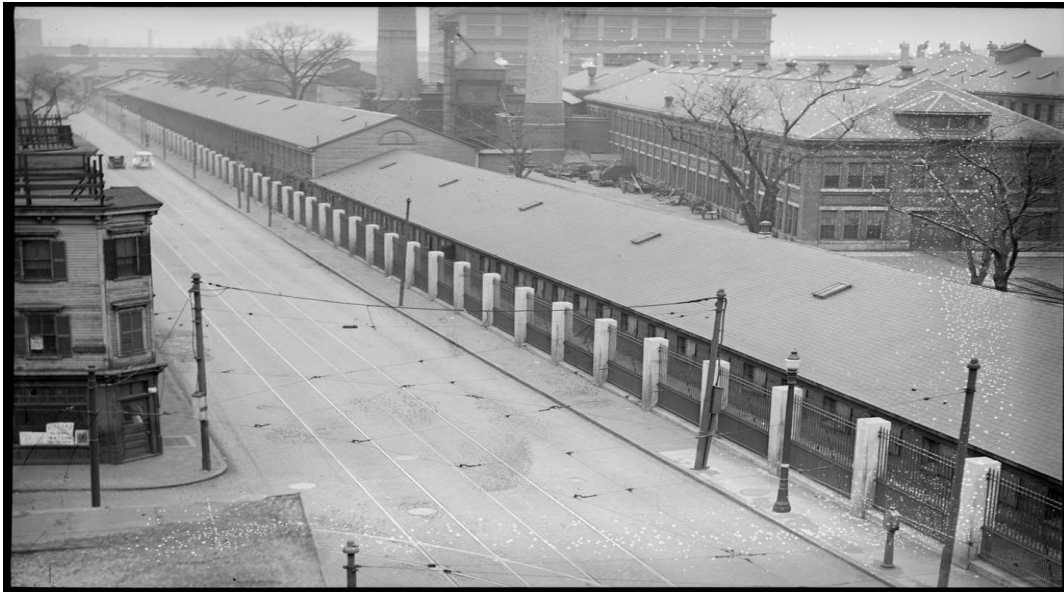
The photo¹ below of the former ropewalk in the Charlestown, MA Navy Yard shows what these long, narrow buildings could look like:

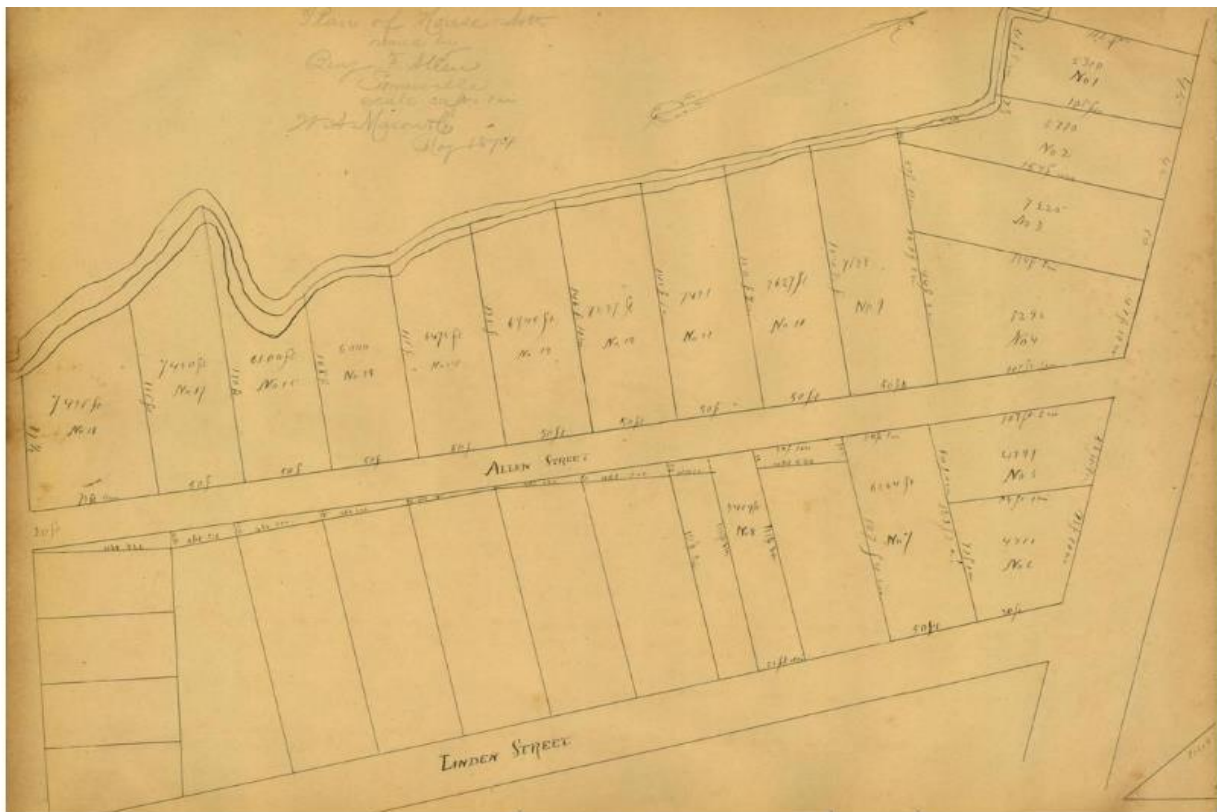
Allen Street, located in the Cobble Hill section of Somerville, was once a marshy area abutting the Miller River. Allen Street runs parallel to a filled-in portion of the Miller River. In fact, a portion of the Miller River flowed directly behind the rear property line of 13 Allen Street. This can be seen in several of the historic maps, starting with the 1852 Draper map with modern parcel overlays. On the 1873 private survey plan below showing building plots prepared for Benjamin Allen, the triple lines drawn along the top of the survey represent a portion of the Miller River seen in the earlier 1852 Draper map. This private survey is a rare find.

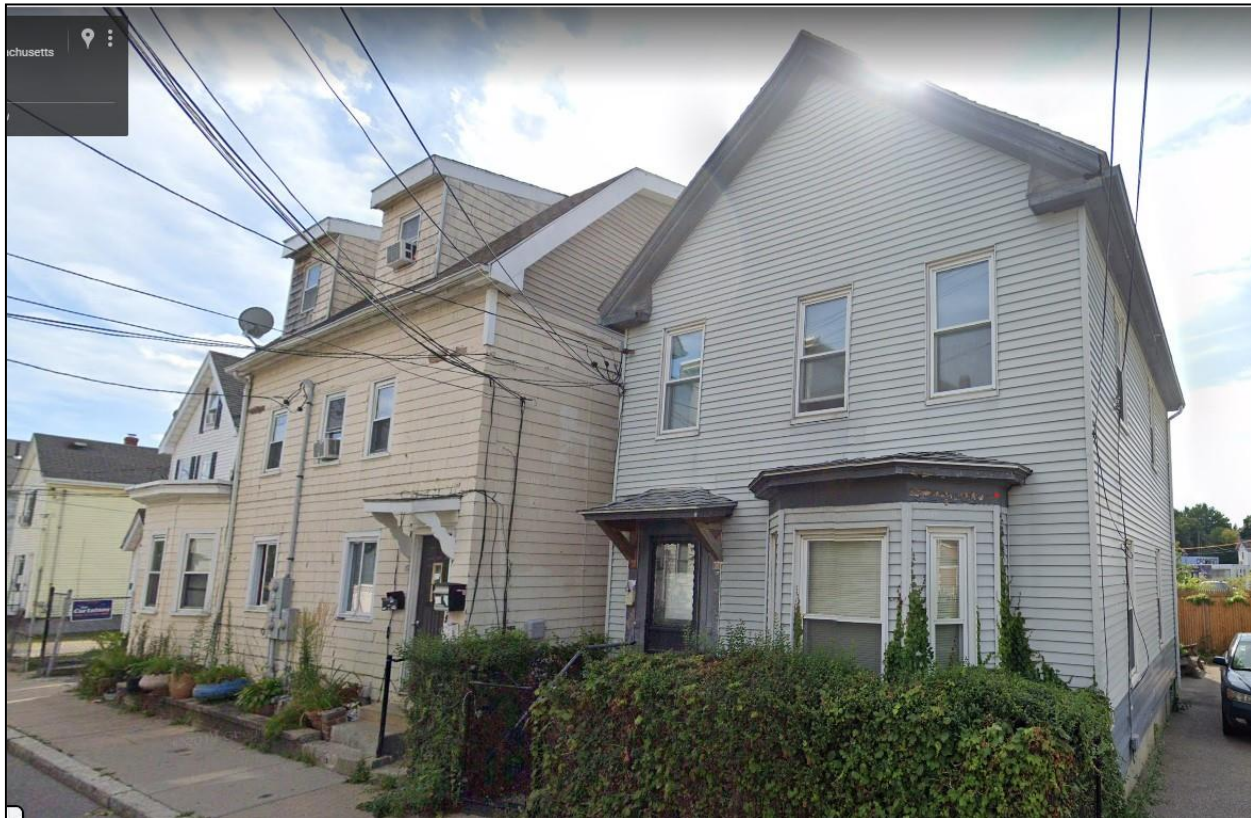
Above: 13 Allen and 11 Allen

Staff believes that the roofline of the structure has been changed from a gable to the current gambrel. It looks as though a low knee wall has been built in order to provide the height off of which the gambrel roof could be constructed. A comparison of 13 Allen to its right-abutting neighbor, 11 Allen, shows what Staff believes to be the original fascia line on the house. It is in a similar linear plane as the gable-fronted 11 Allen Street. This is illustrated below in comparison photos. In any event, 13 Allen Street has undergone considerable alteration.

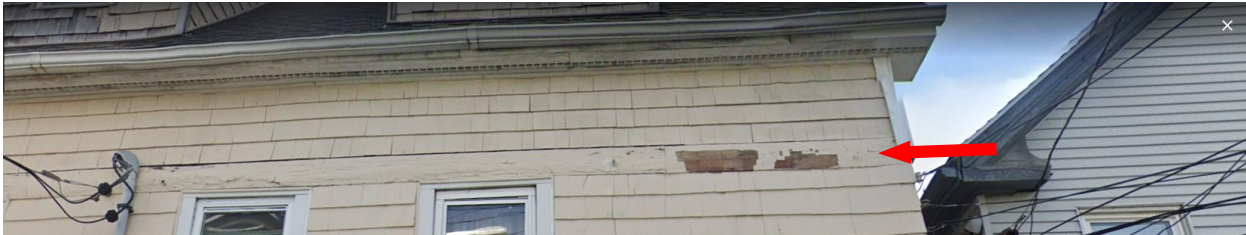
Below: Suspected original fascia line of a gable-roofed structure.

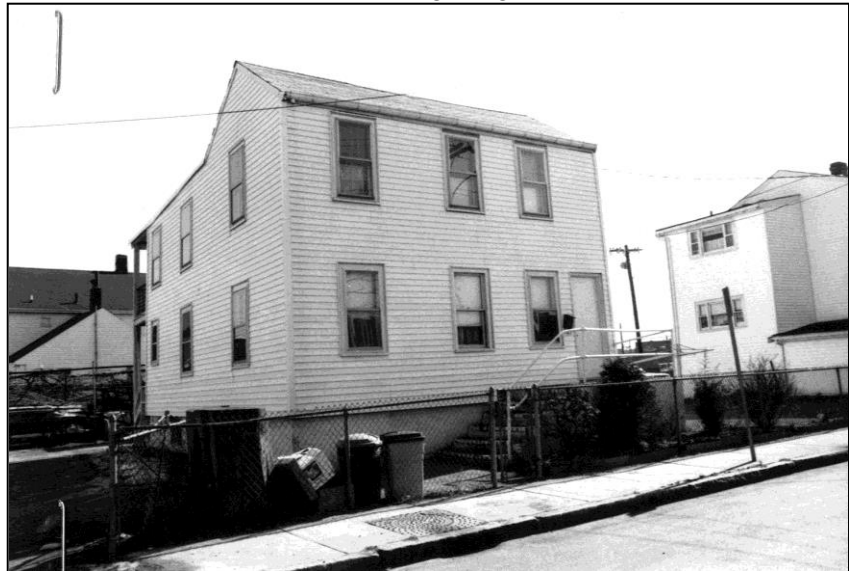
Above: 42 Allen Street, 1980 photo.

Another house exists on Allen Street that lends veracity to this second theory. 42 Allen Street (see attached Form B from 1980) is still extant but its roofline has been altered. However, when the Form B for 42 Allen Street was written in 1980, 42 Allen Street retained its original gabled roof. See the black and white photos below.

The body of the main massing of 42 Allen Street is wider and the depth shallower than the stereotypical vernacular Greek Revival and Italianate residential structures built for workers' housing that we are used to seeing throughout Somerville. Instead, due to its dimensions, 42 Allen Street, like 13 Allen Street, appears squattier than the typical houses built in the area, its street façade broad. 42 Allen Street is three window bays wide on the first and second story front façade and presents

a side hall entry on the right corner of the front façade. Additional, though grainier photos of 42 Allen Street (below) show the side elevations and a since-removed door hood. The main massing of the house was one bay deep. Rear additions had been added. The building still retained several original 6-over-6 windows

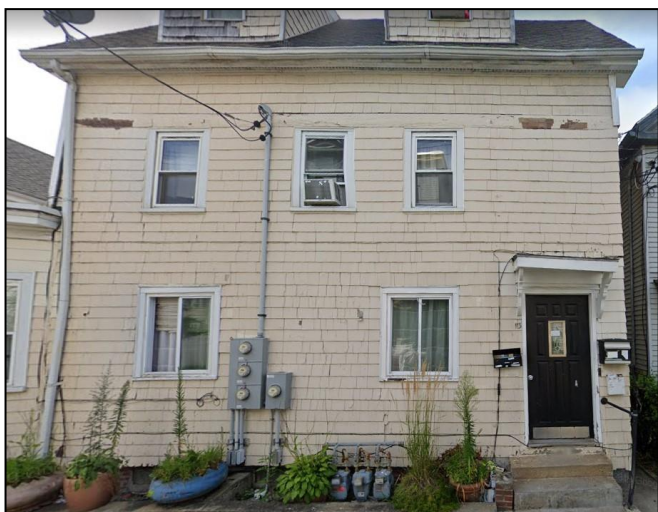
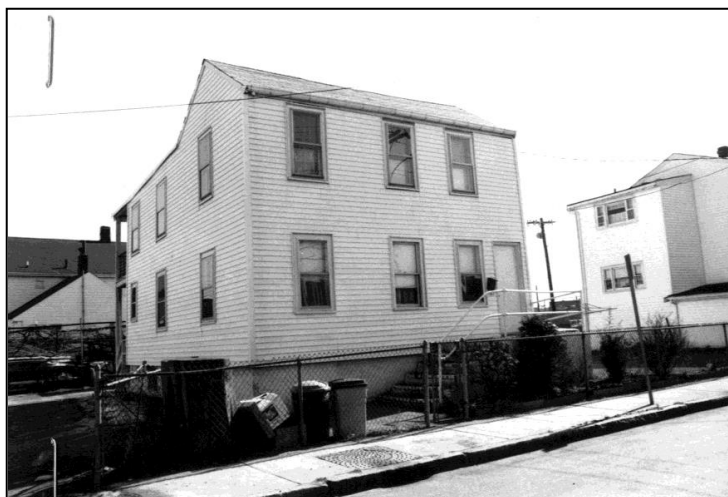
Below is a side-by-side comparison of the main massing of 13 Allen Street and 42 Allen Street (1980 photo). The both the size and locations of the windows on the 13 Allen Street front façade have been altered, it is easy to see how, in an unaltered state, 13 Allen Street could have presented the same dimensions and proportions as 42 Allen Street.

Above, left: 13 Allen Street.

Above, right: 42 Allen Street, 1980 photo.

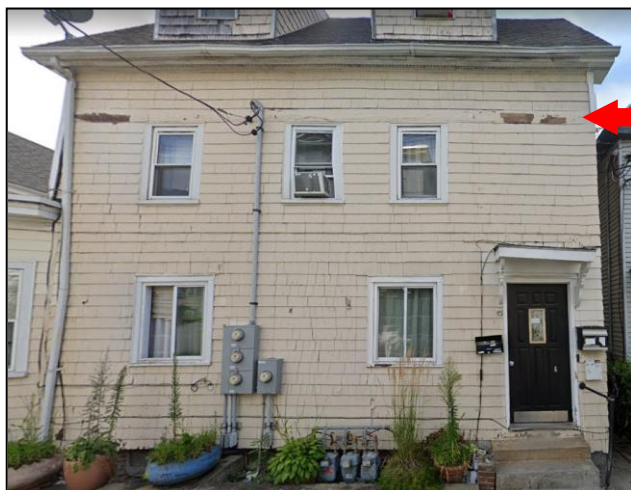
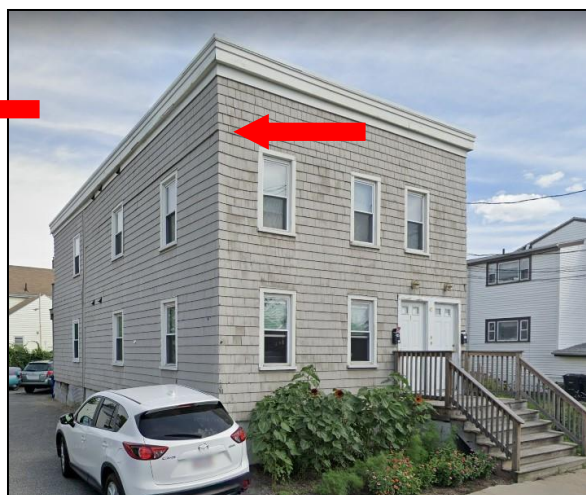
Though both now heavily altered, when comparing the side-by-side images of 13 Allen Street and 42 Allen Street *today*, that their rooflines have been altered and that knee walls have been added to increase the head room on the top floor becomes even more evident. See images below:

Above, left: 13 Allen Street today.

Above, right: 42 Allen Street today.

Red arrows in both images indicate original fascia lines, which are evident on both buildings.

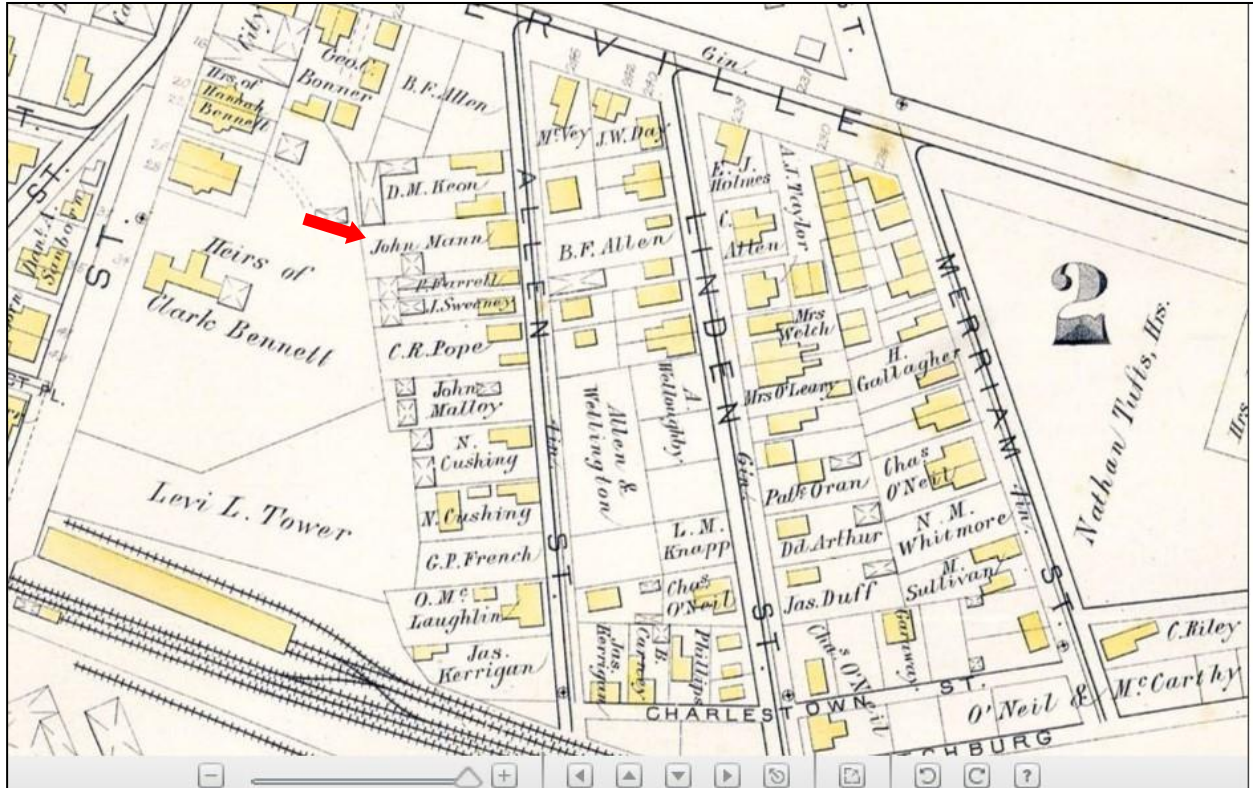
The 1884 Hopkins Plate 7 below shows that 13 Allen Street is now owned by John Mann. The shape of the house has also changed from an elongated front-to rear-of-lot rectangular form to more of the square that we see today. Perhaps the back portion of the house has been infilled. There is now also a barn/stable extant on the lot.
