STEP 1: DETERMINATION OF SIGNIFICANCE
STAFF REPORT

Site: 17 Allen Street

Case: HPC.DMO 2021.32

Legal Ad: *Demolish principal structure.*

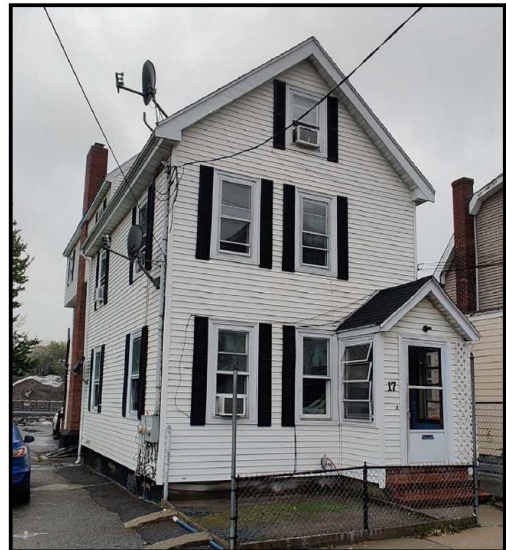
Top: Front elevation

- Front Elevation
 - Asymmetric enclosed entryway with gable roof
 - Entry door on right side of enclosed porch. Set of jalousie windows on left and right elevations

- Brick steps from landing to pavement
 - Fenestration consists of one-over-one single or double-hung, replacement sash windows on all three floors. Each window is flanked by faux shutters. A set of awning windows are on either side of the enclosed entryway

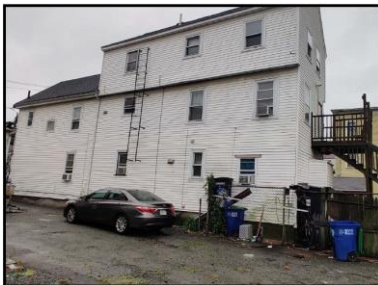
Bottom, left: Left elevation

- Brick chimney towards rear
 - The rear portion of the property juts out on the third floor, encasing the brick chimney
 - Left Elevation
 - Fenestration consists of one-over-one single or double-hung, replacement sash windows on all three floors

- An engaged iron ladder leads from the first to the third floor
 - The rear portion of the property juts out on the third floor
 - Three story brick chimney stack

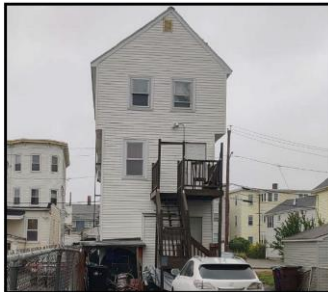
Bottom, middle: Rear elevation

- Rear Elevation
 - Rear addition is taller than the roofline of the main massing
 - Fenestration consists of one-over-one single or double-hung, replacement sash windows on all three floors

- Wood porches and stairs leading from the second floor

- Aluminum or vinyl door leading on to the second-floor porch, and another aluminum or vinyl door on the first floor
- c. Materials:
- Foundation: Concrete. Brick facing extant at front of enclosed entry. The concrete foundation on the main massing at least is likely parged over brick.

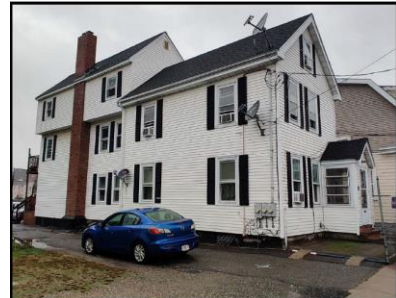
Bottom, Right: Right elevation

- Right Elevation
 - Fenestration consists of one-over-one single or double-hung, replacement sash windows on all three floors. Each window is flanked by faux shutters.

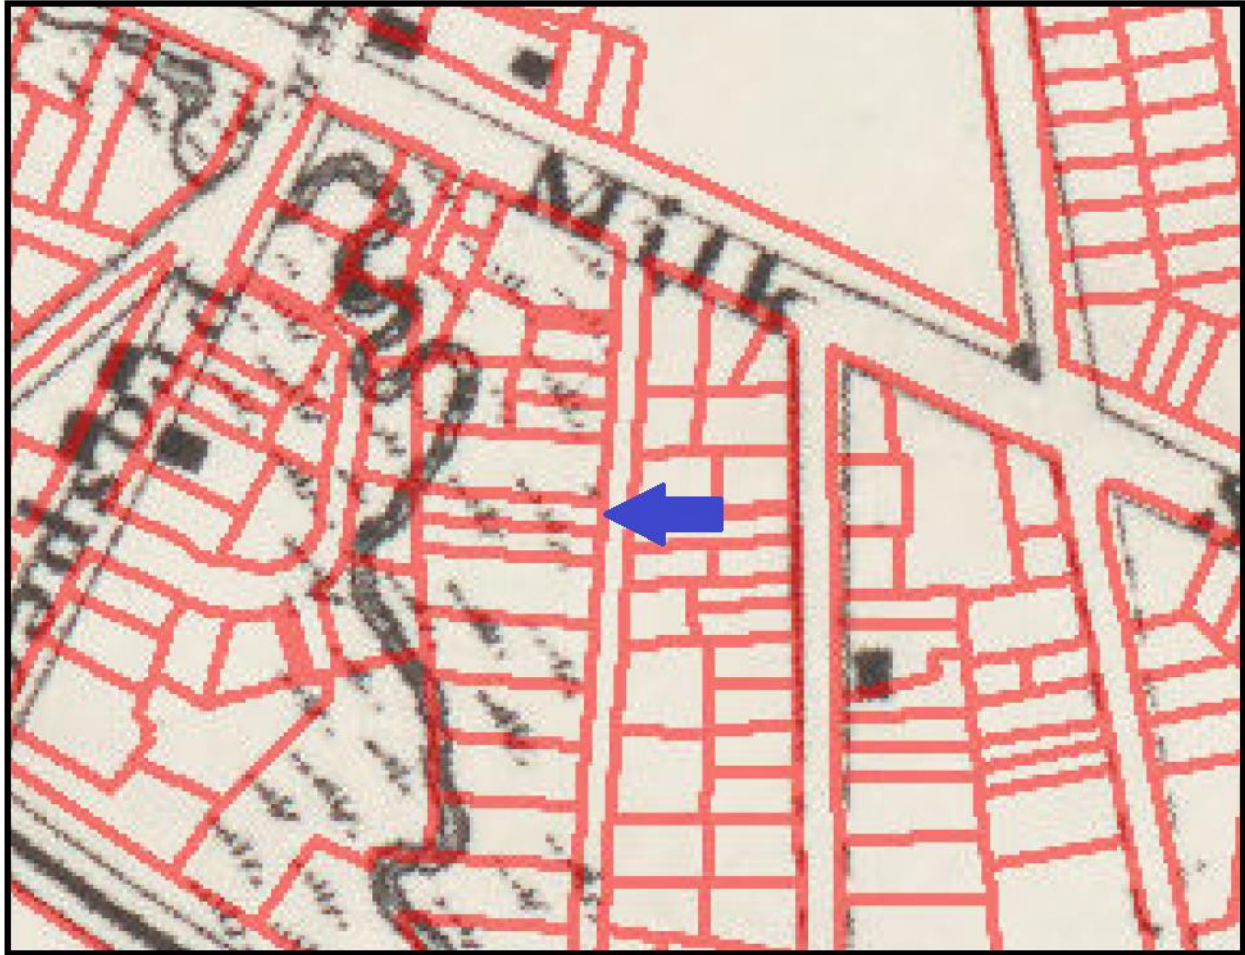
This same portion of the 1852 Draper map below has been overlaid with 21st century parcel lines for context. Note the use of the name “Milk [Street]”. This street is now known as Somerville Avenue. The blue arrow indicates 17 Allen Street today.

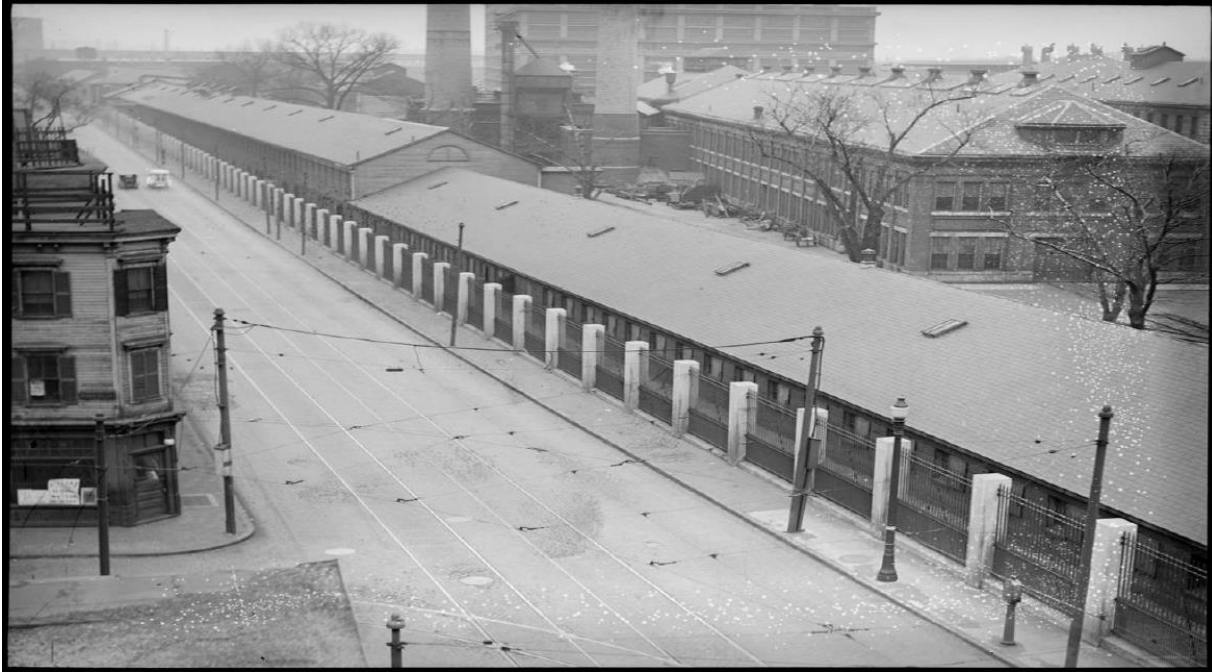
Allen Street was named for Hiram Allen who established a ropewalk (a rope-making factory) in this location in 1839. A ropewalk is a long, narrow building or long, narrow expanse of ground where ropes were made for the shipping industry. Rope was made from hemp and, as hemp fibers are short, countless numbers of them must be strung together to create the significant lengths of rope necessary for ships. Hence the necessity for a long building or long expanse of land near a body of water to make rope. Ropewalks were common through the 19th century in American communities near seaports and navigable rivers not only because the industry they served was close by, but also because much of the machinery used in the ropewalks was tidal powered.

The photo¹ below of the former ropewalk in the Charlestown, MA Navy Yard shows what these long, narrow buildings could look like:

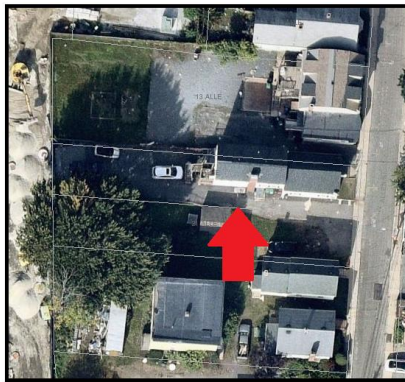
Left: Close-up 2021 GIS image, indicating 17 Allen

Current Satellite images show that the rear structures have since been demolished.

A front entryway has either been added or enclosed on the front of the property since 1895.
