STEP 1: DETERMINATION OF SIGNIFICANCE
STAFF REPORT

Site: 27 Allen Street

Case: HPC.DMO 2021.03

Proposal: *Demolish principal structure.*

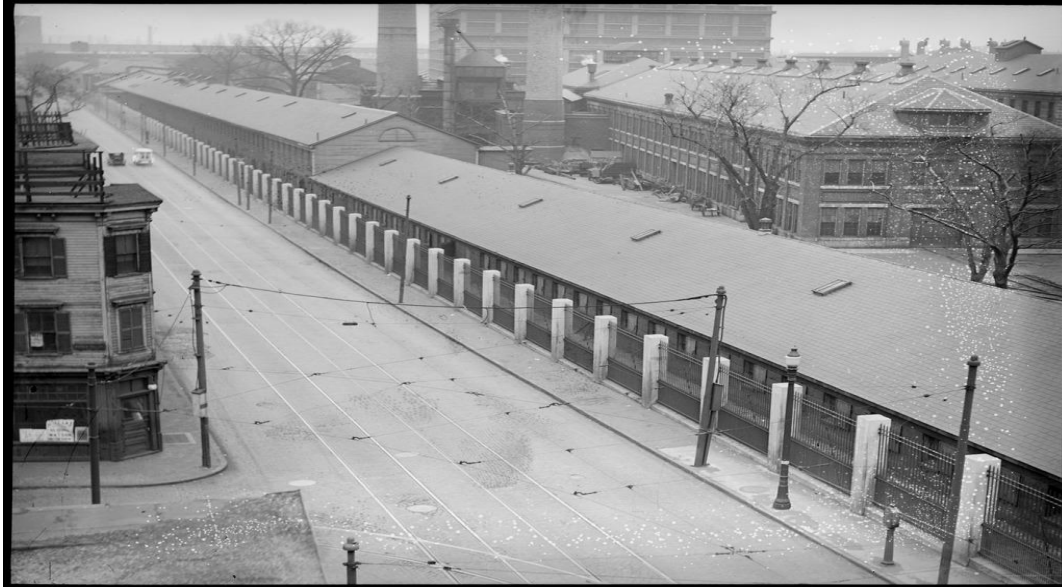
The photo¹ below of the former ropewalk in the Charlestown, MA Navy Yard shows what these long, narrow buildings could look like. Some ropewalks were constructed with no side walls and only a roof. Other ropewalks were long, narrow strips of land with no structure on them at all. It was the long, narrow expanse of land that was needed to construct the great lengths of rope.

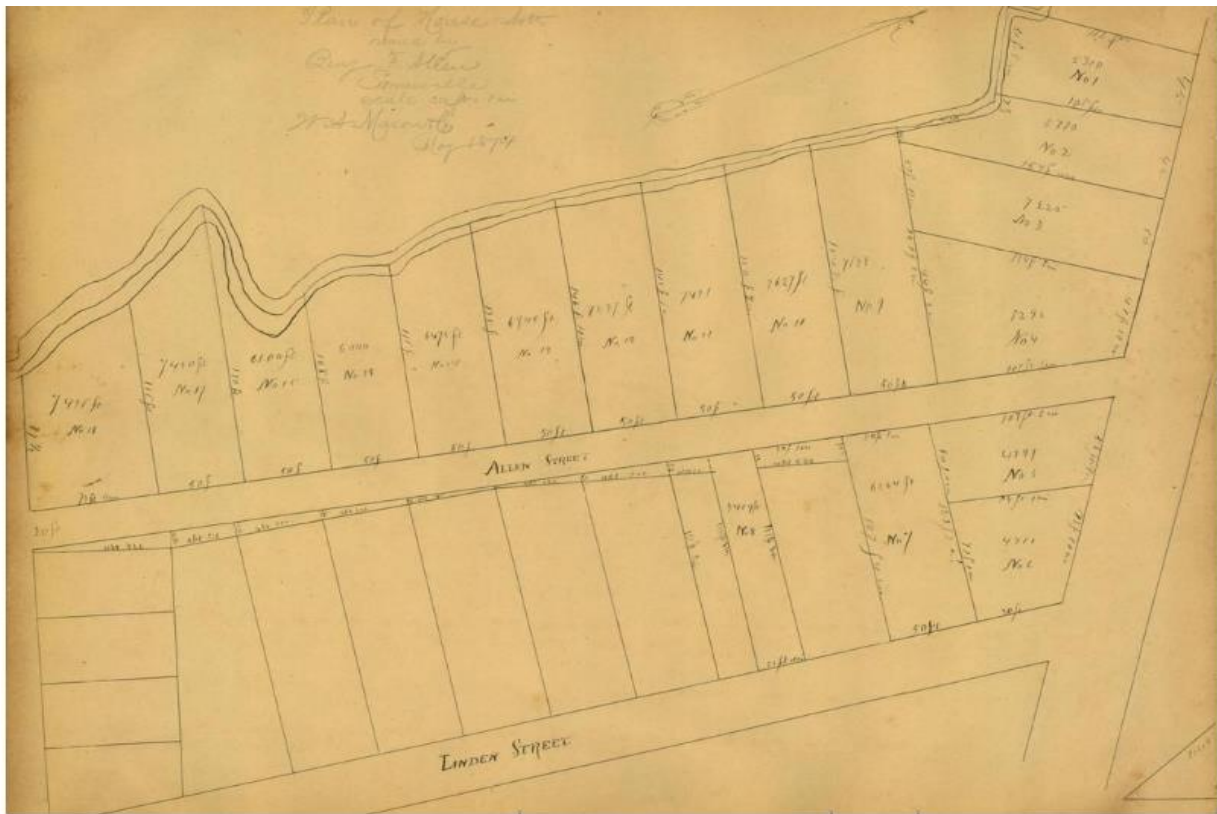
Allen Street, located in the Cobble Hill section of Somerville, was once a marshy area abutting the Miller River. Allen Street runs parallel to a filled-in portion of the Miller River. In fact, a portion of the Miller River flowed directly behind the rear property line of 27 Allen Street. This can be seen in several of the historic maps, starting with the 1852 Draper map with modern parcel overlays. On the 1873 private survey plan below showing building plots prepared for Benjamin Allen, the triple lines drawn along the top of the survey represent a portion of the Miller River seen in the earlier 1852 Draper map. This private survey is a rare find.

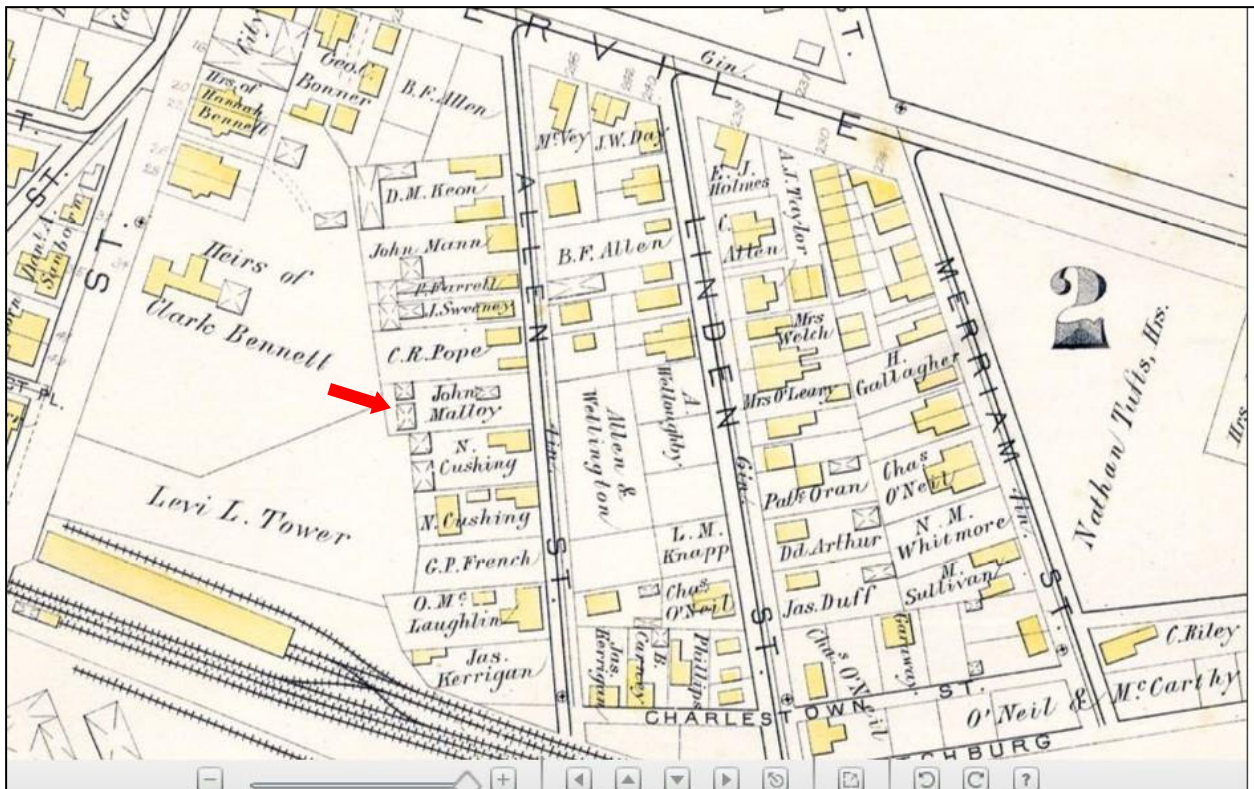
The 1884 Hopkins Plate 7 below shows that 27 Allen Street still owned by John Malloy, but that an additional barn/stable has been added to the property for a total of three such structures.

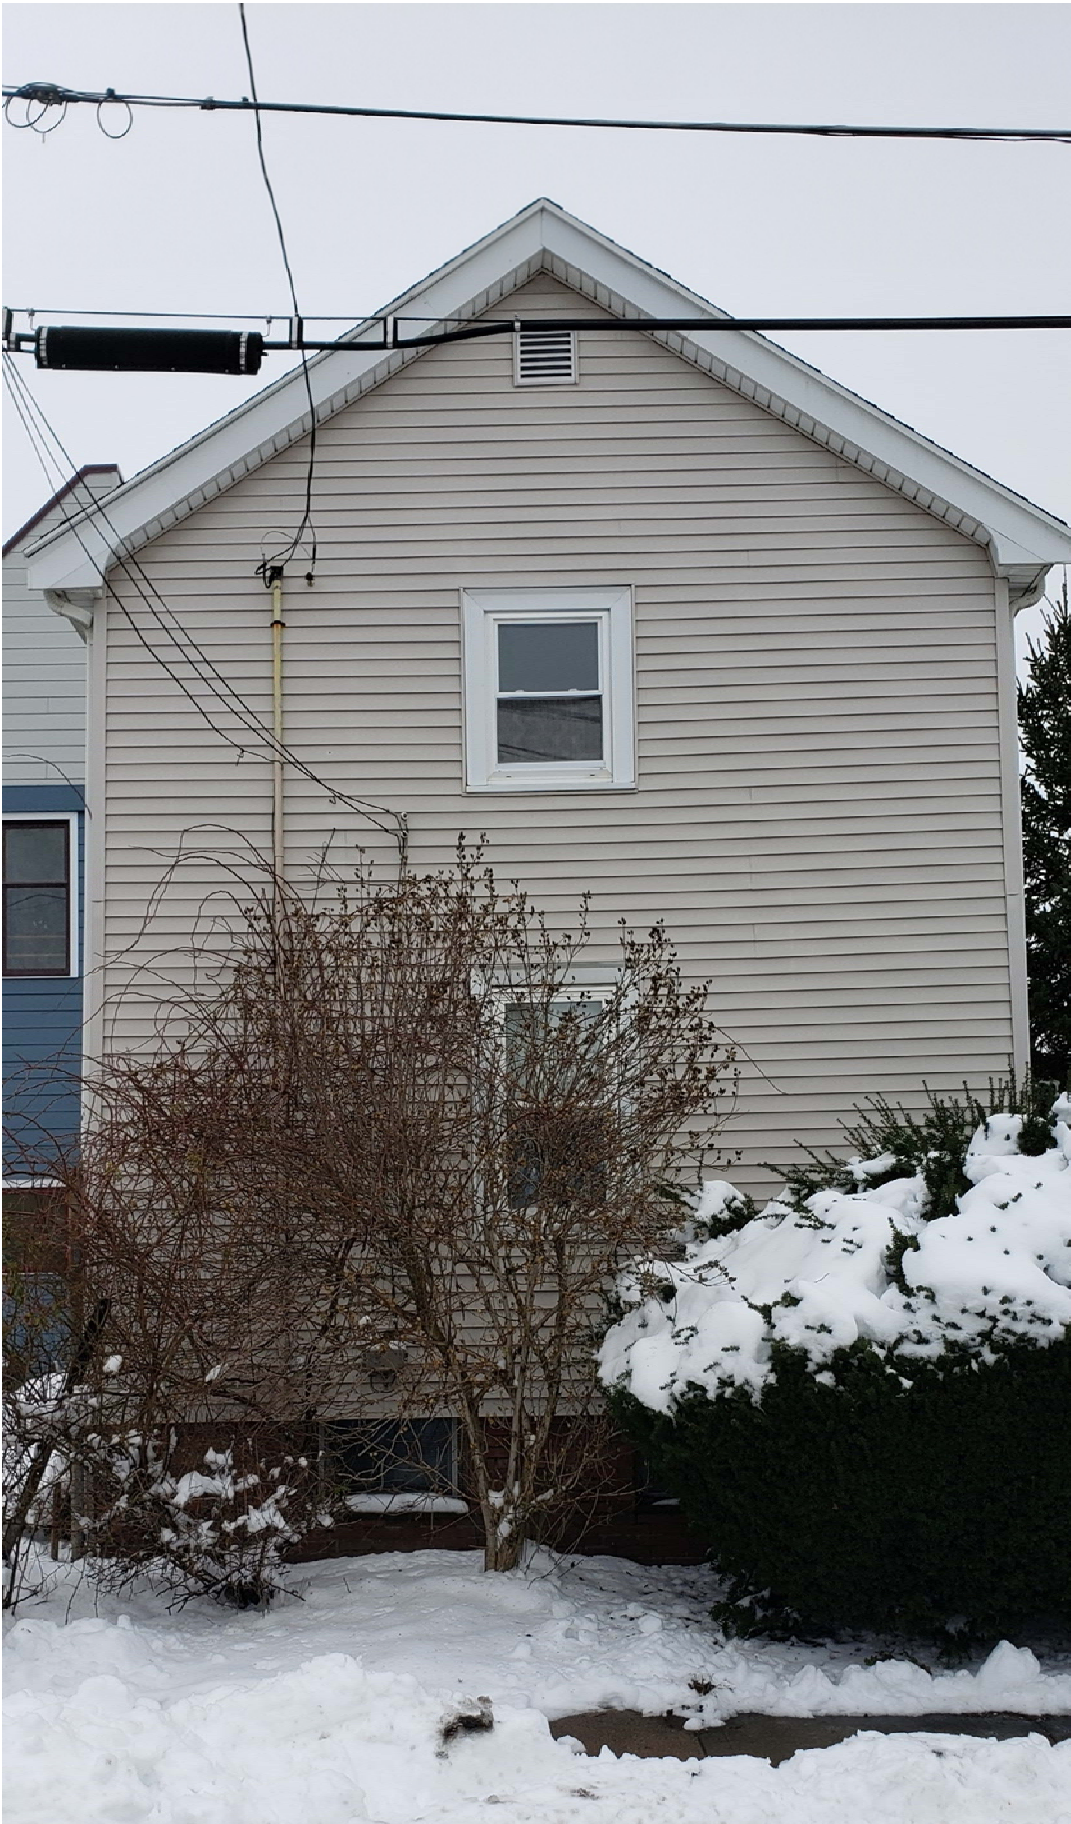
27 Allen Street - Front Elevation#

- a. Location: It is presumed that the structure is in its original location
- b. Design: Two-story gable-fronted residential structure running “shotgun” down the lot. Open rear porches
- c. Materials:
 - Foundation: Brick
 - Windows: one-over-one double-hung vinyl or aluminum. Location of many window openings changed; window sizes changed.
 - Siding: vinyl.
 - Trim: vinyl.
 - Steps: undetermined.
 - Roof: asphalt shingles.
 - Rear open porches: wood/pressure-treated wood
- d. Alterations: It appears that the form and massing of the building may be the same as when originally constructed. However, other than the vinyl siding, trim, replacement windows and change of window locations, it is difficult to determine what this building originally looked like in terms of the details of its facades.

Evaluation of Integrity: The building likely retains integrity of form and massing.
