STEP 1: DETERMINATION OF SIGNIFICANCE
STAFF REPORT

Site: 25 Appleton Street

Case: HPC.DMO 2021.10

Proposal: *Demolish all structures*

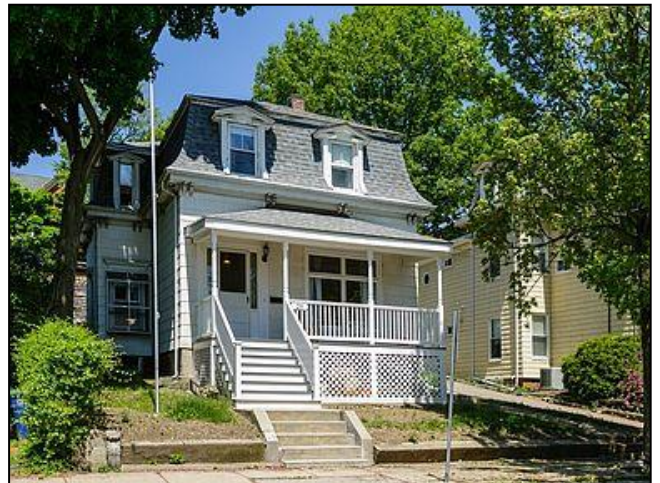
Top: front elevation

- a. **Location:** The structure is in its original location.
- b. **Design:** House: Second Empire. (Concave) Mansard roof with Italianate double-bracketing details. Two-story left elevation jog integrated into Mansard roof.

General: Two gabled dormers with strong returns are present on all elevations of the Mansard roof except left elevation which presents only one which is within the jog; deep lower eave; double brackets along lower cornice on all elevations. Single brick chimney stack extant.

Front elevation. Two bays wide, both stories. Left side front entry hall. The open front porch was constructed in 2014, photographic evidence from Google street view shows.

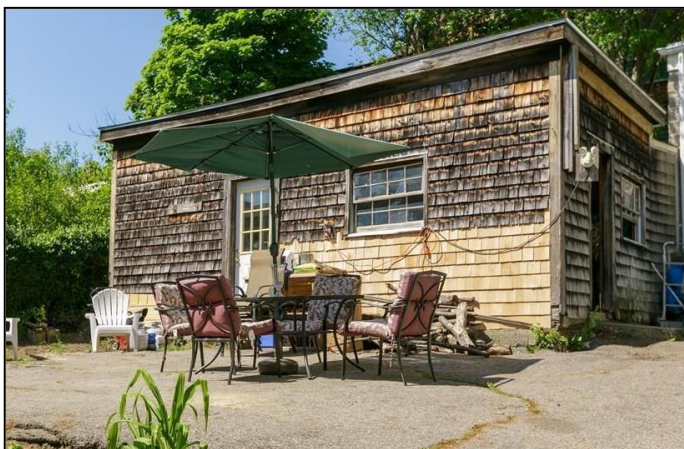
Bottom, left: accessory structure

The age of the accessory structure on the property is unclear to Preservation Planning Staff. No outbuildings show up on the historic maps of this site in 1874, 1884, or 1895. This outbuilding is wood-framed and flat-roofed with two entry doors, windows, and wood shingling. It may have been a single-car garage that was then converted into a shed/work area.

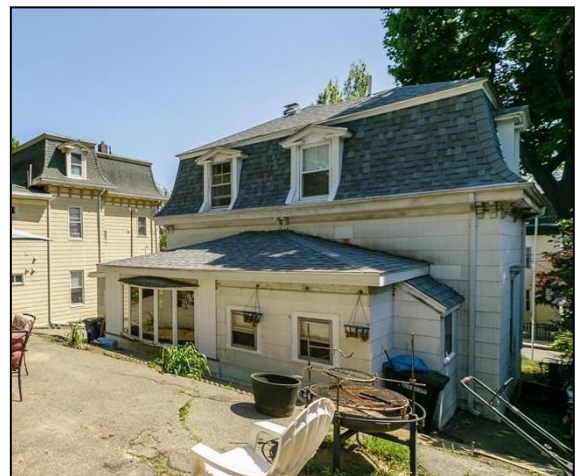
Bottom, right: rear of main structure

Rear elevation. Two bays wide, both stories; later hip-roofed, single-story rear addition.

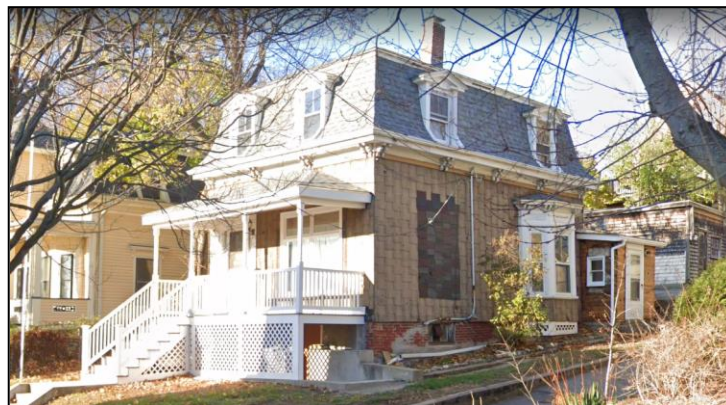
- c. **Materials:** Wood frame; brick foundation; asbestos siding; window sash material unclear, possibly fiberglass or vinyl; brick chimney stack; wood trim and detail (cornice, brackets, panels, window hood); asphalt shingle roofing; 2014 front porch materials unknown.
- d. **Alterations:** asbestos siding, possibly installed over wood clapboard; single-story rear, hip-roofed addition; modern double window with transoms to the right of the front entry door; front porch post-dates construction of house; photographic evidence from 2014 Google street view shows that a portion of the front brick foundation under the porch was removed and cinder blocks installed in their place; right elevation single-story addition; right elevation window closed in (see photo below).
