**STEP 1: DETERMINATION OF SIGNIFICANCE**  
**STAFF REPORT**

**Site:** 1252 Broadway

**Case:** HPC.DMO 2021.24

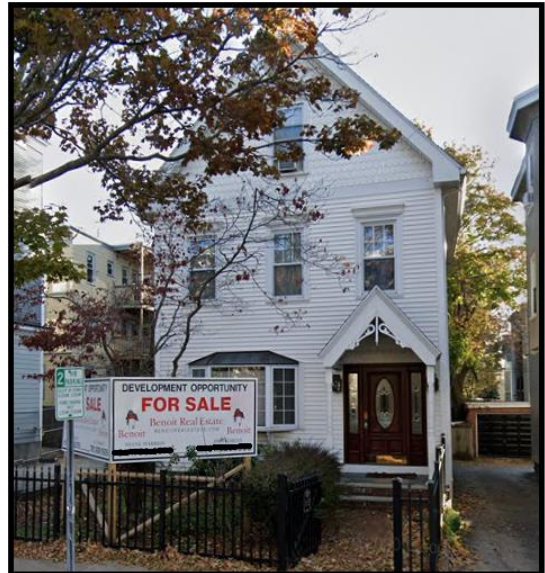
*Top: Front elevation Nov, 2020*

*Bottom, left: Front elevation*

*Bottom, middle left: Left elevation*

*Bottom, middle right: Rear elevation*

*Bottom, right: Right elevation*

- a. Location: It is likely that this structure was in its original location and was built on-site.
- b. Design: The house was a gable roof, wood-framed residential building with an asymmetrical entryway. The property contained a hooded porch for the entryway, an ell on the left side, bay in the rear.
  - Flat roof with deep eaves

- Likely a brick foundation with concrete parging.
- Front Elevation
  - Hooded portico entryway with decorative trim and posts
  - Late 20<sup>th</sup> Century door flanked by sidelights

- Brick and granite or slate steps from landing to walkway
  - Bay window to the left of the entryway
  - Fenestration consisted of three six-over-one windows on the second floor and one six-over-one window on the third floor. First floor bay window contained modern vinyl or aluminum windows with applied muntins.

- Decorative scallop shingling on top floor
  - Clapboard for first and second floors
  - Thick molded caps above windows
- Right Elevation
  - Fenestration consisted of three six-over-one windows on the second floor and one six-over-one window on the third floor. First floor contained a porthole window.

- Decorative scallop shingling with clapboard
- Left Elevation
  - Fenestration consisted of three six-over-one windows on the second floor and one six-over-one window on the third floor. First floor contained a port window.

- Decorative scallop shingling with clapboard
- Rear Elevation
  - Bay  
Further details are not visible using satellite imaging or Google

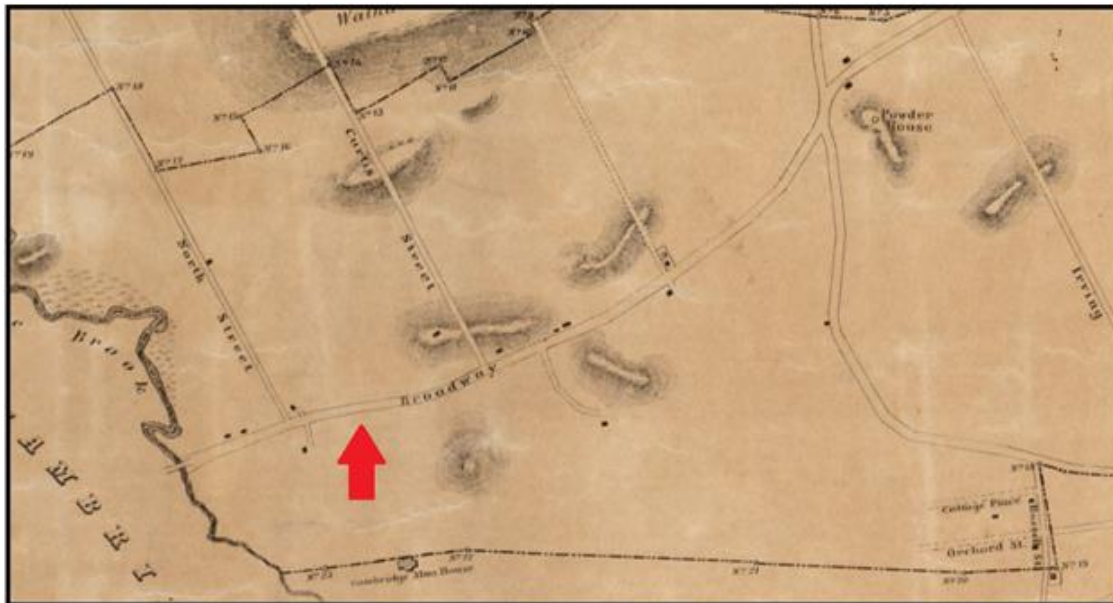
*Above: 1852 Draper Map, indicating general area that 1252 Broadway is constructed*

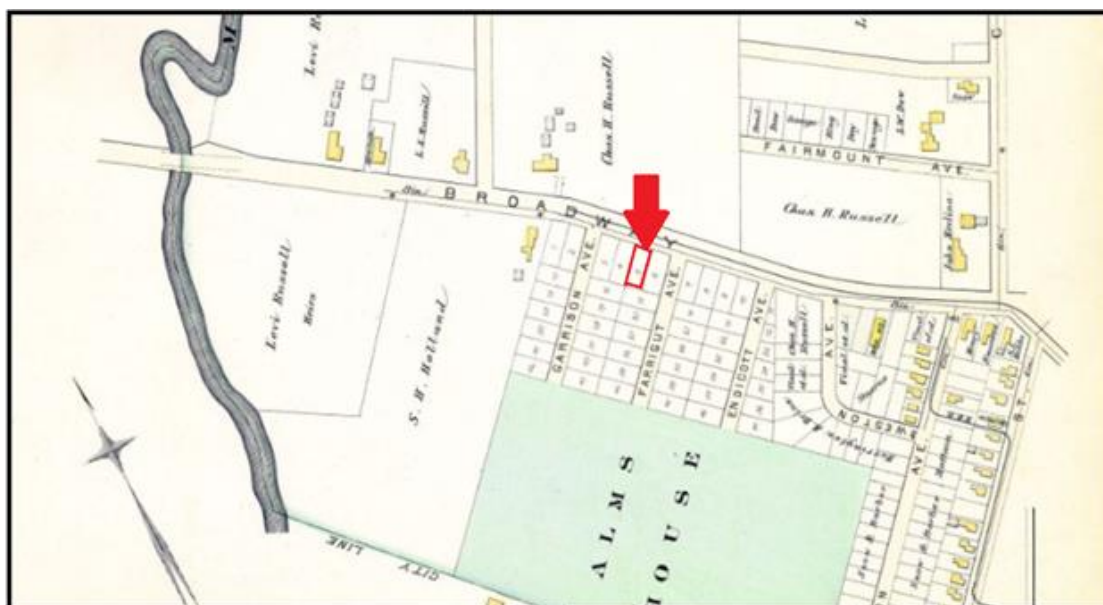
*Above: 1884 Hopkins Map, Plate 15, specifying the location of 1252 Broadway*

In 1885 the West End Street Railway car shop, constructed at the western extreme of Broadway at Alewife Brook Parkway, was built anticipating the imminent development of a commuter use, and by 1900 maps show most of the area around 1252 Broadway platted, but only a few houses built. As buildable land in the other parts of Somerville became scarcer, and as streetcar and trolley service became more available, many of the large landowners and farmers in West Somerville sold their property for residential development. As was the case in other sections of the city, lot subdivision often preceded the actual construction of houses by a decade or more as real estate and homebuilding was affected by various recessions and financial panics. Looking at the 1884 Hopkins Map, this platting in anticipation of new residents is evident.

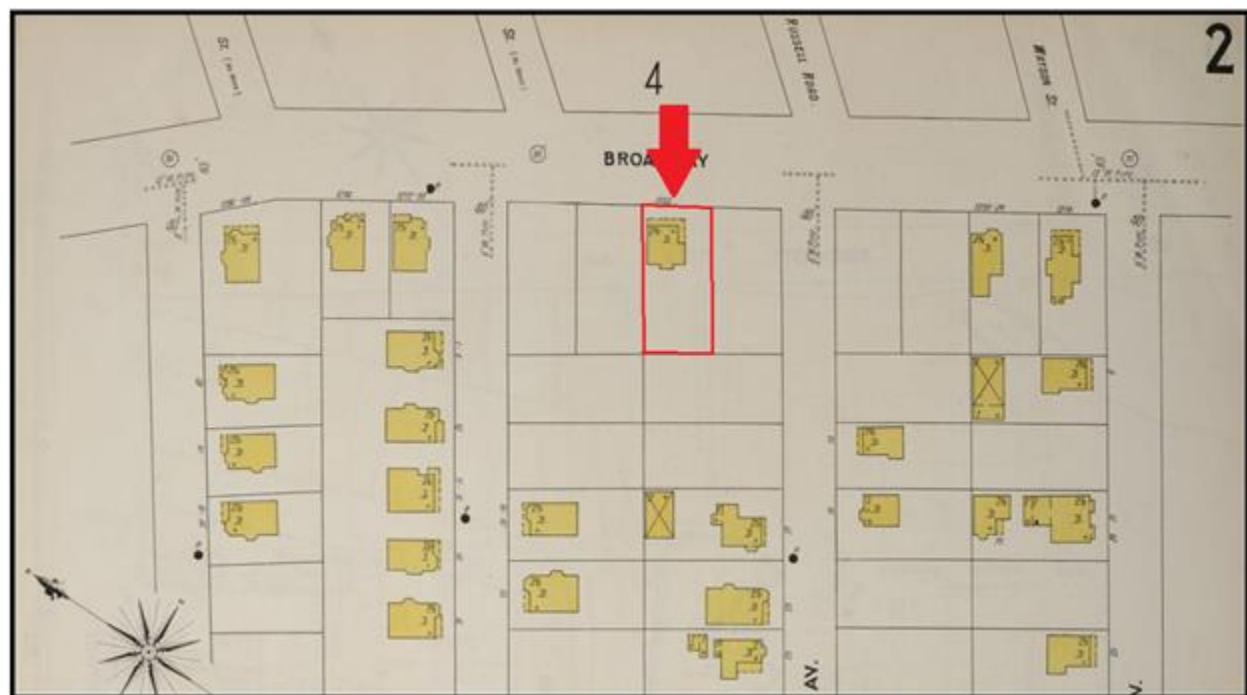
Above: 1900 Sanborn Map, Plate 2, specifying location of 1252 Broadway

By 1900, additional lots have structures built on them. Within several years the Lowell branch of the railroad was extended to Concord Avenue and with it significant commercial and residential
