STEP 1: DETERMINATION OF SIGNIFICANCE
STAFF REPORT

Site: 53 Broadway

Case: HPC.DMO 2022.02

Legal Ad: *Demolish principal structure.*

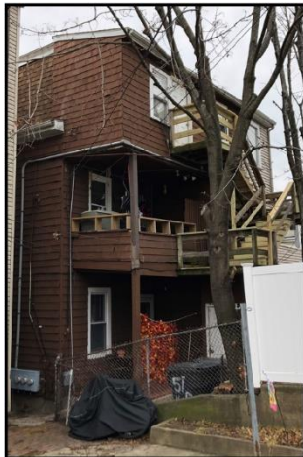
Bottom, left: Rear elevation

- Rear Elevation

- Porches have been added on first and second floor
- On the third floor an addition above the porches has been constructed.
- Wood stairs access the porches and rear third floor addition
- Fenestration consists of one single or double hung one-over-one window one the first, second, and top floor.
- An aluminum or plexiglass door with glass insert is on each floor to access rear.
