DETERMINATION OF SIGNIFICANCE STAFF REPORT

Site: 3-5 Hawkins Street
Historical Name: *Sturtevant House*
Case: HPC 2018.073
Applicant Name: Scott Zink
Owner Name: Rose G. Pisari
Date of Application: July 3, 2018
Recommendation: Italianate structure: **Significant**

FORM B – BUILDING

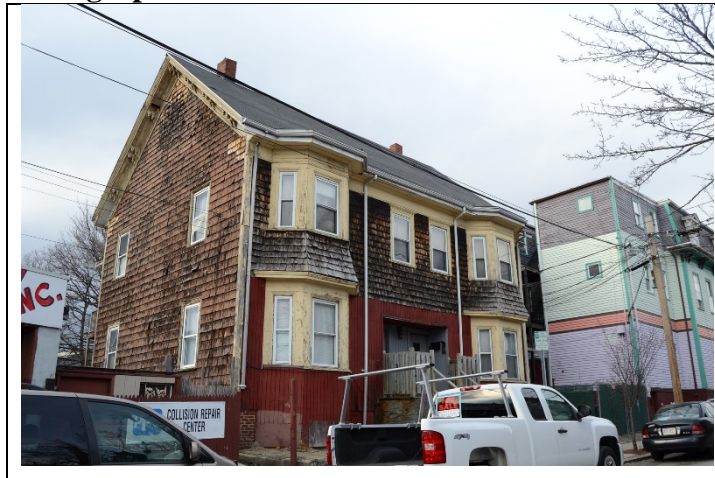
Photograph

The Sturtevant House (SMV.1390), a multiple-family dwelling at 3–5 Hawkins Street is an Italianate-style, two-story, three-bay-by-two-bay, wood-frame building with a symmetric southeast (facade) elevation. The building is rectangular with a rear ell, is seated on a brick foundation, and is topped with a side gable roof. The symmetric main elevation consists of a recessed center entrance flanked by two-story bay windows. The entrance, accessed by a set of wood stairs leading to a wood porch surrounded by a vertical board balustrade, consists of a pair of wood doors each with a square window with simple surround at the top and two concentric square panels below. An end-gable ell projects off the center of the northwest elevation. The first story of the main elevation is clad with vertical boards, and the remainder of the building is clad with painted wood shingles. The roof is covered with asphalt shingles, and is ornamented with a wide cornice along the eaves and paired brackets in the gable ends. Three brick chimneys pierce the center ridge line of the roof, one each on the northwest and southeast ends of the main block, and in the center of the ell. Fenestration consists of one-over-one, double-hung, aluminum sash with simple wood surrounds and narrow sills, installed in the late 20th century..

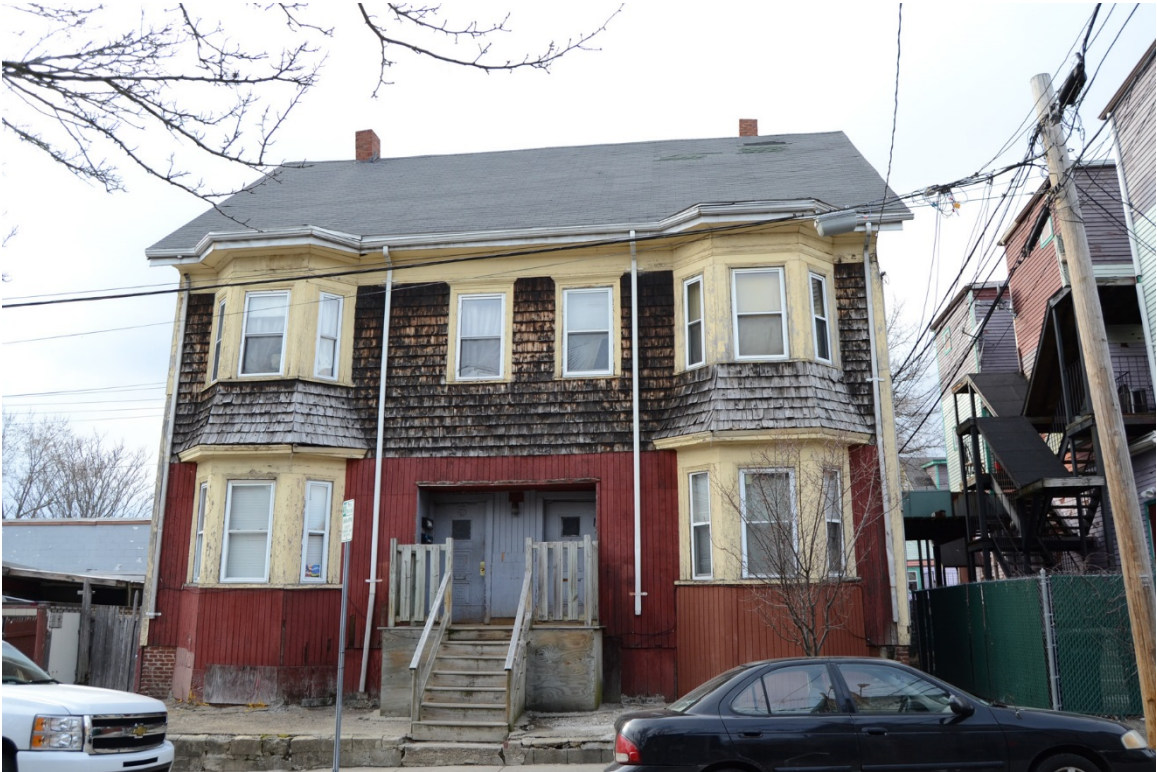
Photo 2. Facade of the house, looking northwest.

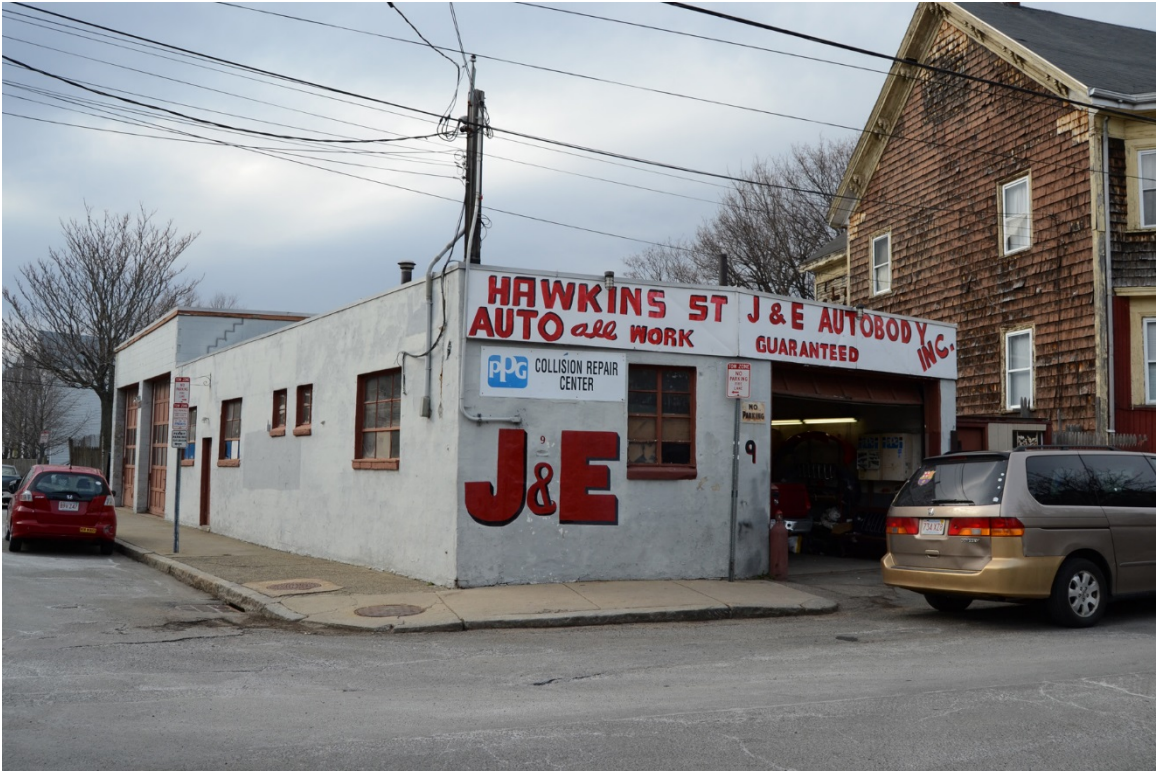
Photo 3. East and south elevations of the repair shop, looking northwest.

The repair shop (SMV.1391) is an astylistic, one-story, two-bay-by-six-bay, parged concrete masonry unit building with an asymmetric east (facade) elevation. The building is approximately L-shaped with an angled northeast elevation, is seated on a poured concrete foundation, and has a flat roof clad with rolled rubber. Three garage bays, one on the east elevation and a pair at the north end of the south elevation, are filled with vertical-lift, six-panel doors. A personnel-size door is south of the paired garage doors. A wide signboard, hung under the cornice, spans the east elevation. Fenestration consists of four-, eight-, and nine-pane casement windows with narrow surrounds and thick sills. The repair shop was built on the site of warehouses which were constructed between 1852 and 1874 for the Sturtevant Brothers grocery store in Union Square. The warehouses were no longer extant by 1933.
