CITY OF SOMERVILLE, MASSACHUSETTS
MAYOR'S OFFICE OF STRATEGIC PLANNING & COMMUNITY DEVELOPMENT
JOSEPH A. CURTATONE
MAYOR

STEP 1: DETERMINATION OF SIGNIFICANCE
STAFF REPORT

Site: 26 Hawthorne Street
Case: HPC.DMO 2020-07

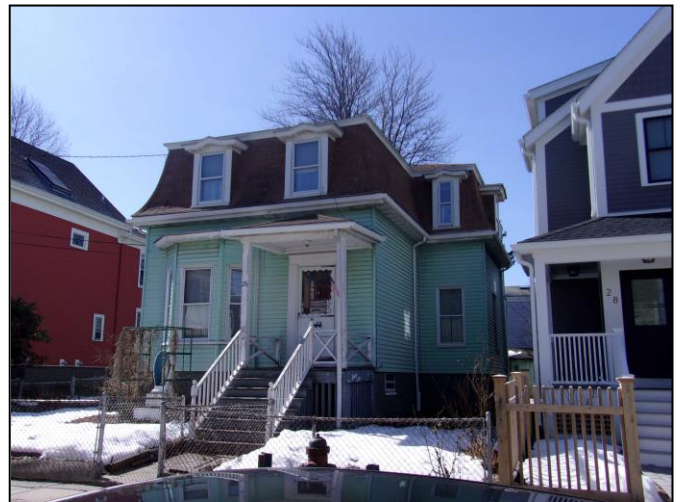
Architectural Description: The dwelling house is a two-story, Mansard-roofed, single-family structure. The building is roofed with brown asphalt shingles and the siding and trim are covered by vinyl.

The front façade is two bays wide on each story. The first story of the front elevation presents a right side hall entry door flanked by fluted pilasters and capped by dentil molding. It is unclear if these features surrounding the front door are of vinyl, composite, or wood or to what era they date. A later, shallow open portico was added over the front door and front stoop decking. A long run of wood stairs with railings leads to the covered stoop. Vertical wood picket-style skirting surrounds the stoop. To the left of the front door is polygonal, single-story bay window. All windows are one-over-one.

The second story of the front elevation presents the lower slope of the flared Mansard roof. Two decoratively-capped single dormers are present which are vertically aligned with the door and bay below. A wide cornice and associated eave defines the lower portion of the Mansard roof. The upper slope of the Mansard roof is not visible from the front elevation, street level, but the cornice separating the lower and upper slopes of the roof is evident.

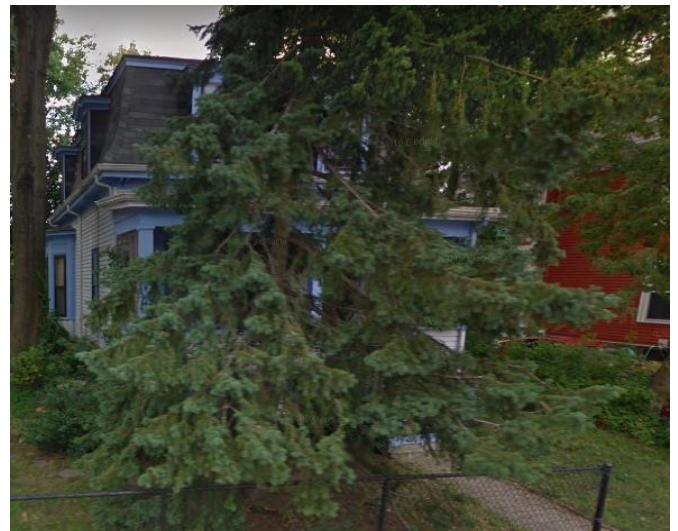
There is one other property on Hawthorne Street, 16 Hawthorne Street, which appears to be identical to 26 Hawthorne. These matching Mansards are separated by one property between them. The main difference between the two Mansards in terms of major architectural features is that 16 Hawthorne Street has a covered open entry porch that runs the length of the front façade. Images of 16 Hawthorne Street appear below:
