CITY OF SOMERVILLE, MASSACHUSETTS
MAYOR'S OFFICE OF STRATEGIC PLANNING & COMMUNITY DEVELOPMENT
JOSEPH A. CURTATONE
MAYOR

STEP 2: DETERMINATION of whether to PREFERABLY PRESERVE

Site: 26 Hawthorne Street
Case: HPC.DMO 2020-07

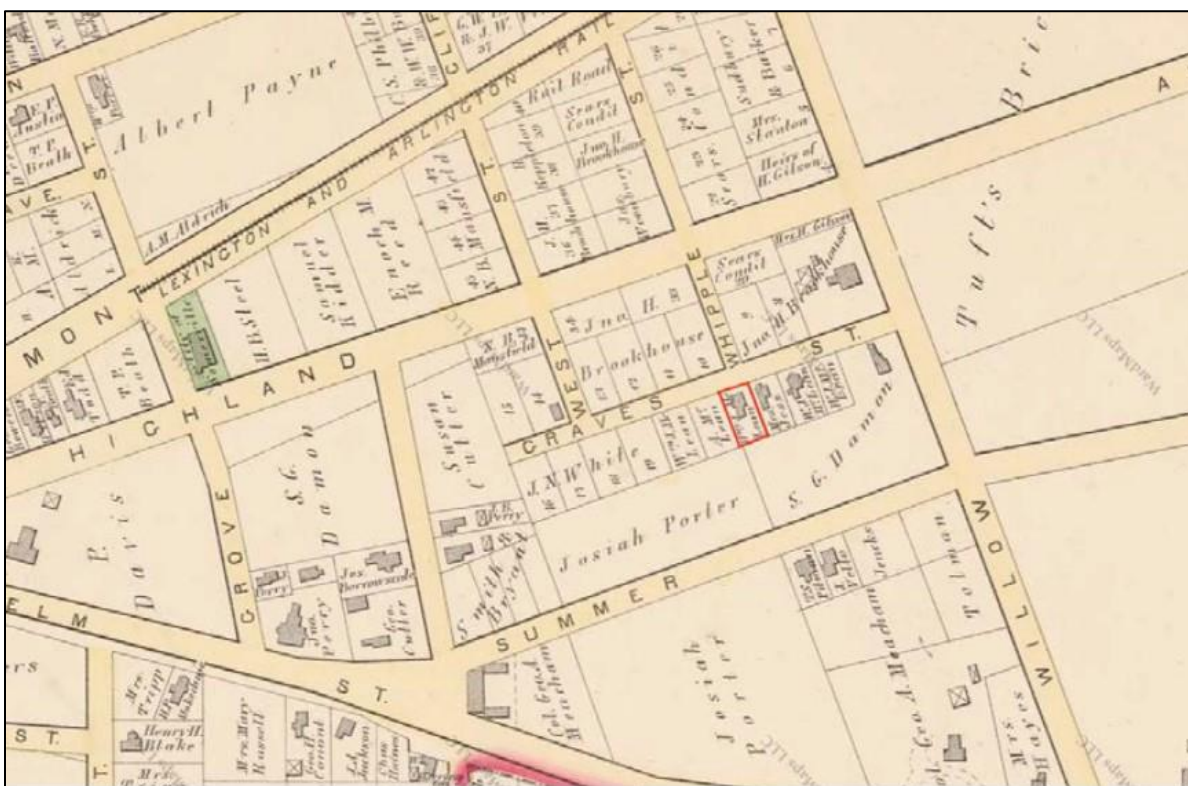
*Left: 1884 Hopkins Atlas.
“Graves Street” is today’s
“Hawthorne Street”.*

Two additional map/plate images are included below. As seen in the two Hopkins Atlases below from 1874 and 1884, Hawthorne Street was known as Graves Street until at least the mid-1880s. No information regarding the change in street name has been uncovered to-date.
