STEP 1: DETERMINATION OF SIGNIFICANCE
STAFF REPORT

Site: 55 Heath Street – Carriage Barn only
Case: HPC.DMO 2020-11

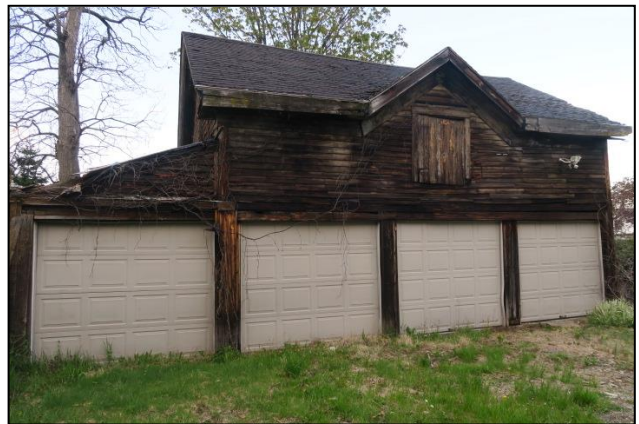
Architectural Description: The structure (carriage barn) that is the subject of the demolition application is a wood-framed, wood-clapboarded 1½-story gable-roofed accessory structure. The gable ends are

found at the right and left elevation of the building and present deep gable returns. A substantial cornice and sturdy corner posts frame the building. The front façade sports a center gabled peak. It is the center gabled peak along with the deep gable returns and roof pitch that identify the structure's style as Italianate.

The left elevation presents a double-hung 6x6, wood-muntined window centered between the gable returns. The right elevation presents two double-hung, 6x6, wood-muntined windows: one at the first story and one centered between where the gable returns were once present. The front façade presents a hay door under the center gabled peak. The first floor of the front façade has been divided into four garage bays. Three of these bays are located on the original body of the house. The left-most bay is located in a single-story, shed-roofed later addition to the structure.

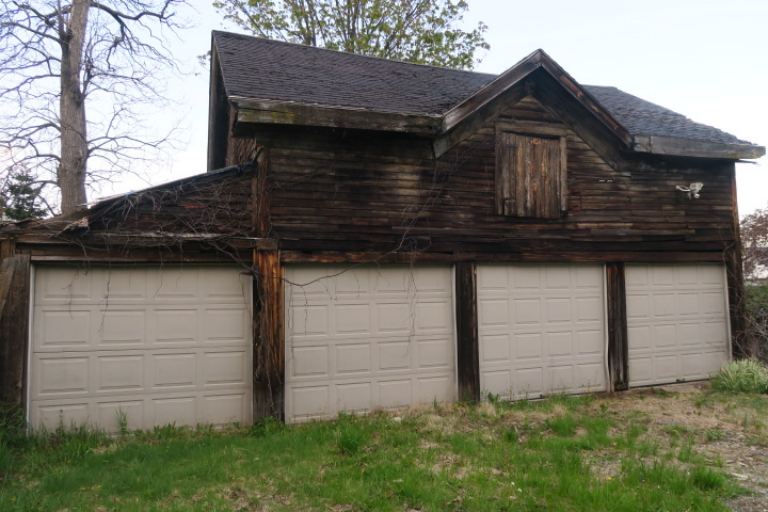
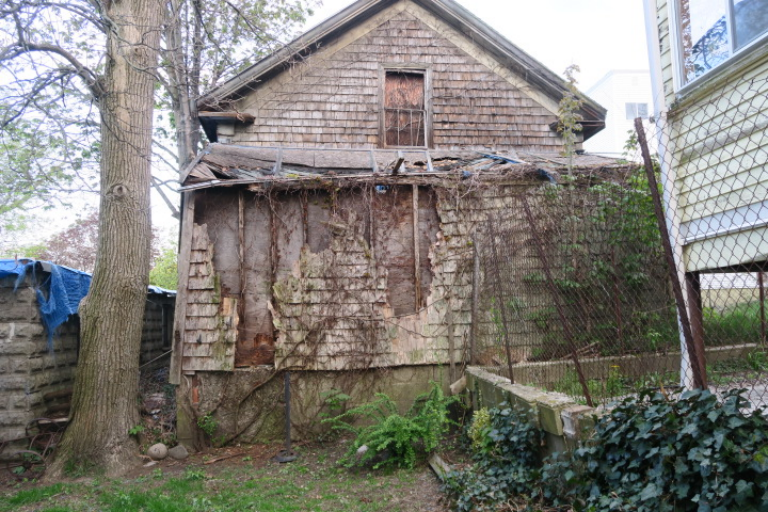
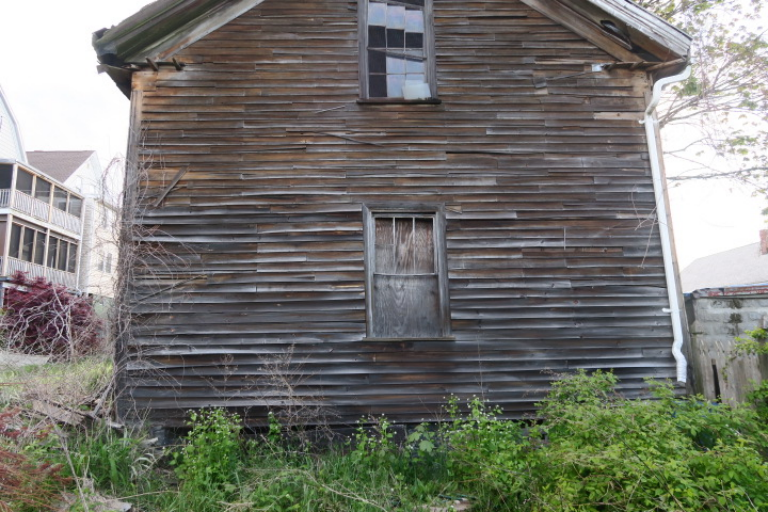
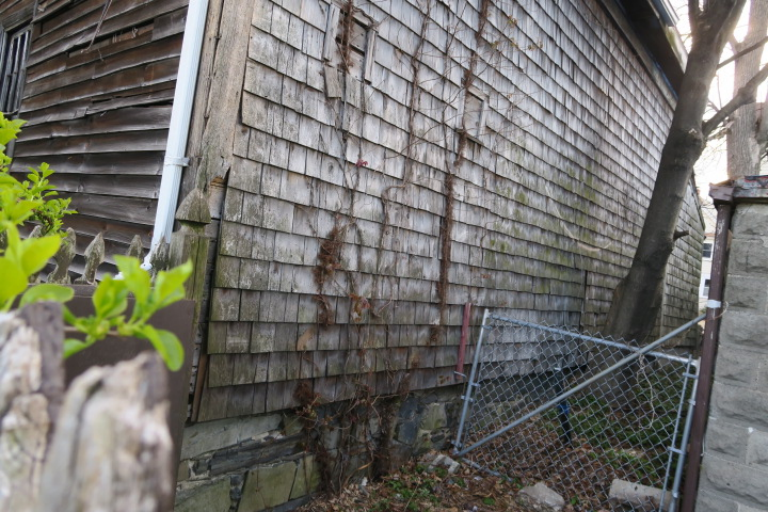
- a. Location: It is believed that the building is in its original location but historic map research will help determine the length of time that the barn has been associated with the dwelling house on this site.
- b. Design: Italianate. Heavy cornice, high-pitch side gable roof with gabled center peak on front façade. Wood frame construction with heavy corner posts. Deep gable returns. See earlier architectural description.
- c. Materials: Wood frame construction, wood clapboarding, glass-paned wood windows. New metal/vinyl garage doors; asphalt shingled roof.
- d. Alterations: Left elevation shed-roofed, single-story addition with garage bay. Three garage bays on main front elevation.

Evaluation of Integrity: Despite the inclusion of modern garage bays and a left elevation addition, the main massing of the original carriage barn building is clear and retains a high degree of architectural integrity (see architectural description earlier in this report and associated photos).

Based on the assessment provided of criteria A and B of the ordinance, Staff recommend that the CARRIAGE BARN at 55 Heath Street be determined **HISTORICALLY SIGNIFICANT** based on Criterion (ii) (historical and architectural significance), including the rarity of these Italianate barns in the City and the clear Italianate architectural style of the structure.
