STEP 1: DETERMINATION OF SIGNIFICANCE
STAFF REPORT

Site: 82 - 86 Prospect Street

Case: HPC.DMO 2021.31

Legal Ad: *Demolish all structures.*

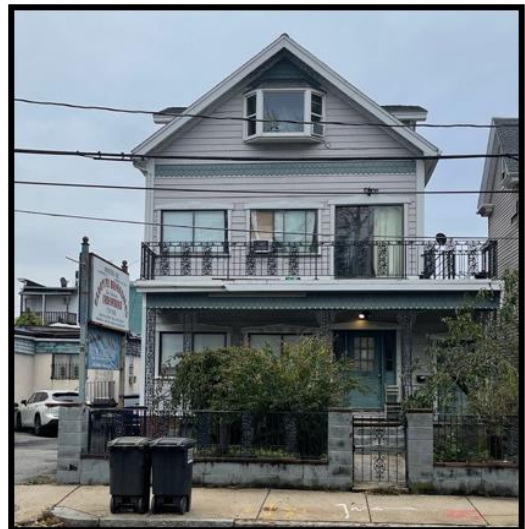
Top: Front elevation – 86 Prospect

1. Location: It is likely that this structure is in its original location and was built on-site.
2. Design: The house is a front facing gable roofed, wood-framed building with a first and second story front porch.

- Front Elevation
 - Asymmetric entryway with sidelights
 - Concrete steps from landing to pavement
 - Mid-late 20th century iron railings along first and second story porch and front steps.

- Fenestration consists of double single pane windows, likely fixed, on the first floor and the second floor. Third floor has a bay window with shingled hood.

- Clapboard siding with decorative fish scale shingle banding between floors
 - Right Elevation
 - One dormer on top floor
 - Rear cross gable with a staircase leading out of it

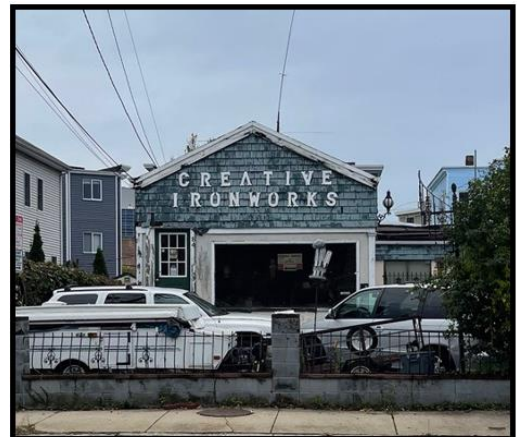
Bottom: Front elevation – 82-84 Prospect

1. Location: What remains of the structure is in its original location and was built on-site.
2. Design: The structure has a gable roof in the new front portion of the structure transitioning to a mansard roof where the remnant of the original structure remains before becoming flat roofed where it connects to the concrete block garage in the rear. It is wood framed in the front and concrete block in the rear.

- Front Elevation
 - Asymmetric entryway with garage/loading opening to the right of entryway
 - Individual letters spelling the name of the building above doors 'CREATIVE IRONWORKS'

- Fenestration on rear portion of structure is double single-pane windows, likely fixed.
 - Shingle siding
 - Right Elevation
 - Fenestration consists of two double pivot or casement steel windows with one over two muntin pattern

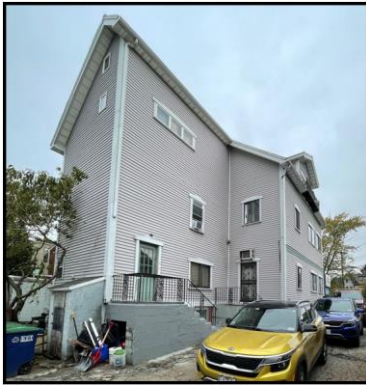
Above: Left Elevation

- Left Elevation

- Fenestration consists of one-over-one, double-hung, replacement sash windows towards the rear on the first and second floor, and double single-pane windows, likely fixed, on towards the front of the building on the first and second floor. There is a triple single-pane set of windows towards the rear of the third floor.
 - Dormer on the top floor towards the front of the structure
 - Two concrete stairs with 20th century iron railings lead up to two elevated entryways
- Rear Elevation
 - Contemporaneous 3rd floor rear addition
 - Two vent openings
 - Fenestration appears to be a horizontal rolling window on the second floor, and a single or double-hung, replacement sash window on the second floor

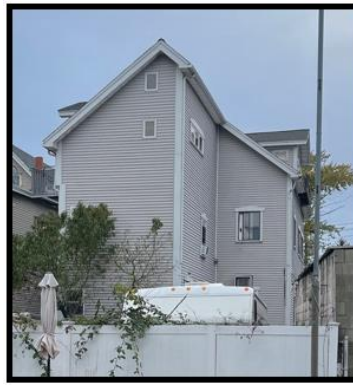
Above: Rear Elevation

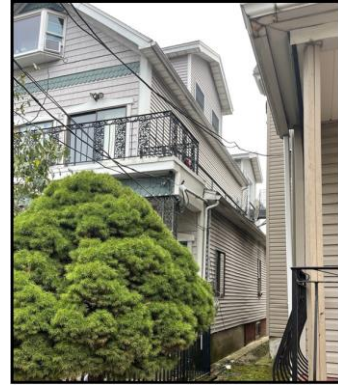
Above: Right Elevation

- Fenestration appears to consist of a one-over-one, single or double-hung, replacement sash windows with simple surround on the first floor and dormer on the third floor

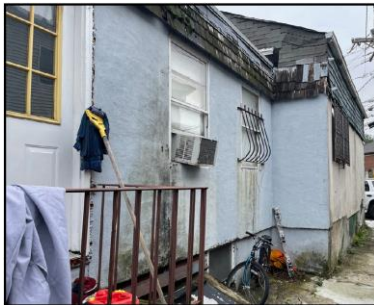
Above: Left Elevation

- Concrete block
 - Left Elevation
 - The newer front portion of the structure is concrete with shingle siding at the top and exposed concrete below.
 - The middle portion of the building, that which survived the fire, is exposed concrete with asphalt shingle on the mansard roof

- Fenestration consists of one-over-one, single or double-hung, replacement sash windows with simple surround. Two windows are covered by protective 20th century iron railings.

- A set of concrete steps with iron railing lead up to a side entrance.
 - Rear Elevation

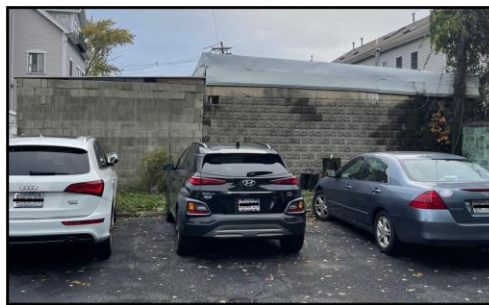
Above: Rear Elevation

- Concrete block

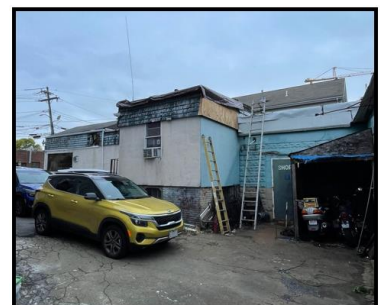
Above: Right Elevation

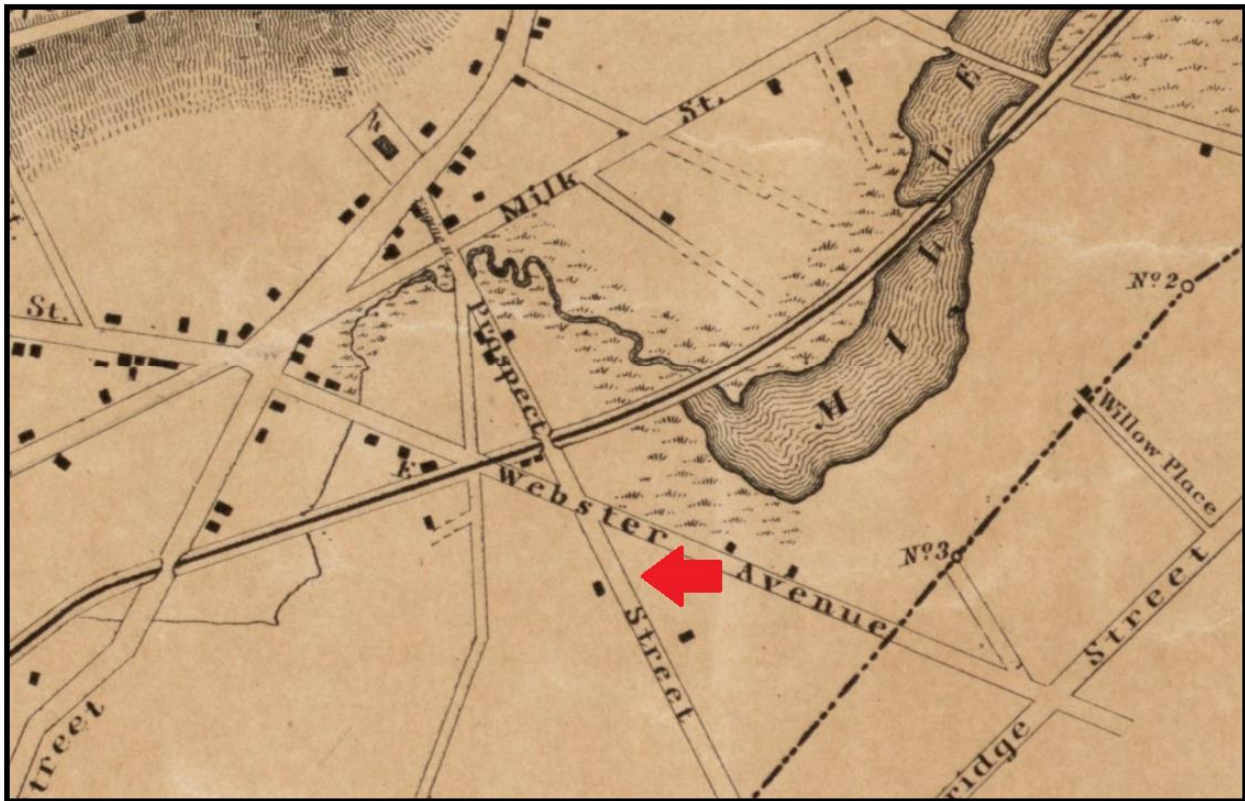
Above: 1852 Draper Map, indicating general area that 82-86 Prospect is constructed

Prior to the Civil War only a handful of residential structures along the main thoroughfares existed in the area; Washington, Bacon, Prospect, Webster, and Medford Streets. The 1852 Draper Map shows little development, commercial or residential, around Prospect Hill and Ward 2. Along Prospect Street only three structures are denoted.

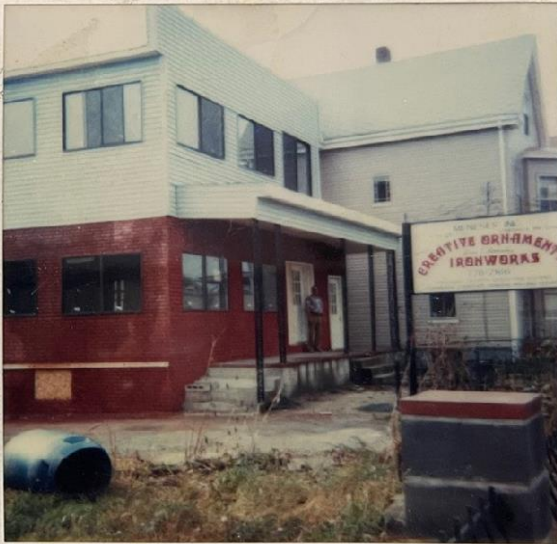
The structure at 86 Prospect St was restored, and in 2002 a third floor was added to the top of 86 Prospect. The history for 82-84 Prospect Street will be for the buildings that existed prior to the fire in 1984.

86 Prospect Reconstruction
(Before 3rd floor was added in 2002)

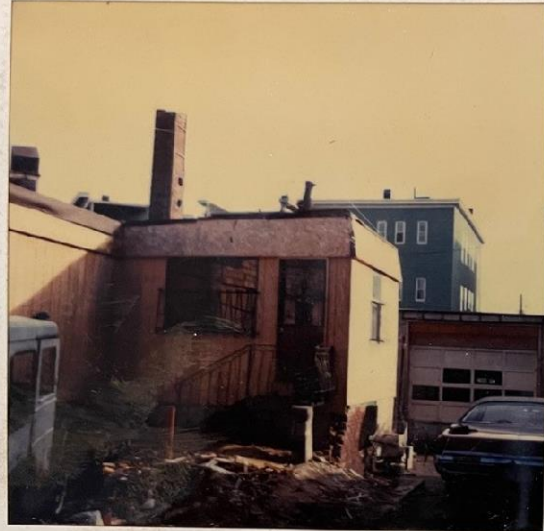
The rear of 84 Prospect was reconstructed and has since had an addition built on the front and connected to its once detached garage. The garage was likely built after 1950.

84 Prospect Reconstruction
