STEP 1: DETERMINATION OF SIGNIFICANCE
STAFF REPORT

Site: 2 Quincy Street

Case: HPC.DMO 2021.25

Legal Ad: *Demolish all structures.*

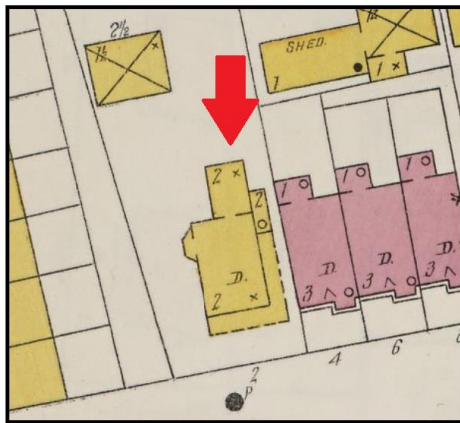
Left: Close-up of 1895 Bromley Map

The 1895 Bromley Map shows that a wrap around porch has been added extending from the ell on the right side to the front elevation and around the front.

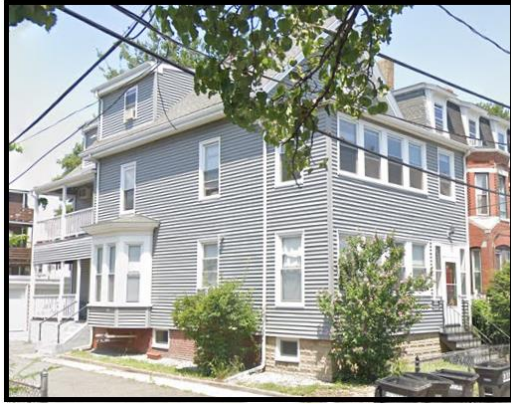
Left: Google Street view July 2019

The wrap around porch on the right and front elevations appears to have been enclosed since 1900. The dormer on the left elevation is a later addition as is the rear two-story porch on the left side towards the rear.

d. Alterations: Prior to current condition caused by a fire - the dormer on the left elevation is a later addition as is the rear two-story porch on the left side towards the rear. Modern replacement doors. Replacement windows.
