**STEP 1: DETERMINATION OF SIGNIFICANCE**  
**STAFF REPORT**

**Site:** 9 Taylor Street

**Case:** HPC.DMO 2022.04

**HPC Meeting Date:** March 15, 2022

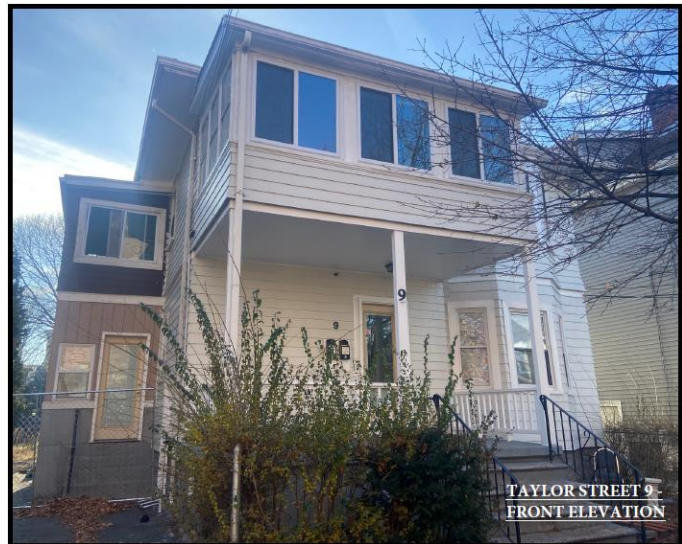
*Top: Front elevation*

- Front Elevation
  - First floor open porch with an aluminum or plexiglass front door with glass insert.
  - Porch has three narrow columns to support the enclosed space above; railings along the sides of the porch.

- The front porch on the second floor has been enclosed but was originally an open porch.
  - Lean-to on the left elevation with entrance on the front through an aluminum or plexiglass front door with glass insert.

- Two-story bay to the right of the front entry door.
  - Fenestration consists of three one-over-one, double-hung, replacement sash windows on the bay and one double-hung, replacement sash window on the enclosed porch next to the door. The second-floor fenestration consists of four horizontal sliding windows, and three one-over-one, double-hung, replacement sash windows with simple surround on the bay.

- Concrete steps lead to a concrete landing to the main front entrance with mid-late 20<sup>th</sup> century iron railings.
  - Concrete steps lead to the entryway to the lean-to on the left elevation with mid-late 20<sup>th</sup> century iron railing.

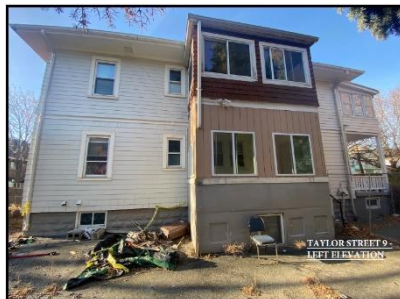
*Bottom, left: Left elevation*

- Left Elevation
- Roofline has a deep eave.
  - Fenestration on the first floor consists of two one-over-one, double-hung, replacement sash windows towards the rear of the left elevation, and two horizontal sliding windows on the lean-to. On the second floor, the fenestration consists of two one-over-one, double-hung, replacement sash windows, two horizontal sliding windows on the lean-to, and three one-over-one, double-hung, replacement sash windows with simple surround on the second-story addition of the front elevation.

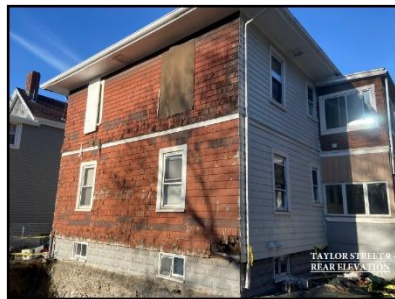
*Bottom, middle: Rear elevation*

- Basement fenestration consists of one horizontal sliding sash window and two hinged or fixed windows.
- Rear Elevation
- Roofline has a deep eave.
  - Fenestration on the first floor consists of two one-over-one, double-hung, replacement sash windows on the main structure, and three horizontal sliding or fixed windows on the lean-to. On the second floor, the fenestration consists of two horizontal sliding windows on the lean-to. Two windows on the original structure have been boarded up but likely contained one-over-one, double-hung sash windows.

- Basement fenestration consists of two horizontal sliding windows.

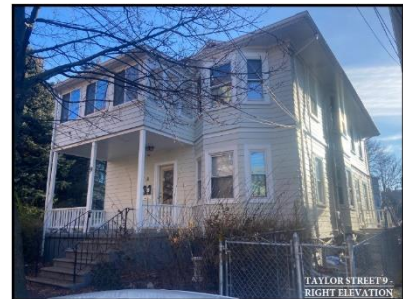
*Bottom, Right: Right elevation*

- Wood or aluminum railings on front steps.
- Right Elevation
- Roofline has a deep eave.
  - Contains a two-story bay with access from the outside to the first floor via exterior steps.

- Fenestration consists of one one-over-one, double-hung, replacement sash windows towards the front of the right elevation, three one one-over-one, double-hung, replacement sash windows along the bay, and two one-over-one, double-hung, replacement sash windows towards the rear of the elevation.
