STEP 1: DETERMINATION OF SIGNIFICANCE
STAFF REPORT

Site: 15-16 Winter Hill Circle

Case: HPC.DMO 2021.19

Legal Ad: *Demolish principal structure*

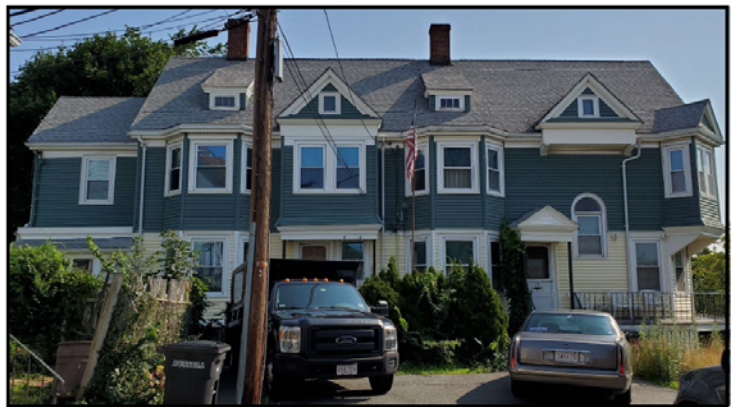
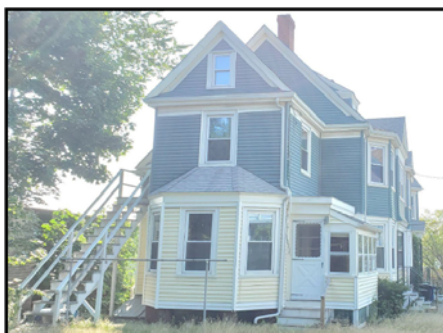
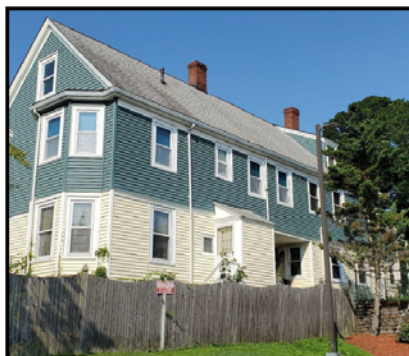
Top: Front elevation

Bottom, left: Left elevation

Bottom, middle: Rear elevation

Bottom, right: Right elevation

- a. Location: It is likely that this structure is in its original location and was built on-site.
- b. Design: The structure is a gable roofed, two- and one-half story, five bay Victorian style building with an asymmetric design.
 - Gable roof with shingles
 - Brick chimneys

- Brick foundation
- Front Elevation
 - Asymmetric entrance with two entryways; one under second story bay with hood, and a porch entryway to the right
 - Mid-late 20th century iron railings

- Two two-story bays
 - Two second-story bays
 - Four dormers
 - Fenestration consists of one-over-one windows single or double-hung, replacement sash windows with simple surround on first two floors. Dormer fenestration consists of single top hung window and three-pane top hung windows with simple surround

- Right Elevation
 - Fenestration consists of one-over-one windows single or double-hung, replacement sash windows with simple surround
 - Two-story bay
 - Second-story bay

- Left Elevation
 - Entryway on right side
 - Fenestration consists of one-over-one windows single or double-hung, replacement sash windows with simple surround

- Banding beneath top floor
 - Concrete steps leading to door
 - First floor bay
 - Wood stairs leading to second story
- Rear Elevation
 - Fenestration consists of one-over-one windows single or double-hung, replacement sash windows with simple surround

- Lean-to addition
 - Recessed rear entryway

- Foundation: Brick,
- Windows: Vinyl or aluminum
- Entry door: Modern. Manmade materials, likely fiberglass.
- Siding: Vinyl
- Railings: Iron
- Roof: Asphalt shingle
- Metal gutters

- c. Alterations: Modern metal railings. Replacement windows. Vinyl siding. Replacement one-over-one vinyl or aluminum windows throughout. Modern replacement doors, likely fiberglass. The second-story bay in the front right corner of the structure and an additional dormer with hood on the front elevation are likely 20th century additions.

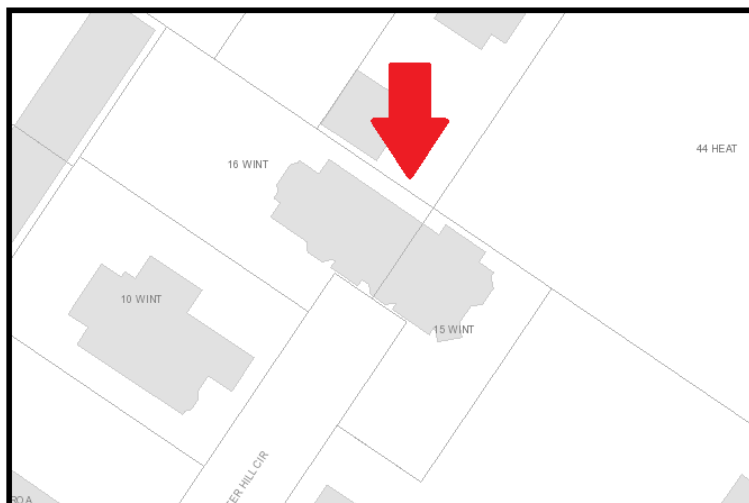
Looking at the current structure, we see that, since 1959, a second story bay has been added in the front right corner of the structure and an additional dormer with hood has been added to the front elevation. It also appears that the left wing, first evident in the 1895 Bromley Map, has been rebuilt with a one-story bay at the end. It may also be that this feature was mistakenly left out of the 1938-1959 Sanborn Map.

Left: 1938 – 1959 Sanborn Map with 15-16 Winter Hill Circle indicated
