**STEP 1: DETERMINATION OF SIGNIFICANCE**  
**STAFF REPORT**

**Site:** 16 Woodbine St

**Case:** HPC.DMO 2021.20

**Legal Ad:** *Demolish principal structure*

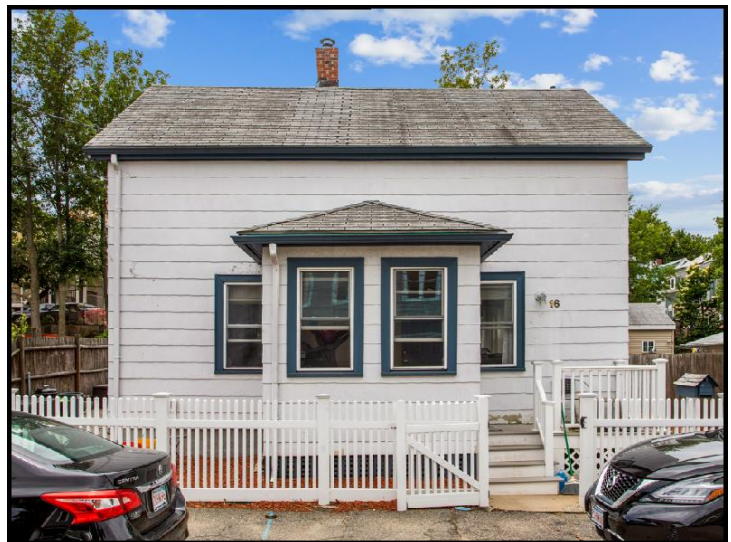
***Top: Front elevation***

- Front Elevation

- Symmetric front elevation with enclosed porch,
- Entry door on right side of enclosed porch with steps leading to small open porch on right side
- Wood steps from porch to pavement
- Fenestration consists of one-over-one single or double-hung sash windows with simple surround
- Lattice porch skirt around enclosed and open porches

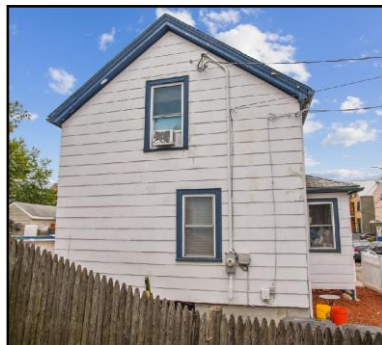
***Bottom, left: Left elevation***

- Left Elevation

- Fenestration consists of one-over-one single or double-hung sash windows with simple surround
- Gable-ended roof

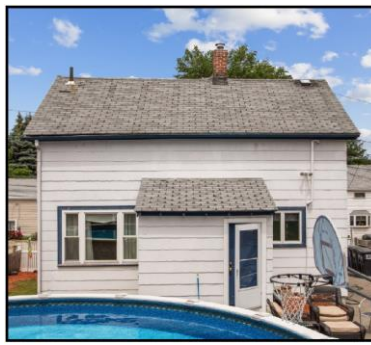
***Bottom, middle: Rear elevation***

- Rear Elevation

- Fenestration consists of double casement window with simple surround and a fixed or casement window between one-over-one single-hung sash windows on either side
- One-story lean-to with vinyl or aluminum door

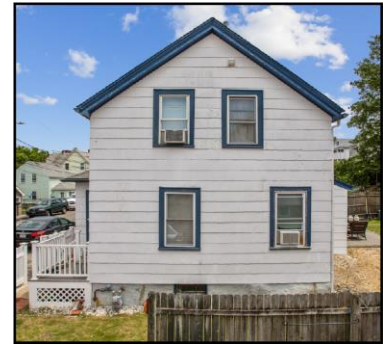
***Bottom, Right: Right elevation***

- Right Elevation

- Fenestration consists of one-over-one single or double-hung sash windows with simple surround
- Gable-ended roof
