**STEP 1: DETERMINATION OF SIGNIFICANCE**  
**STAFF REPORT**

**Site:** 12 Woodbine St

**Case:** HPC.DMO 2022.23

**HPC Meeting Date:** June 21, 2022

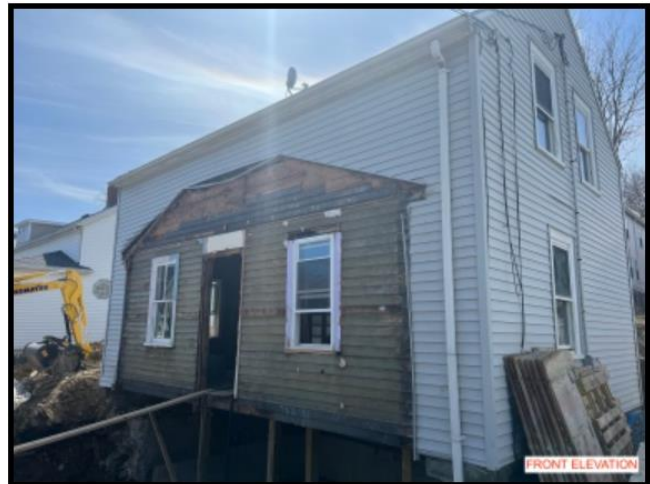
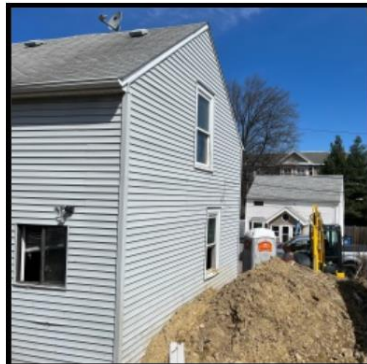
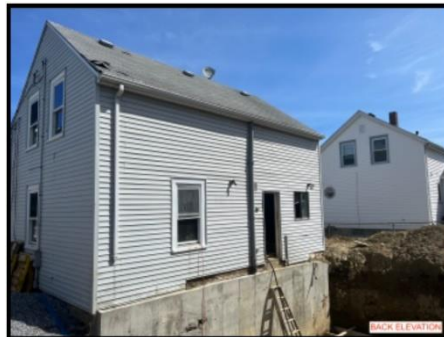
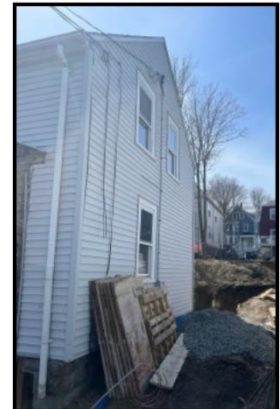
*Top: Front elevation*

*Bottom, left: Left elevation*

*Bottom, middle: Rear elevation*

*Bottom, right: Right elevation*

Prior to applying to the HPC for demolition review, the Applicant removed the front enclosed porch and rear portion of the building without permission. This unauthorized activity can be seen in the photos on the first page of this staff report. After the Applicant was notified by ISD that demolition review by the HPC was required, the Applicant began to submit their application documents. The Applicant was allowed to secure the house from the elements and secure the property.

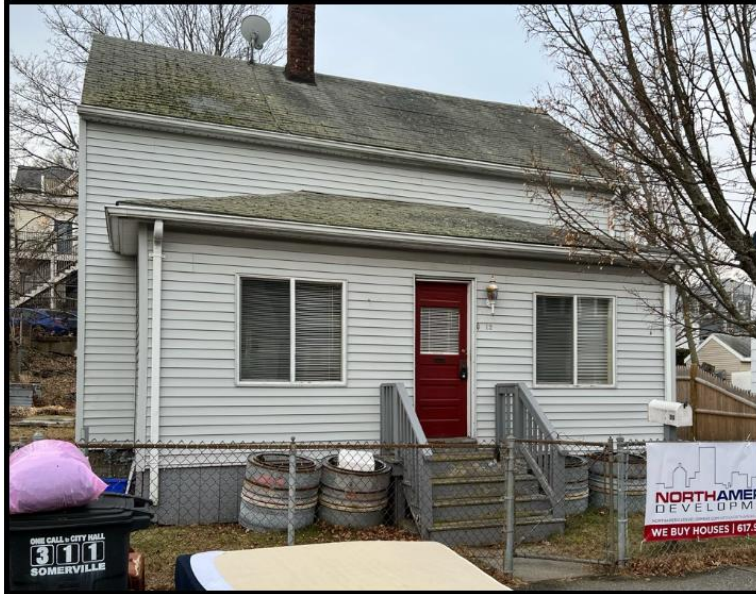
*Above: Front elevation prior to commencement of demolition*

- Symmetric front elevation, formerly with an enclosed porch
- Formerly wood steps from porch to pavement
- Prior to demolition the fenestration consisted of either double casement or horizontal sliding windows
- There was a skirt with vertical wood slats along the enclosed front porch.

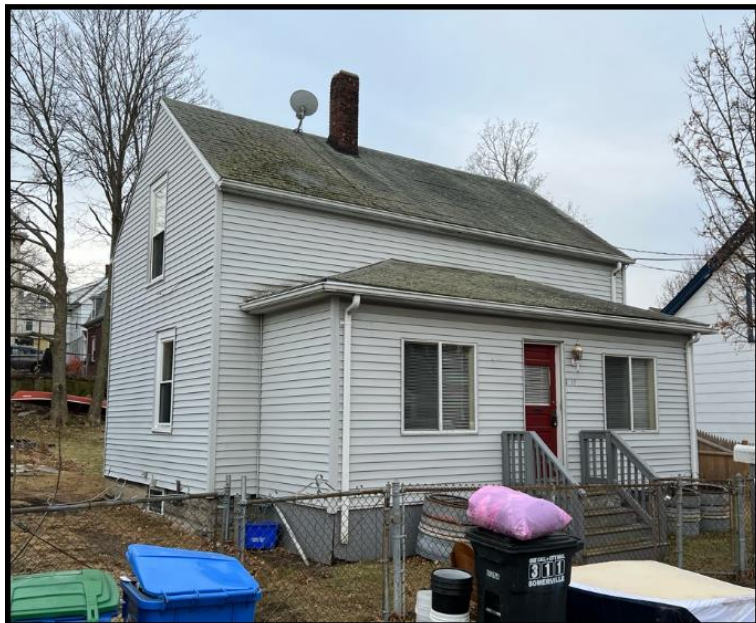
*Above: Left elevation prior to commencement of demolition*

- Right Elevation
    - Fenestration consists of one-over-one double-hung sash windows with simple surround
    - Gable-ended roof
  - Left Elevation
    - Fenestration consists of one-over-one double-hung sash windows with simple surround

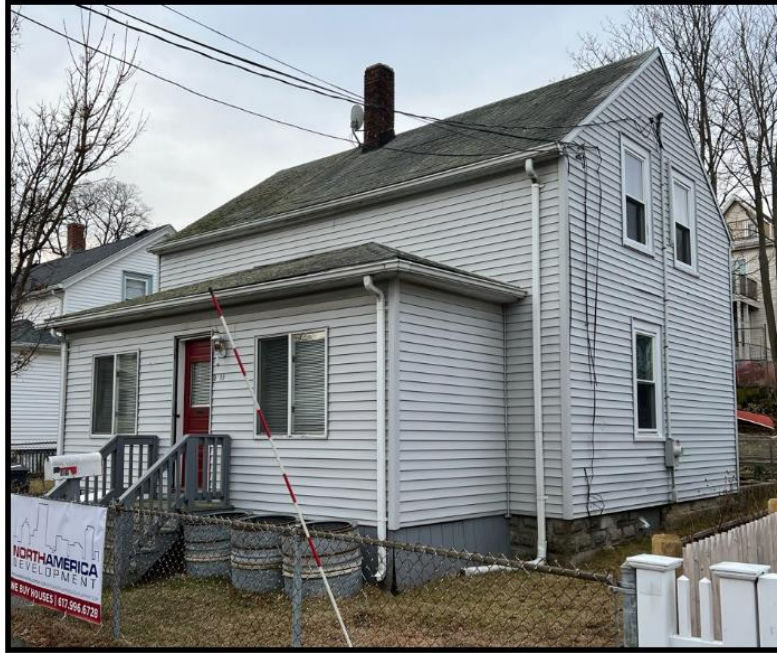
*Above: Right elevation prior to commencement of demolition*

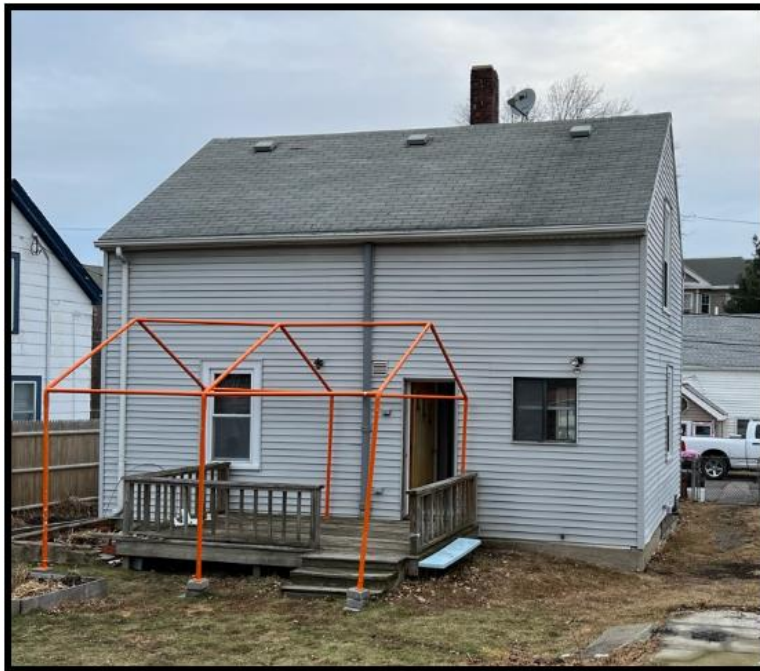
*Above: Rear elevation prior to commencement of demolition*

- Gable-ended roof
  - Rear Elevation
    - Fenestration consists of two-over-two fixed window with simple surround and one one-over-one double-hung sash window.

- Prior to demolition a door led to wood porch with wood steps
- c. Materials:
- Foundation: Concrete parged brick or stone/rubble.
  - Windows: Aluminum

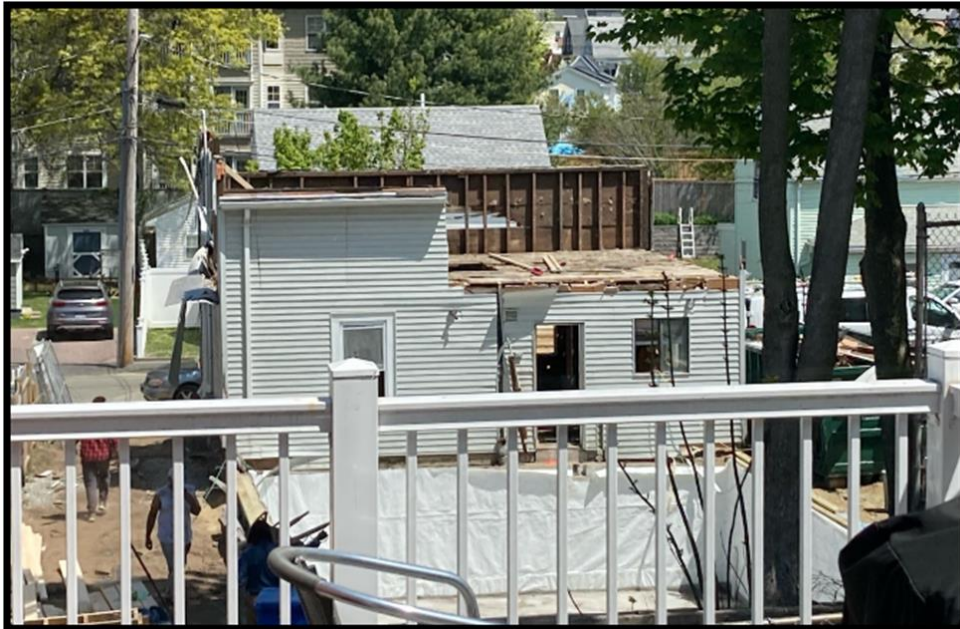
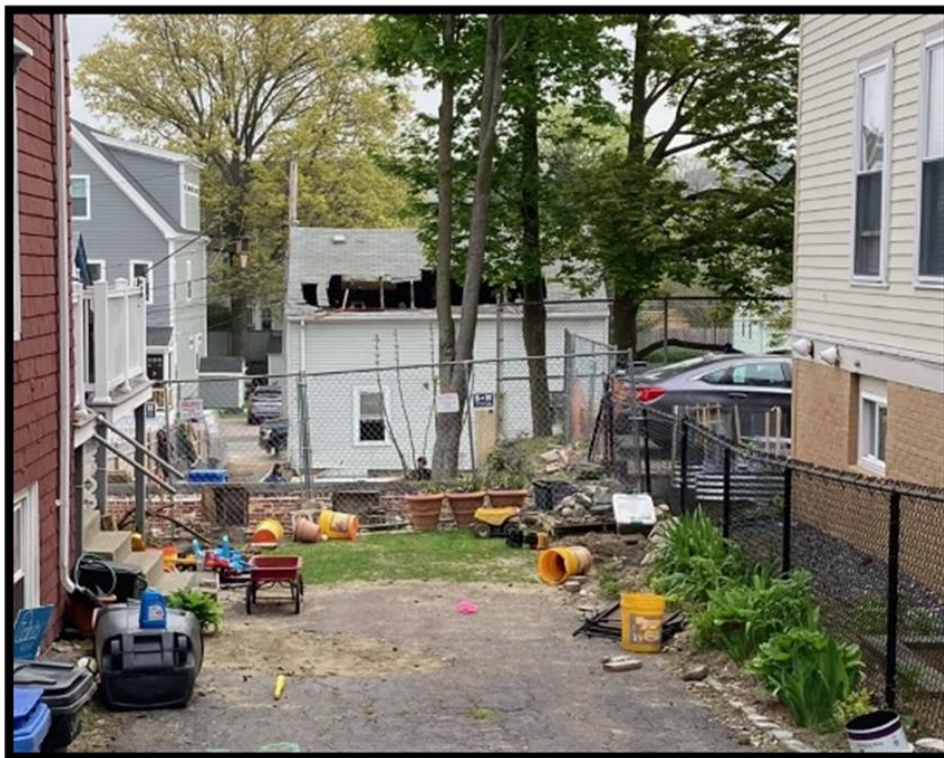
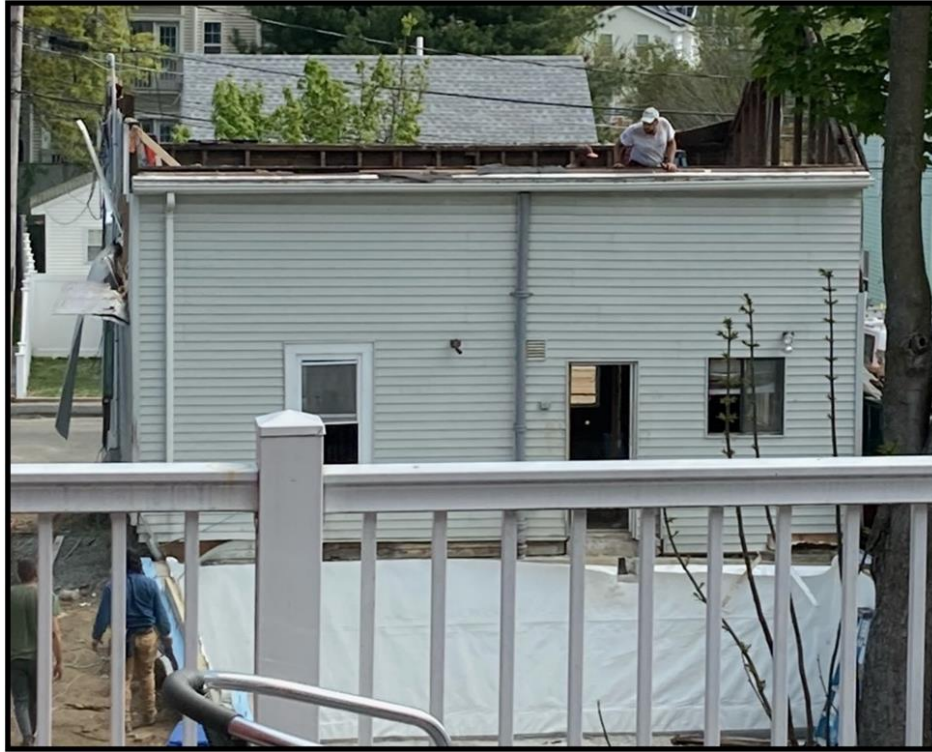
Yet, while the Applicant was in the process of submitting their application materials for demolition review, the Applicant team, within a few short hours, proceeded to remove the roof structure and the entire second floor. The City was alerted to this unauthorized activity by the neighborhood. This was again done without authorization from the City. ISD visited the property again and issued a Stop Work Order.

*Above: Photo after commencement of demolition*
