INSPECTION REPORT BY BIG BEN INSPECTIONS

1000 Glenwood Drive
Raleigh, NC 27603

JUNE 2, 2023

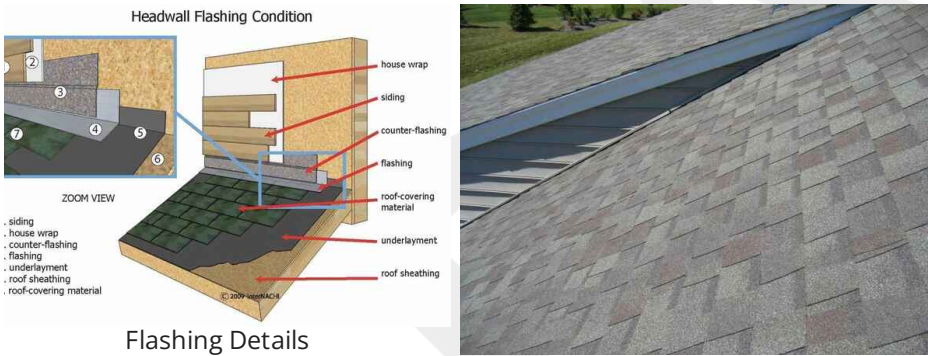
Flashing: Wall Intersections

I looked for flashing where the roof covering meets a wall or siding material. There should be step and counter flashing installed in these locations. This is not an exhaustive inspection of all flashing areas.

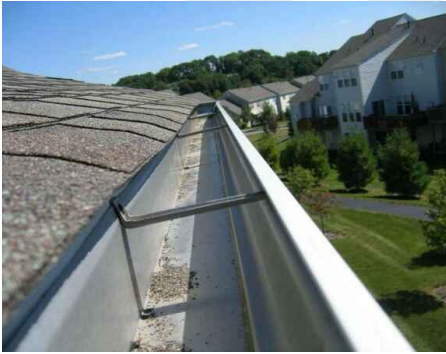
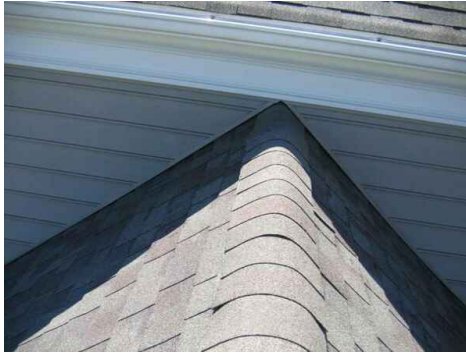
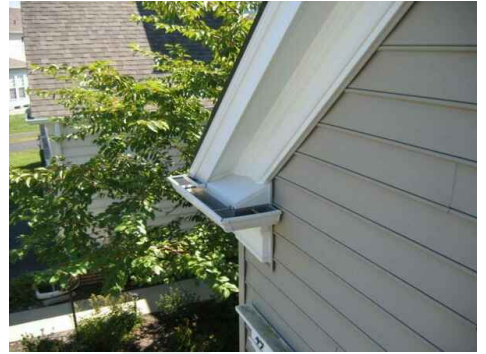
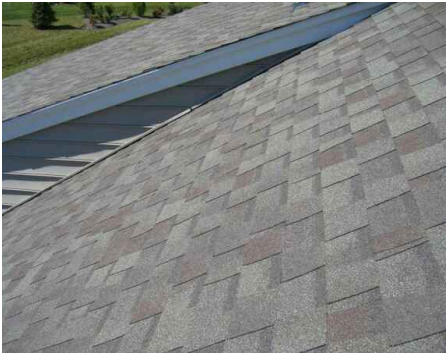
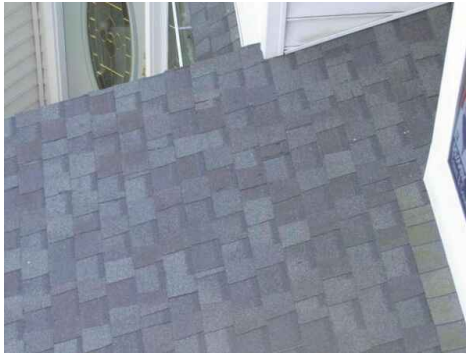
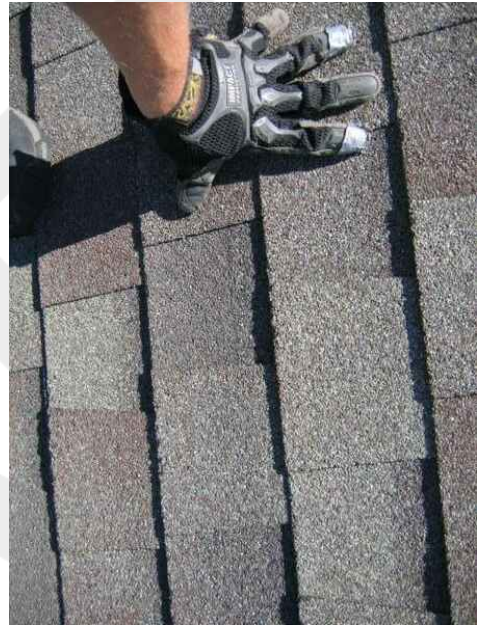
Flashing: Eaves and Gables

I looked for flashing installed at the eaves (near the gutter edge) and at the gables (the diagonal edge of the roof). There should be metal drip flashing material installed in these locations. The flashing helps the surface water on the roof to discharge into the gutter. Flashing also helps to prevent water intrusion under the roof-covering.

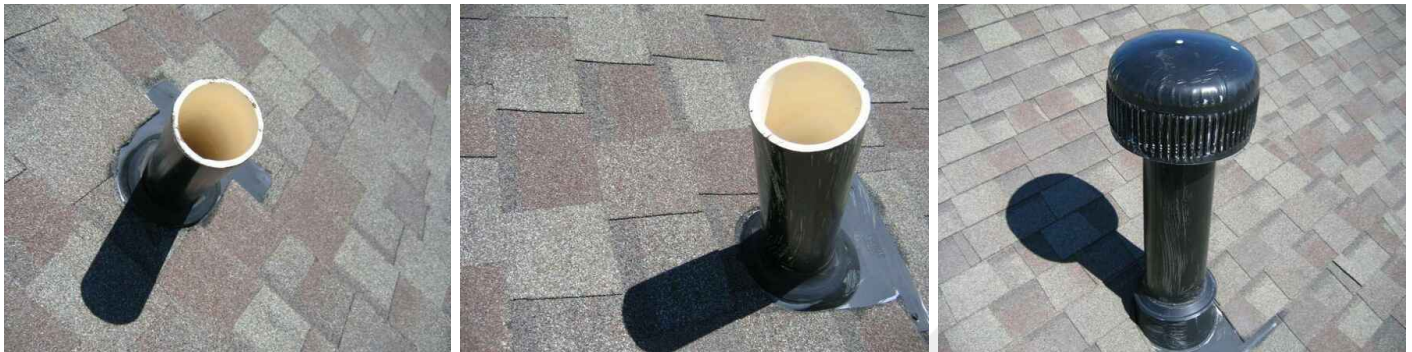
Plumbing Vent Pipes: Plumbing Vent Pipes Inspected

I looked at DWV (drain, waste and vent) pipes that pass through the roof covering. There should be watertight flashing (often black rubber material) installed around the vent pipes. These plumbing vent pipes should extend far enough above the roof surface.

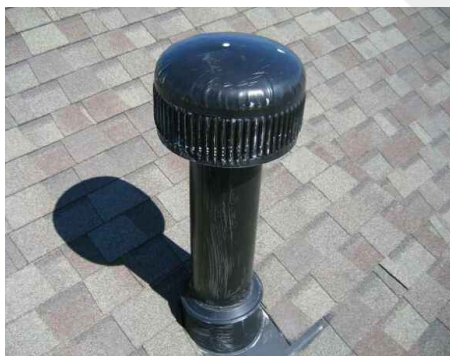
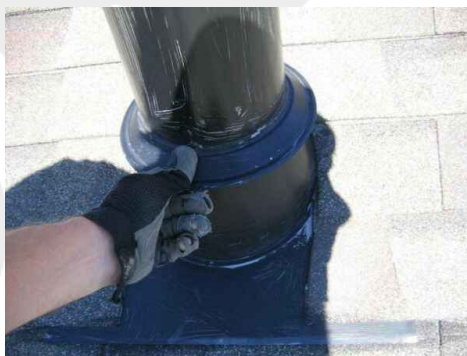
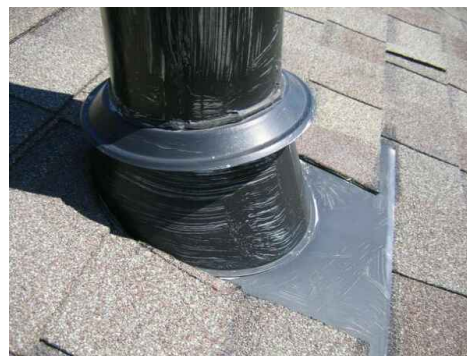
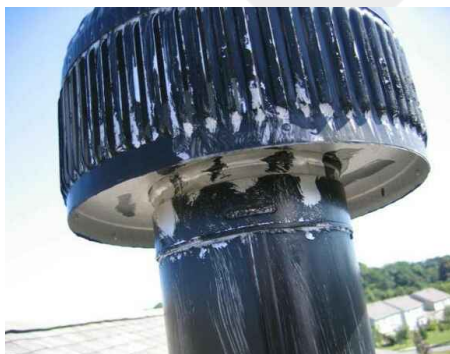
Flue Gas Vent Pipes: Flue Gas Vent Pipe Inspected

I looked at flue gas vent pipes that pass through the roof covering.

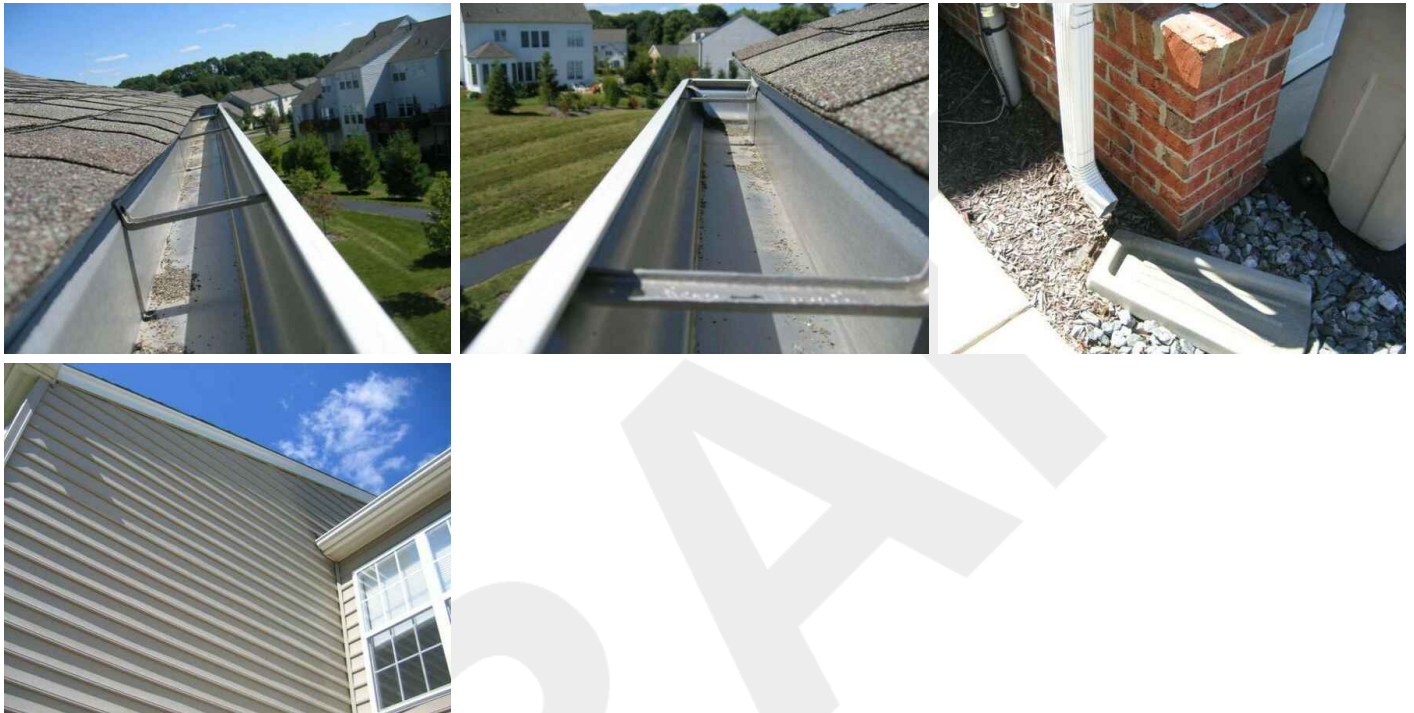
I inspected the gutters. I wasn't able to inspect every inch of every gutter. But I attempted to check the overall general condition of the gutters during the inspection and look for indications of major defects.

Monitoring the gutters during a heavy rain (without lightening) is recommended. In general, the gutters should catch rain water and direct the water towards downspouts that discharge the water away from the house foundation.

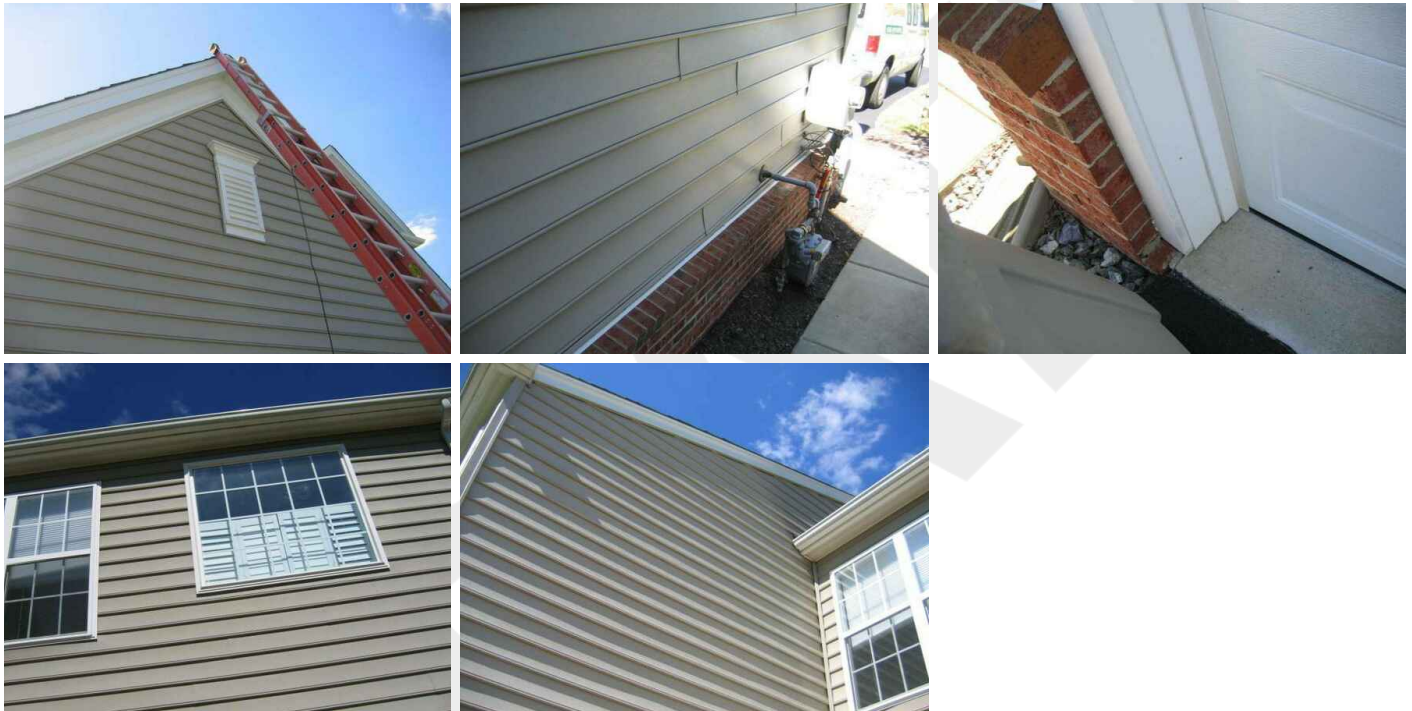
General: Exterior Was Inspected

I inspected the exterior of the house.

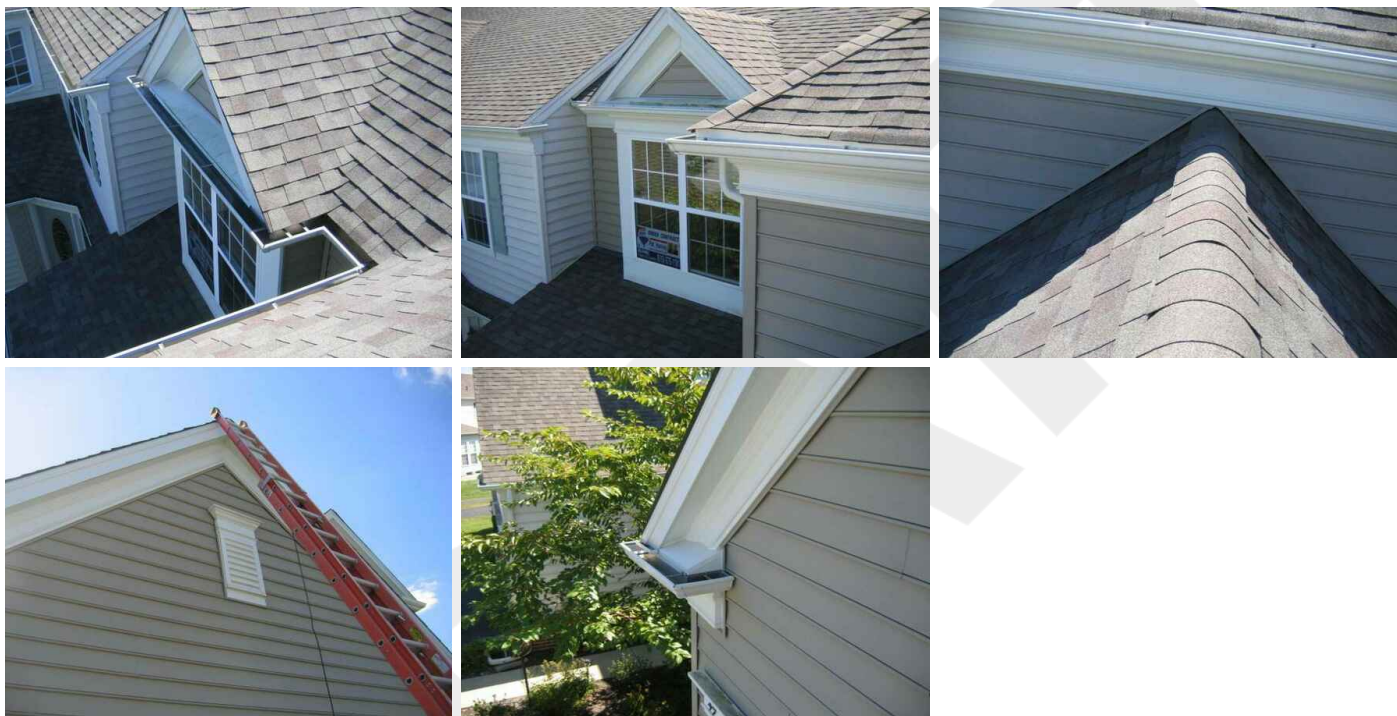
Eaves, Soffits & Fascia: Eaves, Soffits and Fascia Were Inspected

I inspected the eaves, soffits and fascia. I was not able to inspect every detail, since a home inspection is limited in its scope.

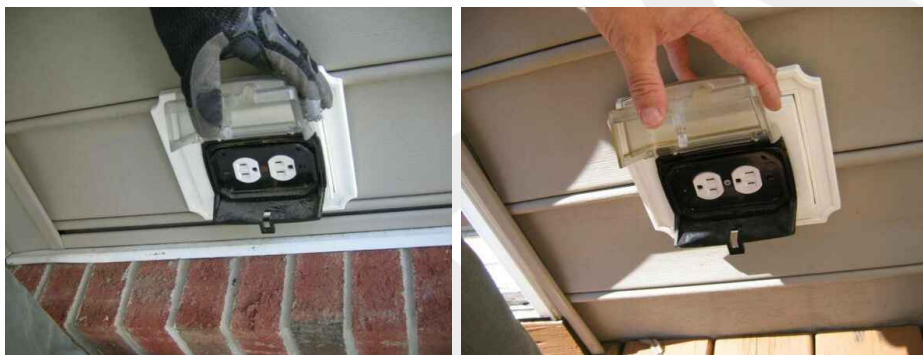
GFCIs & Electrical: Inspected GFCIs

I inspected ground-fault circuit interrupter receptacles and circuit breakers observed and deemed to be GFCIs using a GFCI tester, where possible.

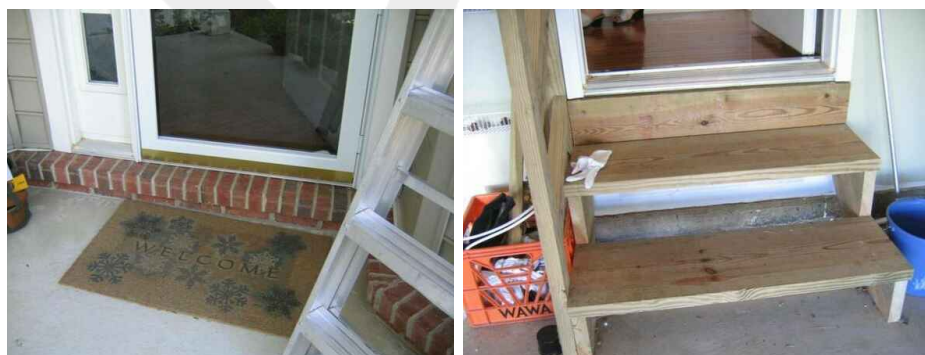
I inspected the stairs, steps, stoops, stairways and ramps that were within the scope of my home inspection.

All treads should be level and secure. Riser heights and tread depths should be as uniform as possible. As a guide, stairs must have a maximum riser of 7-3/4 inches and a minimum tread of 10 inches.

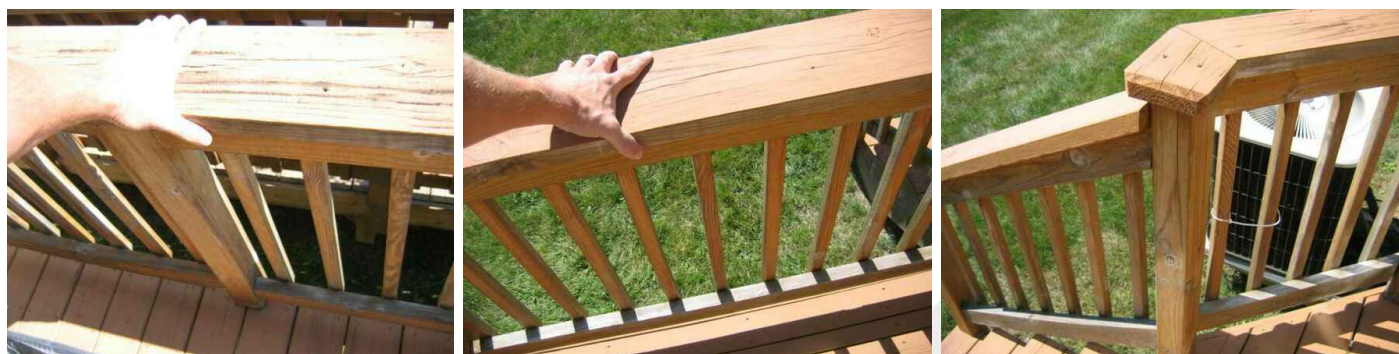
Railings, Guards & Handrails: Railings, Guards & Handrails Were Inspected

I inspected the railings, guards and handrails that were within the scope of the home inspection.

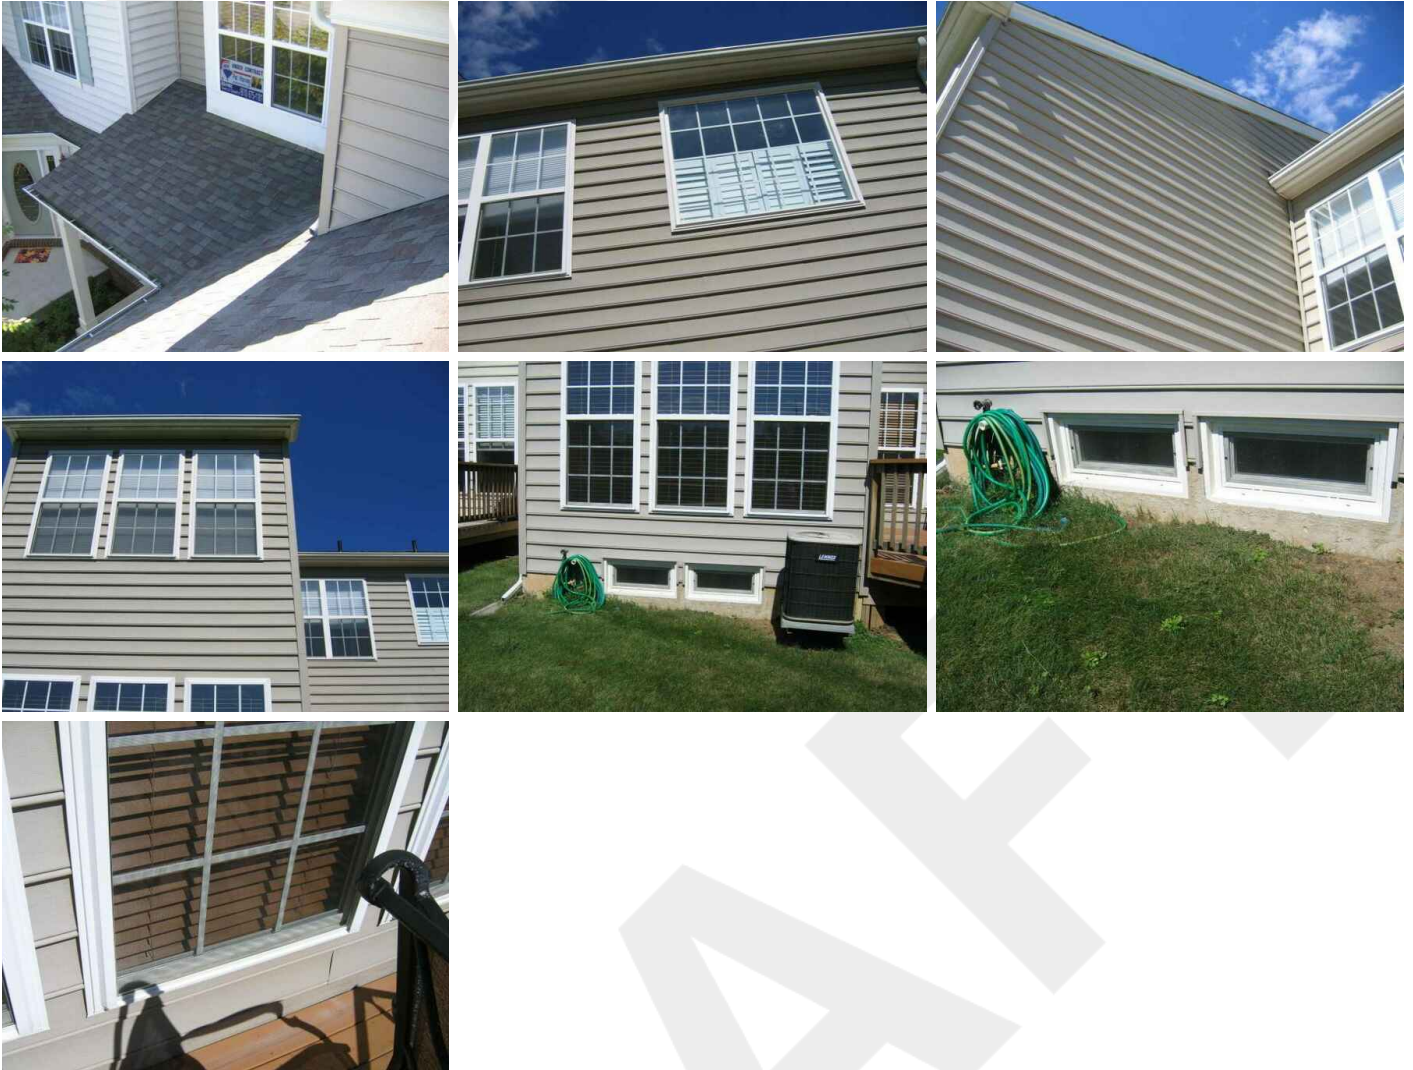
Windows: Windows Inspected

A representative number of windows from the ground surface was inspected.

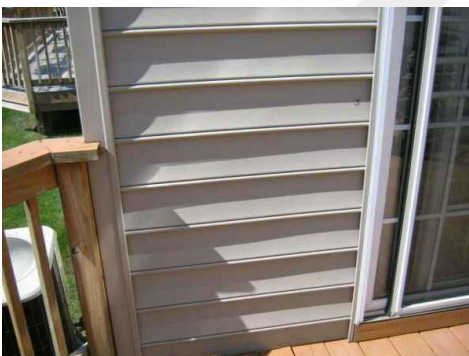
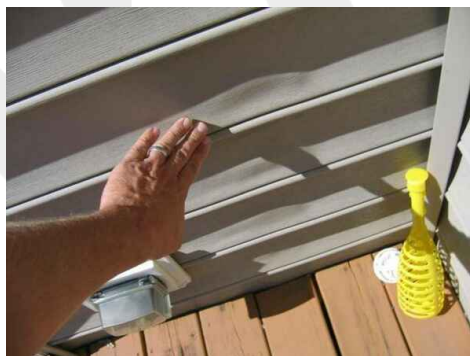
DAMAGED WALL-COVERING MATERIAL

I observed indications of a defect at the exterior wall-covering material. Damaged siding near the grill area at the deck.

Major Defect

Correction and further evaluation is recommended.

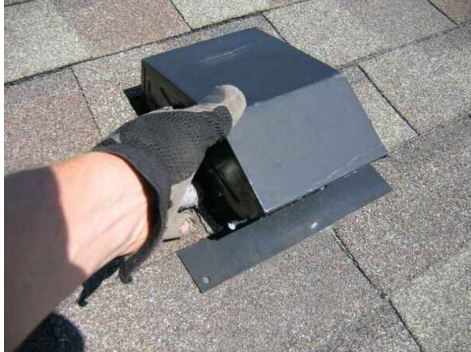
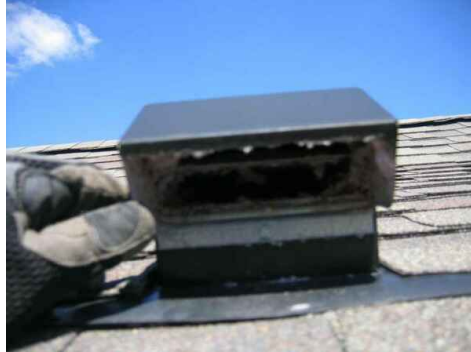
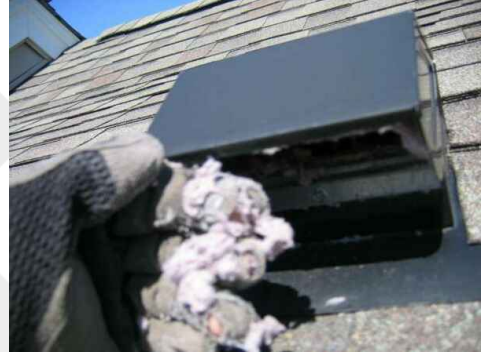
4.12.1 Exhaust Hoods

CLOGGED DRYER EXHAUST HOOD

I observed an exhaust hood that seemed to be connected to the clothes dryer, and it was clogged. Fire hazard.

Major Defect

Contact a qualified appliance repair professional.

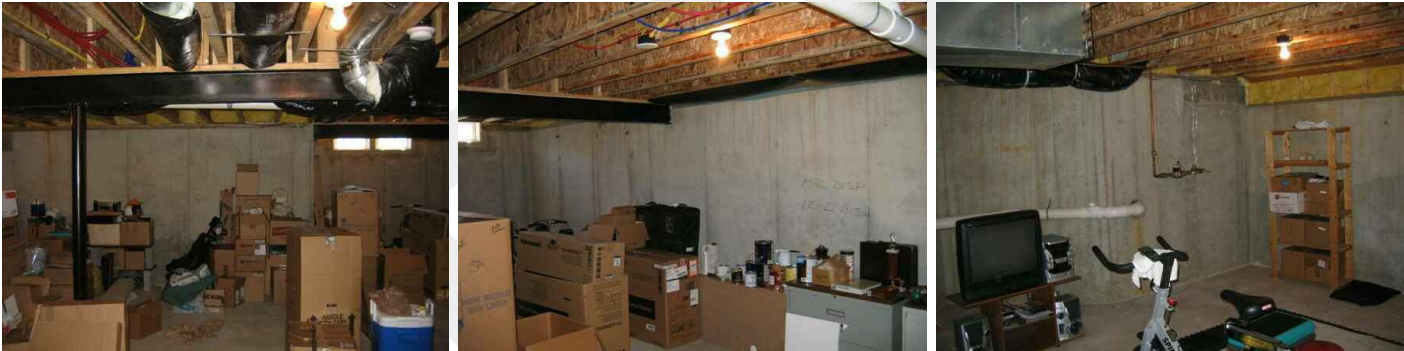
Basement: Basement Was Inspected

The basement was inspected according to the [Home Inspection Standards of Practice](#).
The basement can be a revealing area in the house and often provides a general picture of how the entire structure works. In most basements, the structure is exposed overhead, as are the HVAC distribution system, plumbing supply and DWV lines, and the electrical branch-circuit wiring. I inspected those systems and components.

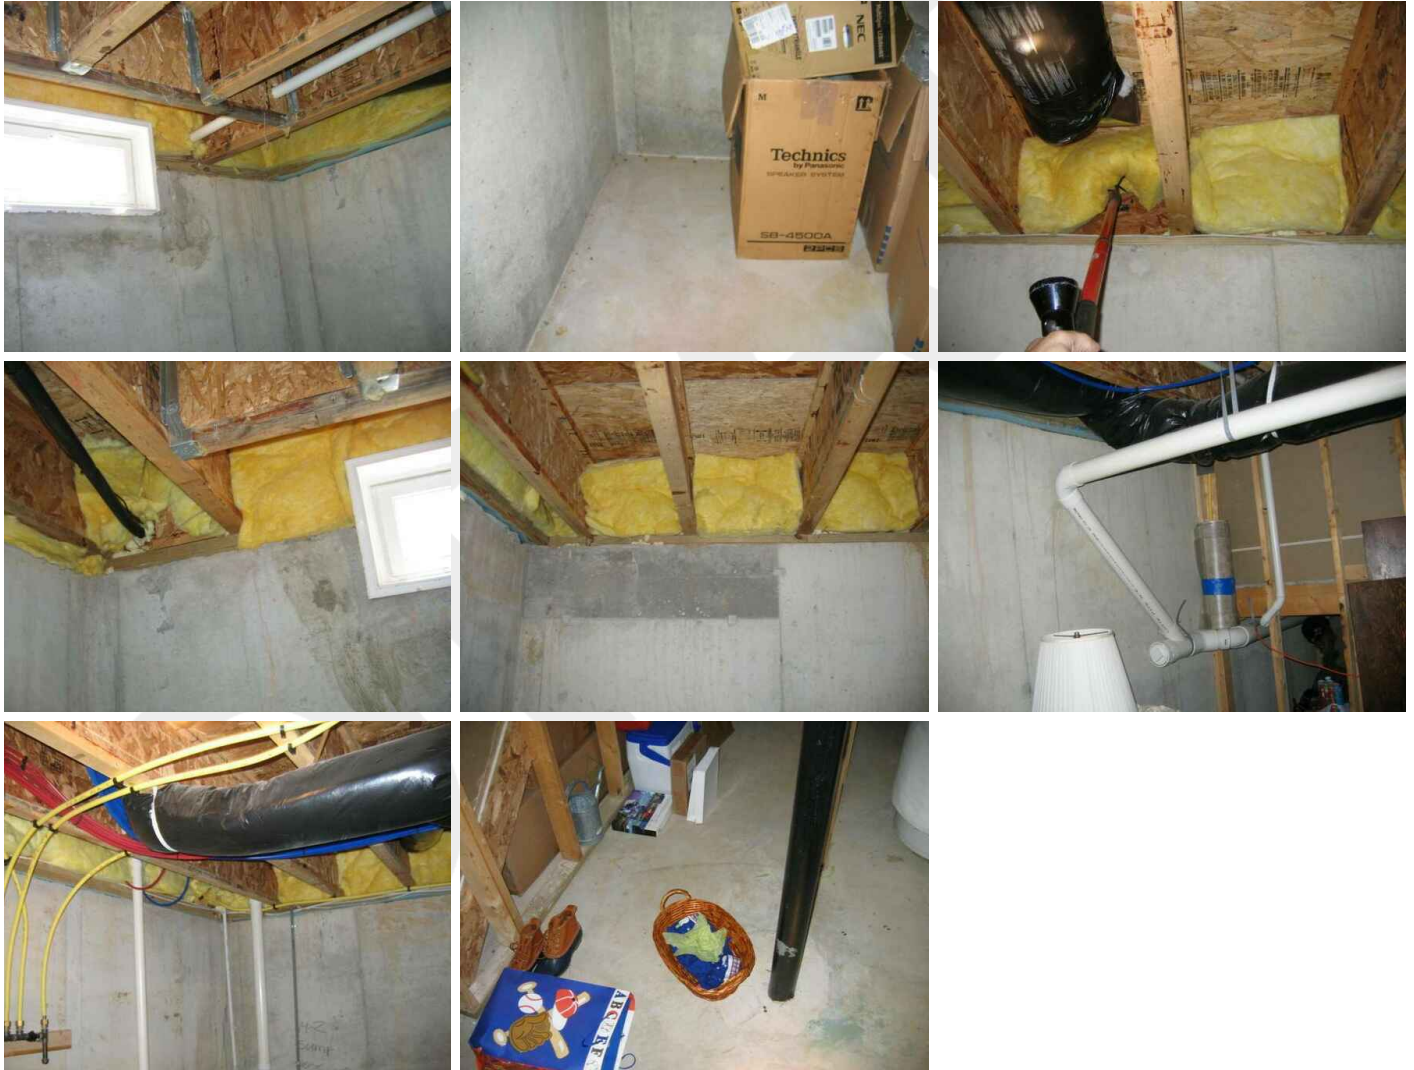
Basement: Foundation Was Inspected

The foundation was inspected according to the [Home Inspection Standards of Practice](#).

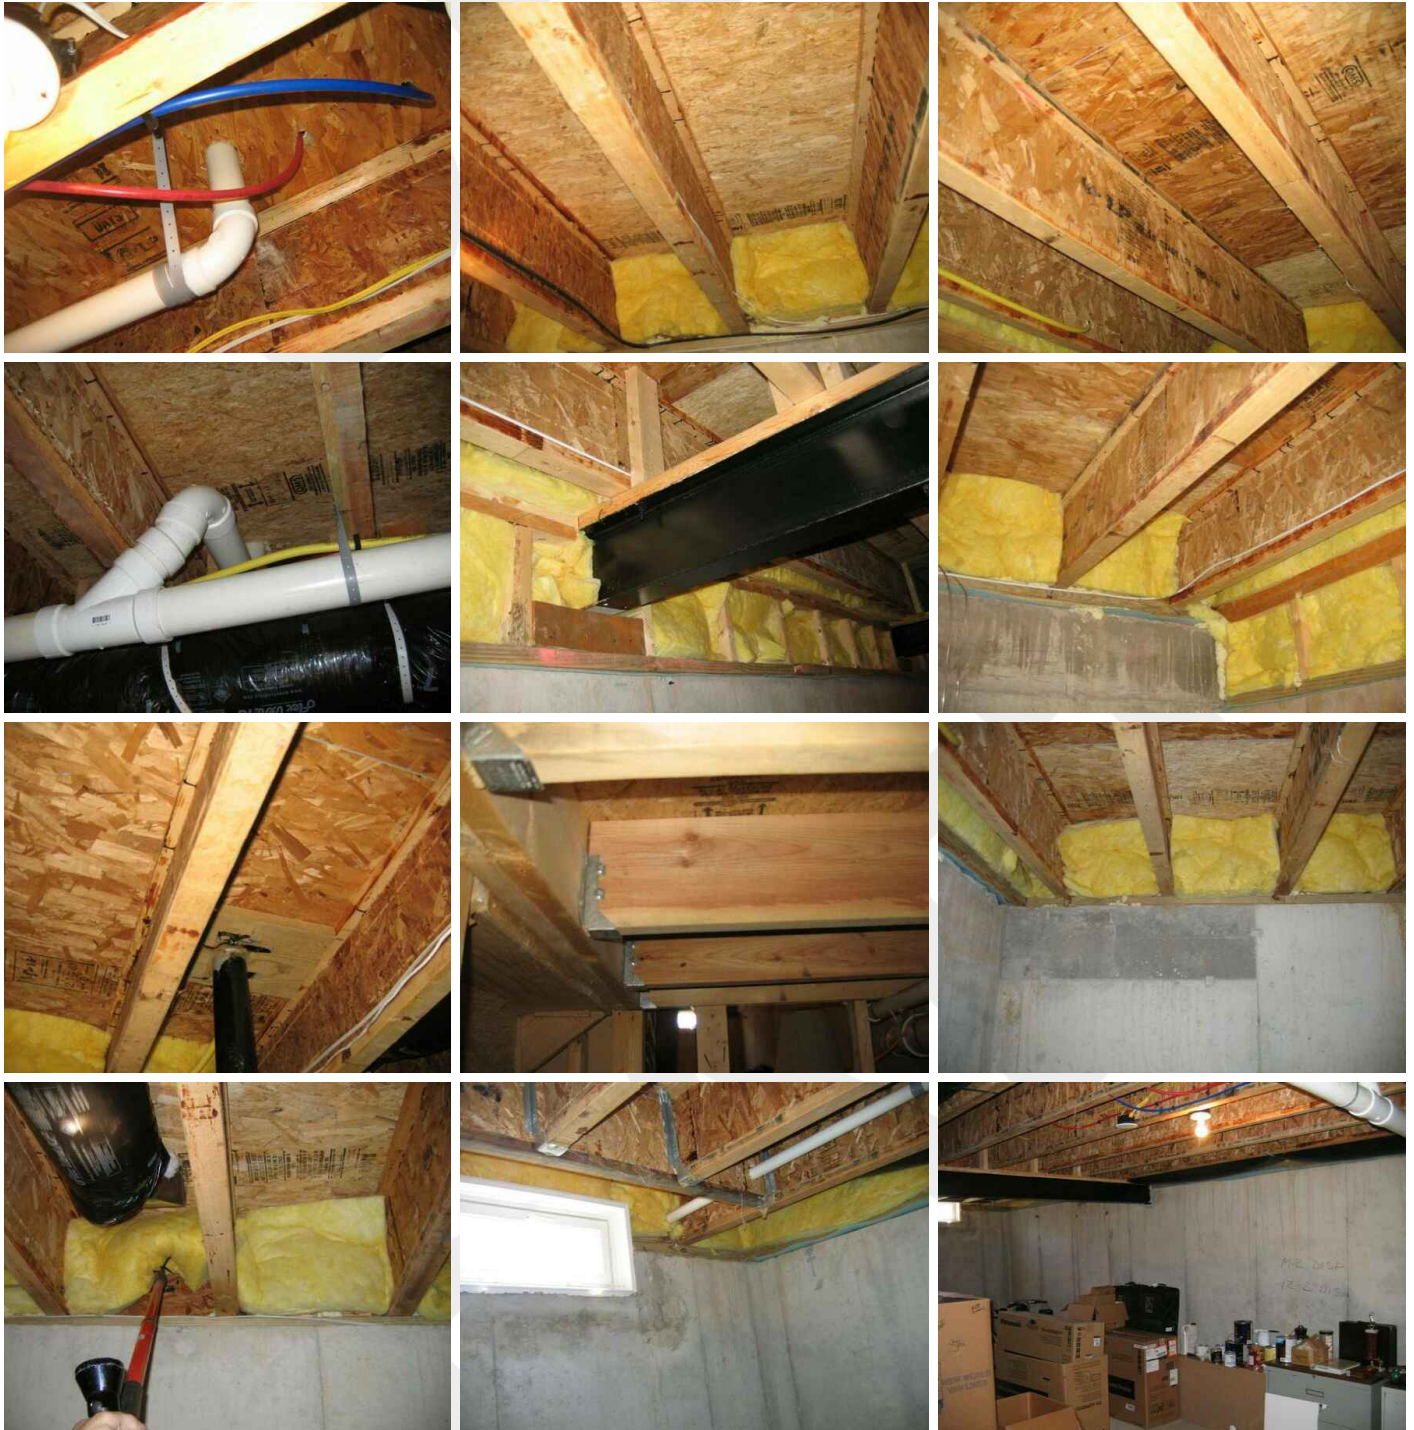
Basement: Structural Components Were Inspected

Structural components were inspected according to the [Home Inspection Standards of Practice](#), including readily observed floor joists.

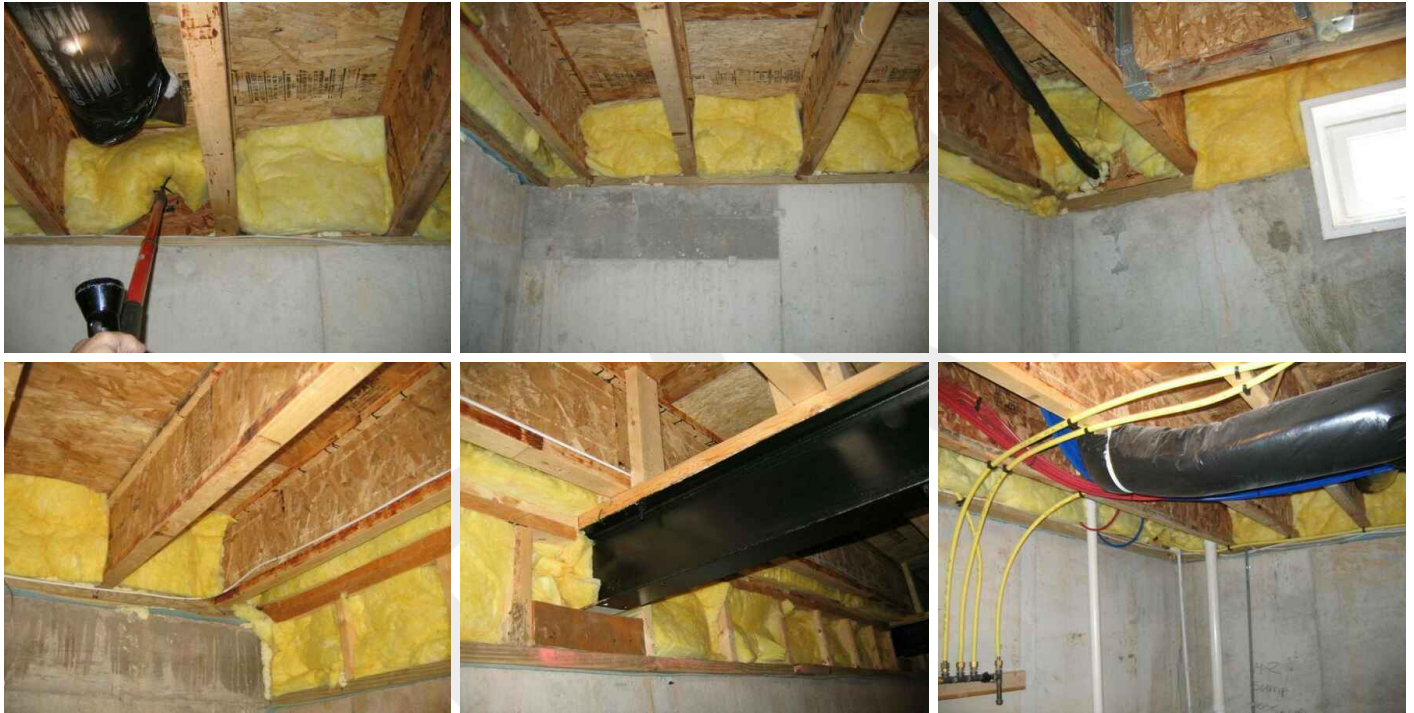
Insulation in Foundation/Basement Area: Insulation Was Inspected

During the home inspection, I inspected for insulation in unfinished spaces, including attics, crawlspaces and foundation areas. I inspected for ventilation of unfinished spaces, including attics, crawlspaces and foundation areas. And I inspected mechanical exhaust systems in the kitchen, bathrooms and laundry area.

I attempted to describe the type of insulation observed and the approximate average depth of insulation observed at the unfinished attic floor area or roof structure.

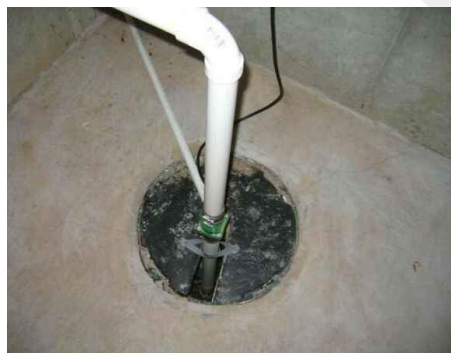
I observed a sump pump was installed in the house.

I observed standing water in the sump pump bucket. This may indicate that the sump pump is critical and necessary to keep the house basement or foundation from having water intrusion problems developing.

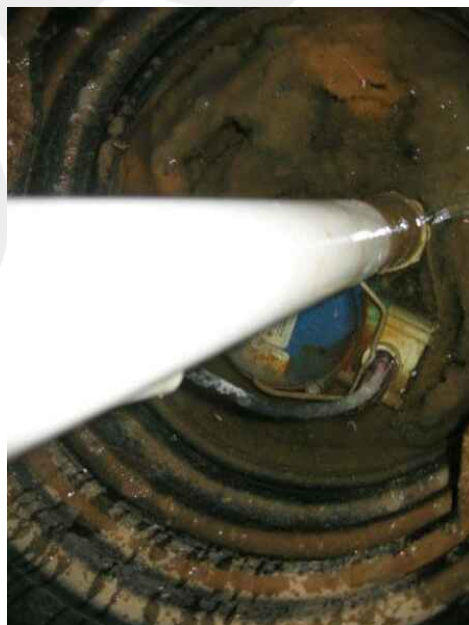
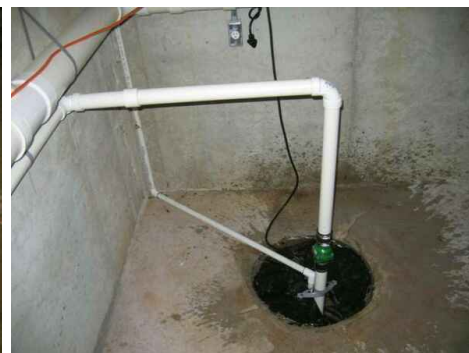
I activated the sump pump. It turned on.

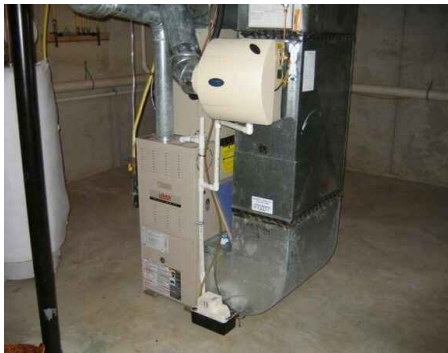
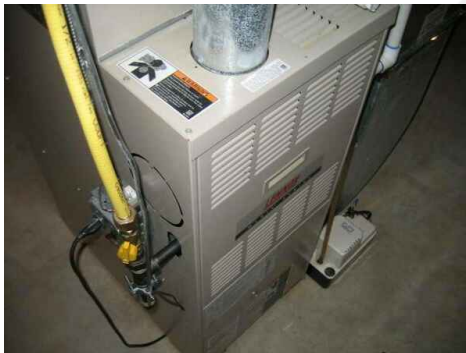
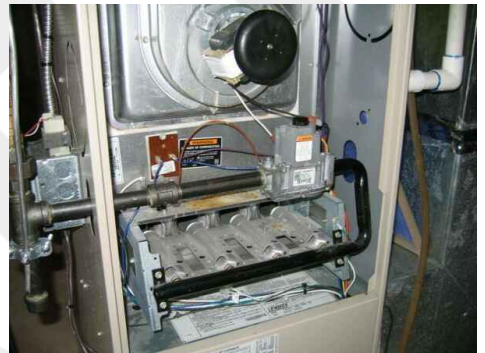
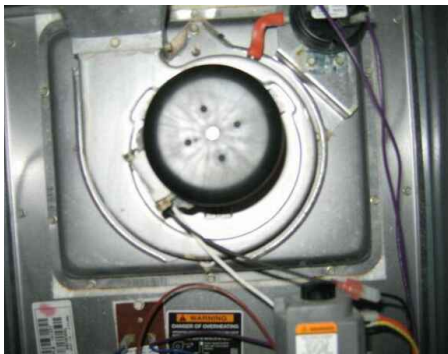
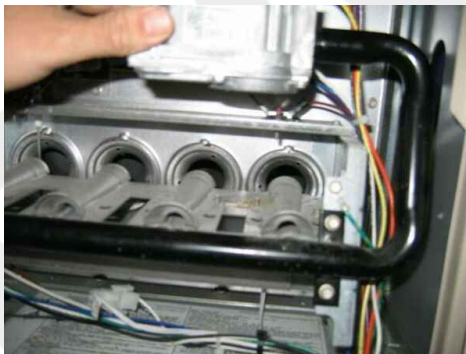
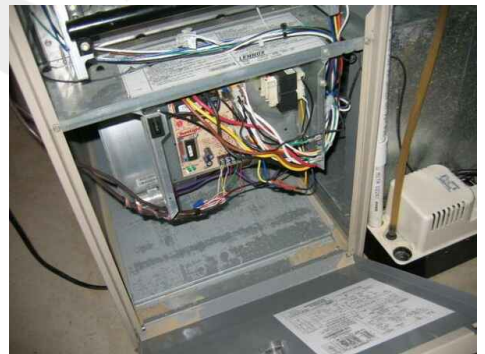
I observed an emergency shut-off switch. I inspected it. It worked when I used it during my inspection.

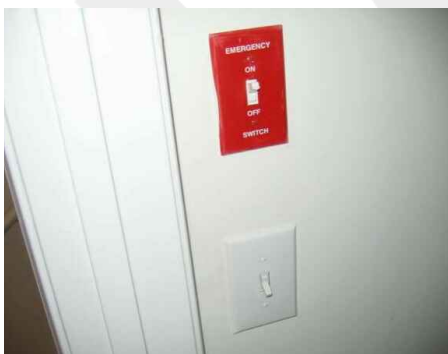
I observed a service switch. I inspected it. It worked when I used it during my inspection.

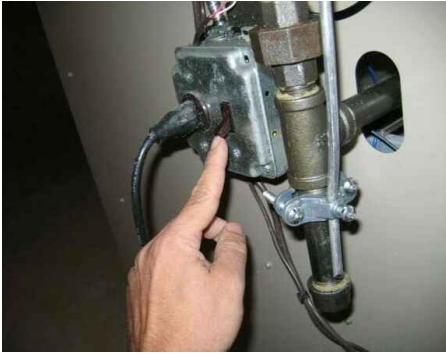
I observed a service disconnect within sight of the cooling system.

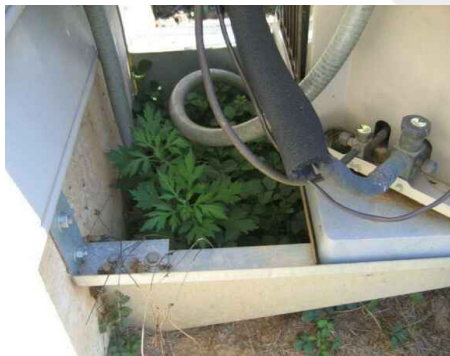
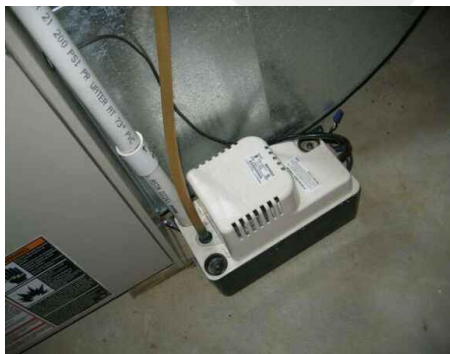
I observed a discharge pipe apparently connected to the condensate pump installed at the cooling system.

I observed a condensate pump installed at the cooling system. This component collects condensate water that is created when the cooling system is operating. The condensate pump should collect and discharge the water properly.

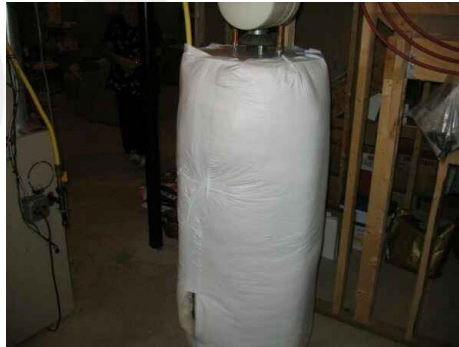
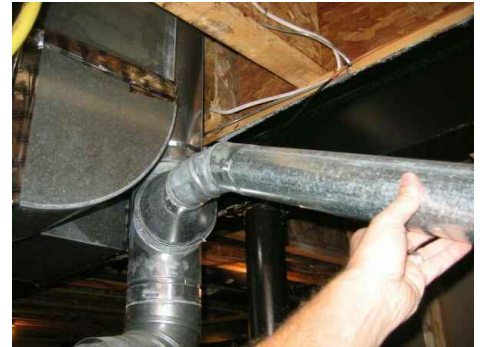
Hot Water Source: Inspected TPR Valve
I inspected the temperature and pressure relief valve.

Hot Water Source: Inspected Venting Connections
I inspected the venting connections.

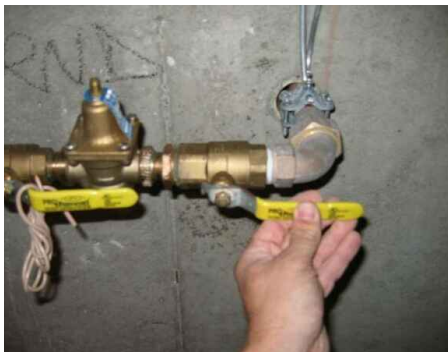
It's your job to know where the main water and fuel shutoff valves are located. And be sure to keep an eye out for any water and plumbing leaks.

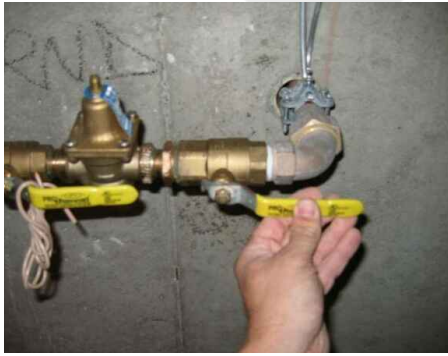
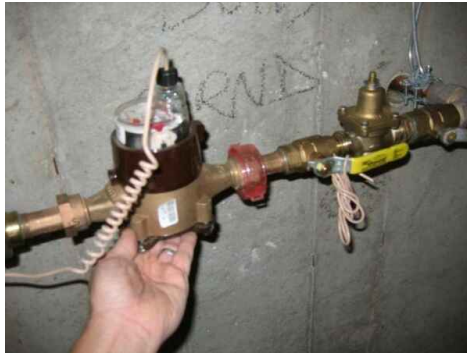
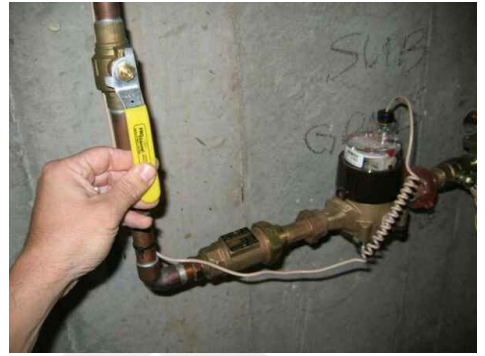
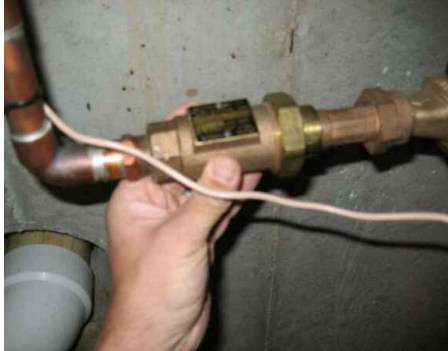
The water supply to the house appeared to be from the public water supply source based upon the observed indications at the time of the inspection. To confirm and be certain, I recommend asking the homeowner for details.

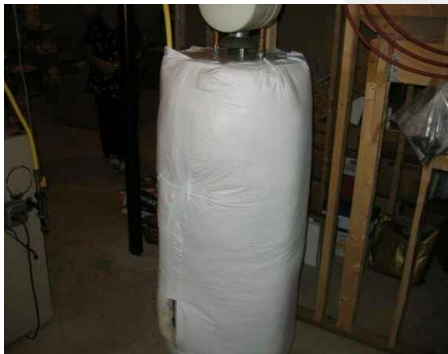
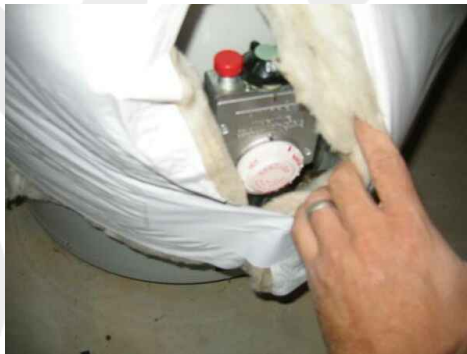
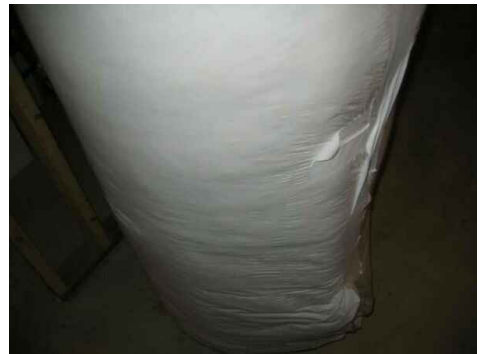
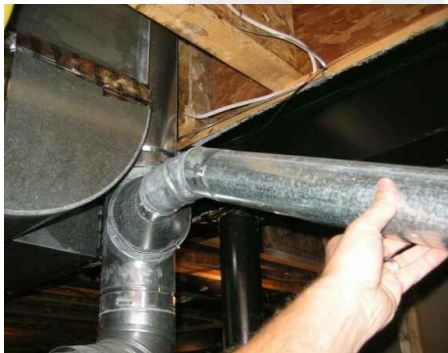
Gas-Fired Hot Water Tank

I inspected for the main source of the distributed hot water to the plumbing fixtures (sinks, tubs, showers). I recommend asking the homeowner for details about the hot water equipment and past performance.

I inspected the hot water source and equipment according to the [Home Inspection Standards of Practice](#).

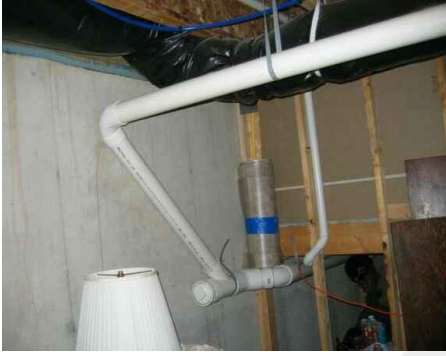
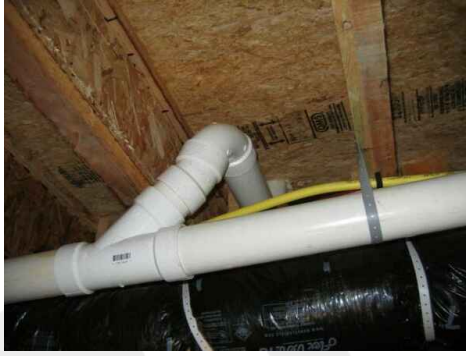
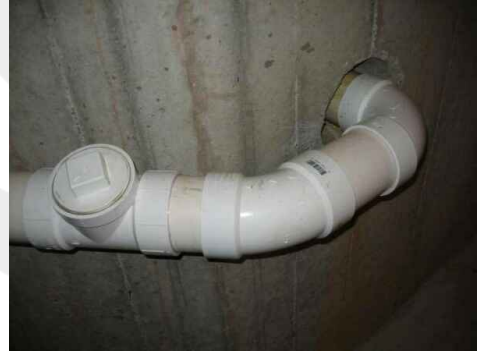
I attempted to inspect the drain, waste, and vent pipes. Not all of the pipes and components were accessible and observed. Inspection restriction. Ask the homeowner about water and sewer leaks or blockages in the past.

The inspection was restricted because not all of the pipes were exposed, readily accessible, and observed. For example, most of the drainage pipes were hidden within the walls.

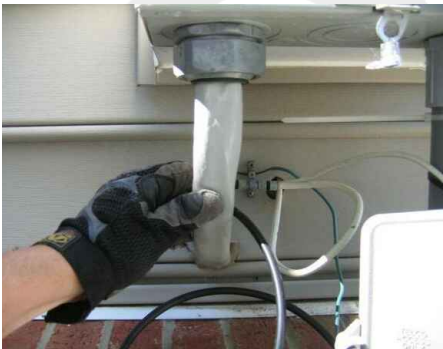
I inspected the electrical service-
entrance conductors.

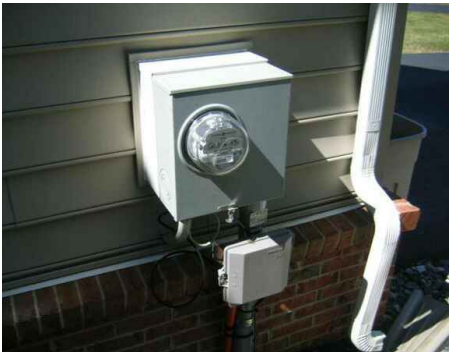
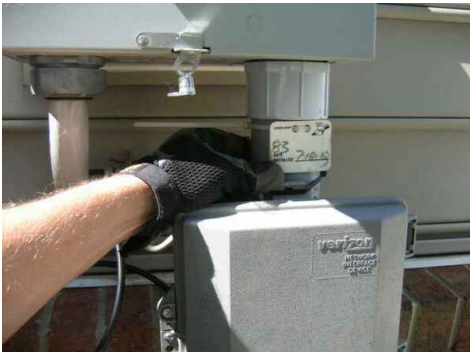
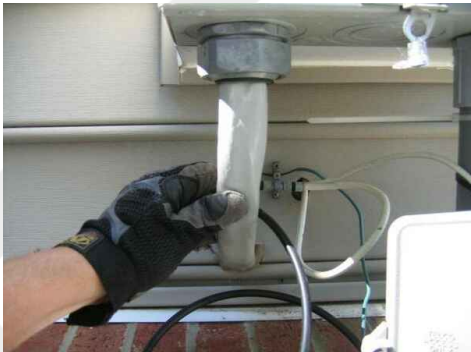
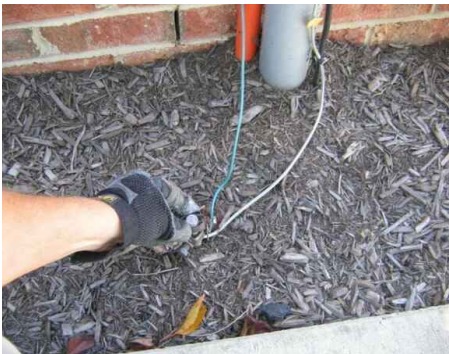
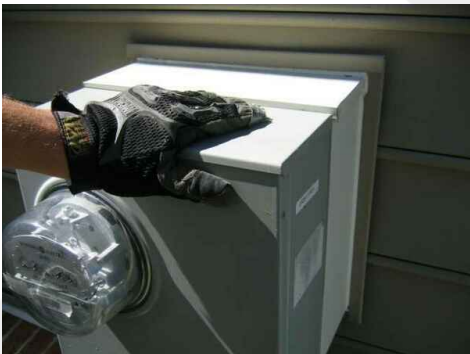
I inspected the electrical electric meter and base.

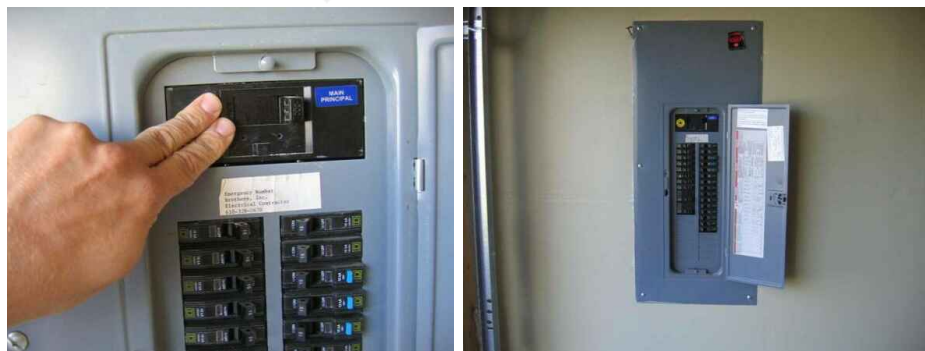
Garage

It's your job to know where the main electrical panel is located, including the main service disconnect that turns everything off.

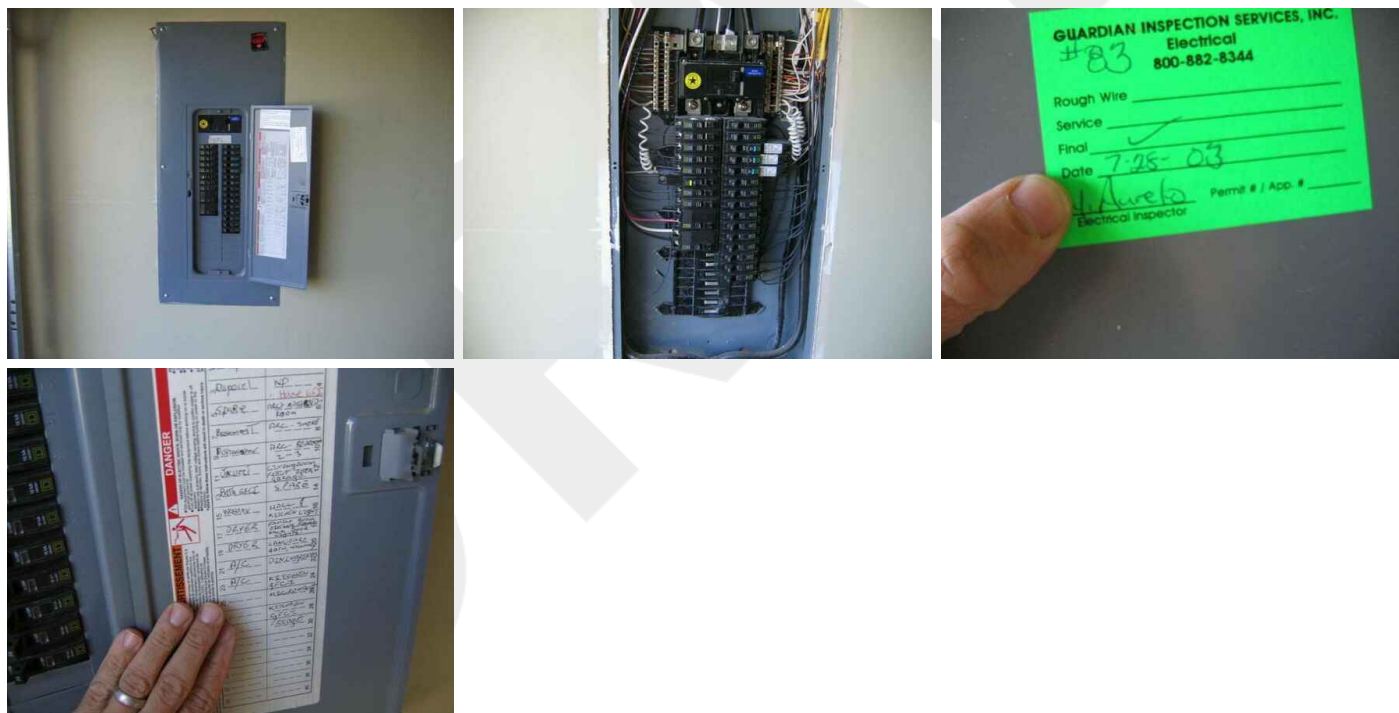
Garage

I observed indications of the main service disconnect's amperage rating. It was labeled.

I inspected the electrical panelboards and over-current protection devices (circuit breakers and fuses).

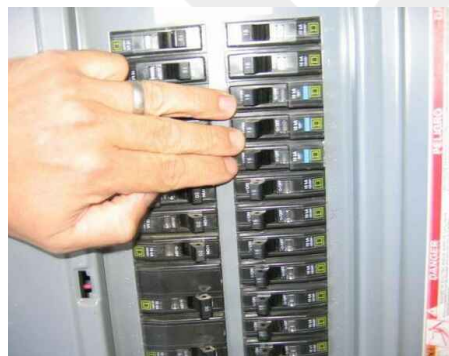
I inspected receptacles observed that were deemed to be arc-fault circuit interrupter (AFCI)-protected using the AFCI test button, where possible.
