INSPECTION REPORT BY BIG BEN INSPECTIONS

1000 Glenwood Drive
Raleigh, NC 27603

JUNE 2, 2023

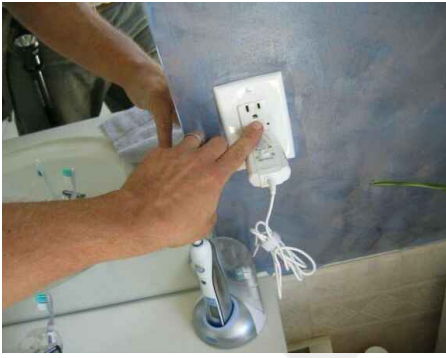
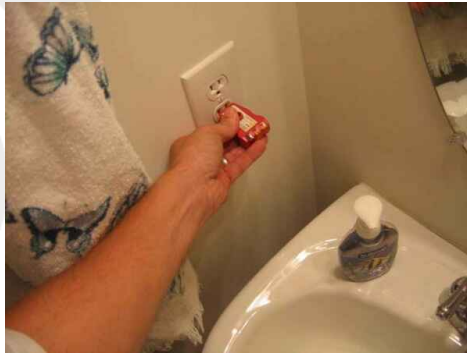
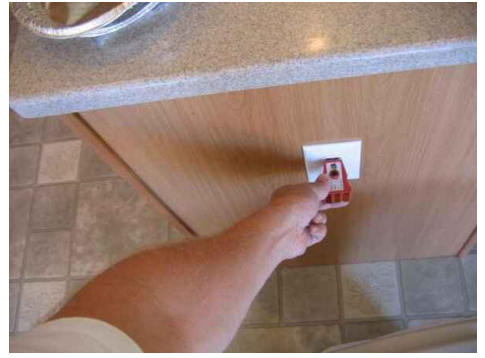
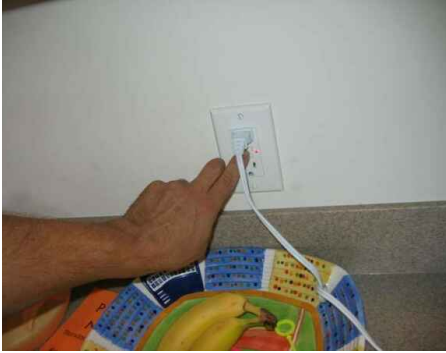
GFCIs: Inspected GFCIs

I inspected ground-fault circuit interrupter receptacles and circuit breakers observed and deemed to be GFCIs using a GFCI tester, where possible.

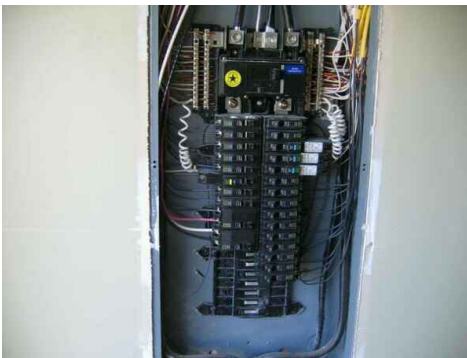
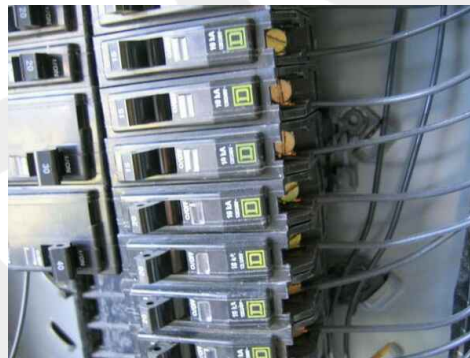
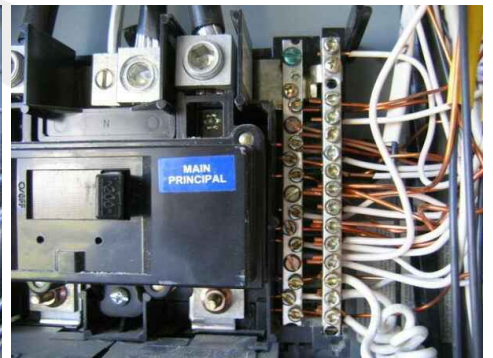
UNABLE TO INSPECT ALL OF THE WIRING

I was unable to inspect all of the electrical wiring. Obviously, most of the wiring is hidden from view within walls. Beyond the scope of a visual home inspection.

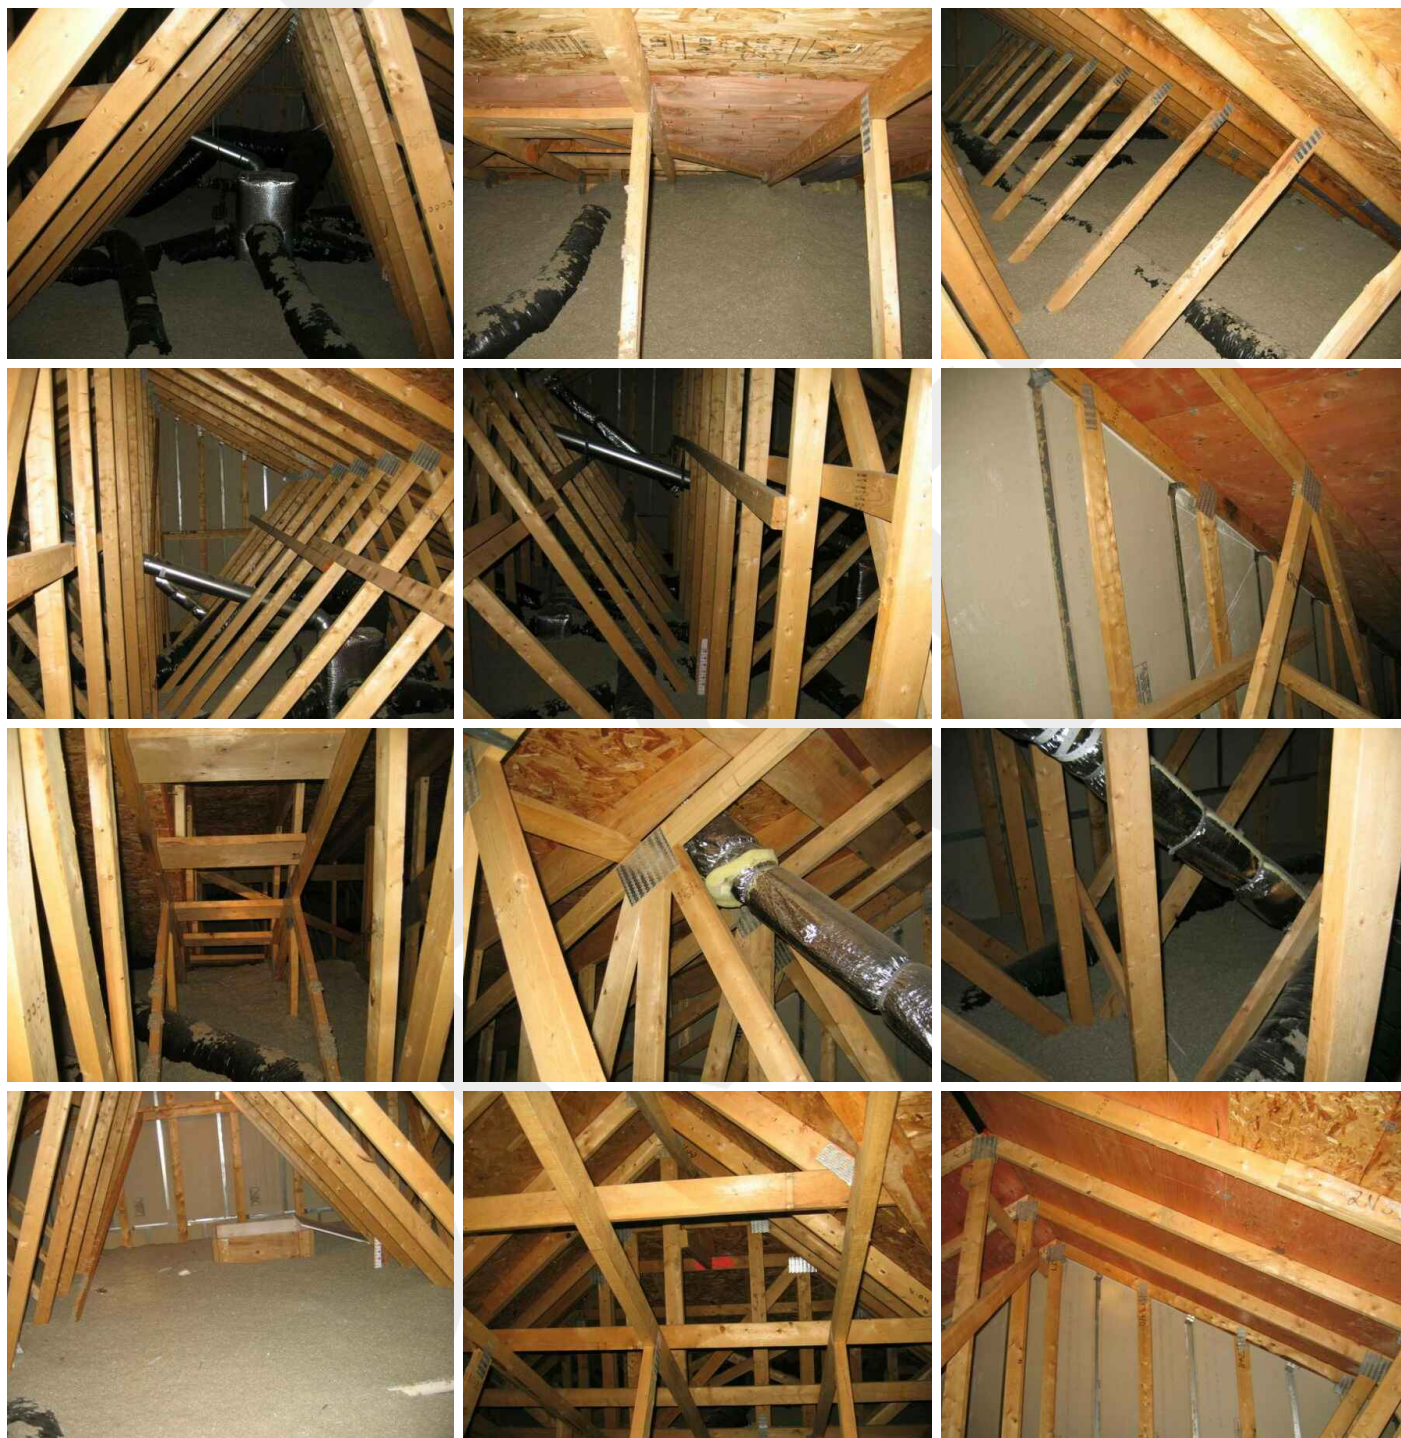
Structural Components & Observations in Attic: Structural Components Were Inspected

Structural components were inspected from the attic space according to the [Home Inspection Standards of Practice](#).

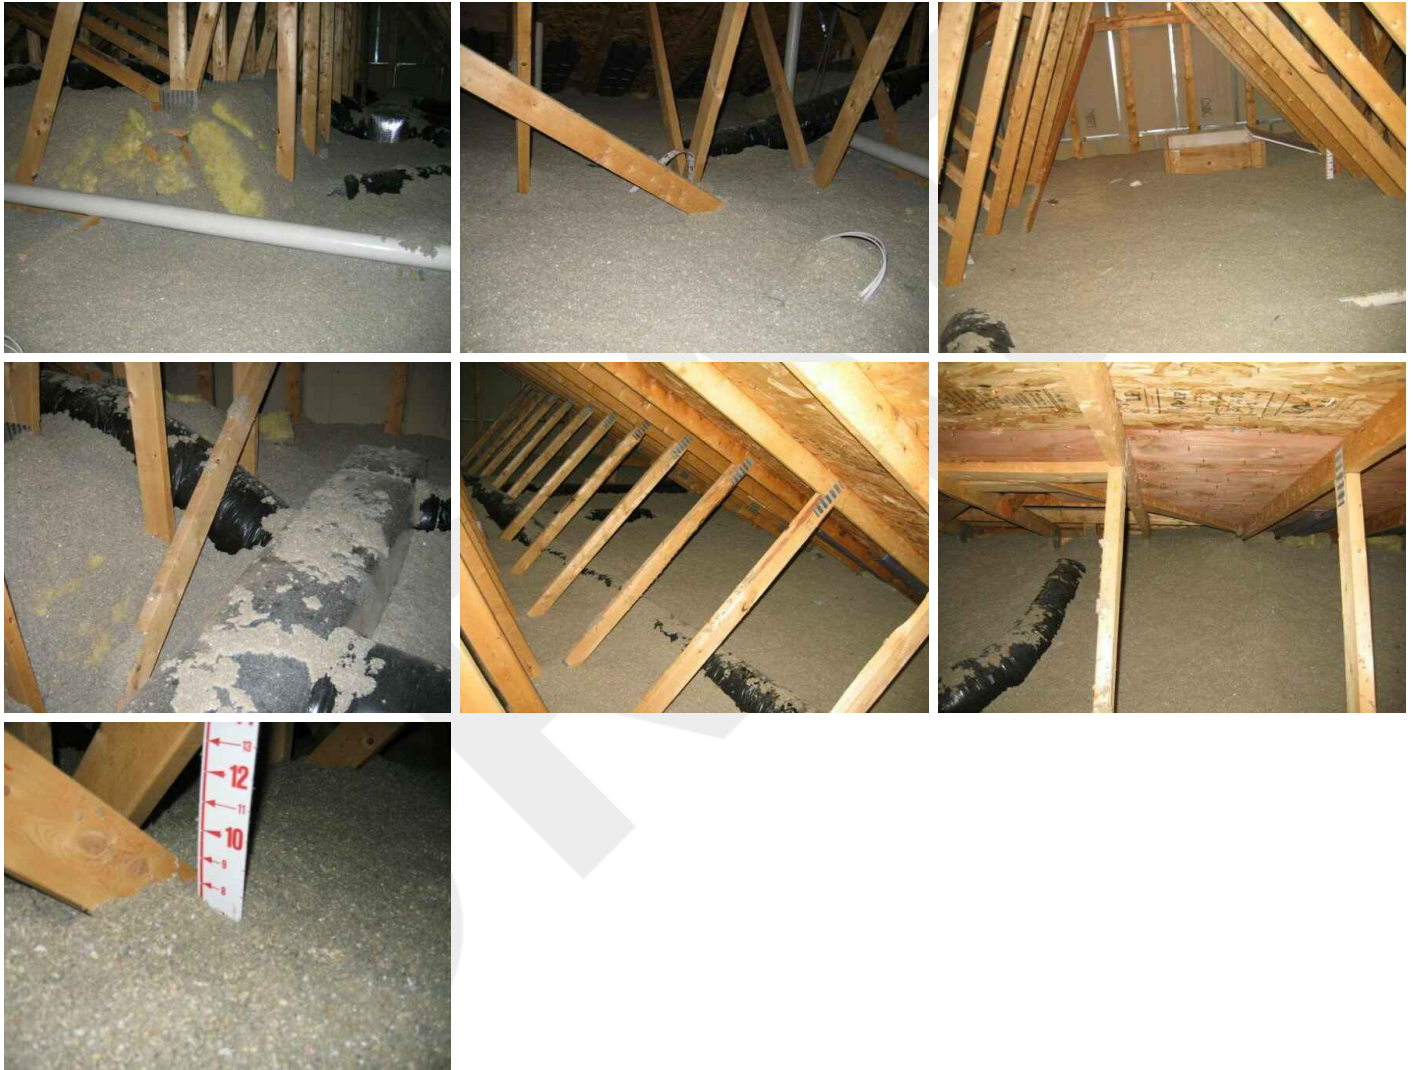
Insulation in Attic: Insulation Was Inspected

During the home inspection, I inspected for insulation in unfinished spaces, including attics, crawlspaces and foundation areas. I inspected for ventilation of unfinished spaces, including attics, crawlspaces and foundation areas. And I inspected mechanical exhaust systems in the kitchen, bathrooms and laundry area.

I attempted to describe the type of insulation observed and the approximate average depth of insulation observed at the unfinished attic floor area or roof structure.

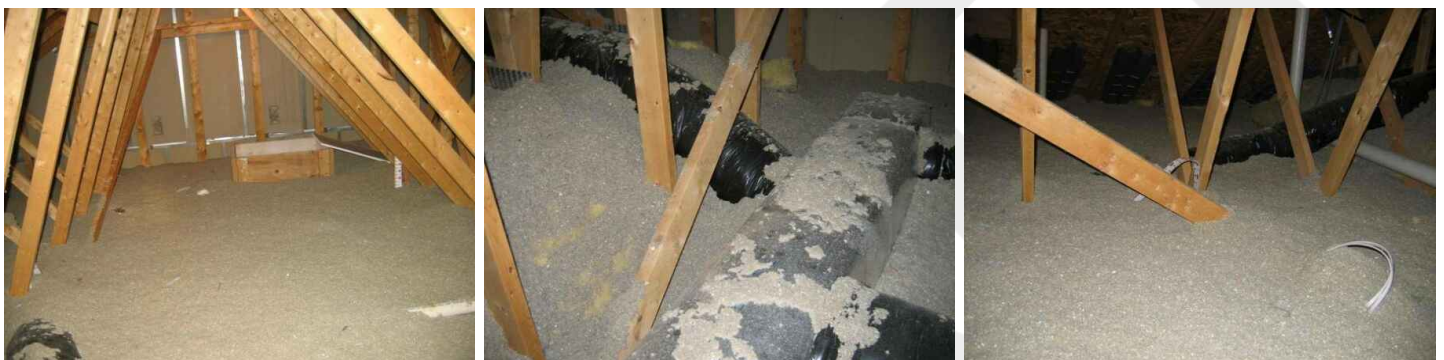
COULD NOT SEE EVERYTHING IN ATTIC

I could not see and inspect everything in the attic space. The access is restricted and my inspection is limited.

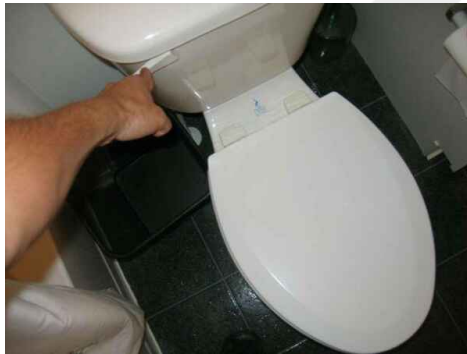
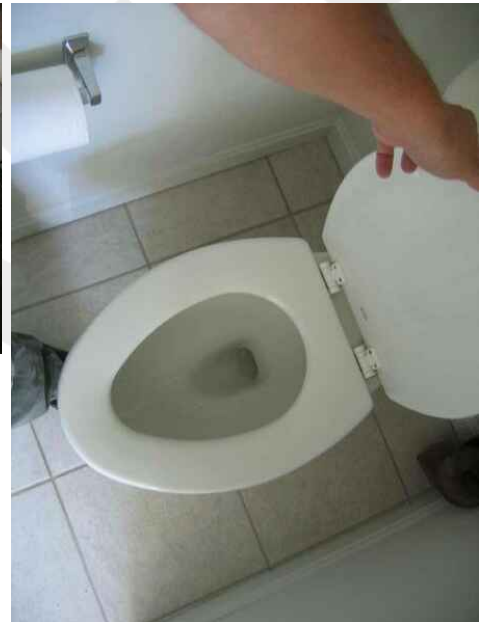
Bathroom Toilets: Toilets Inspected

I flushed all of the toilets.

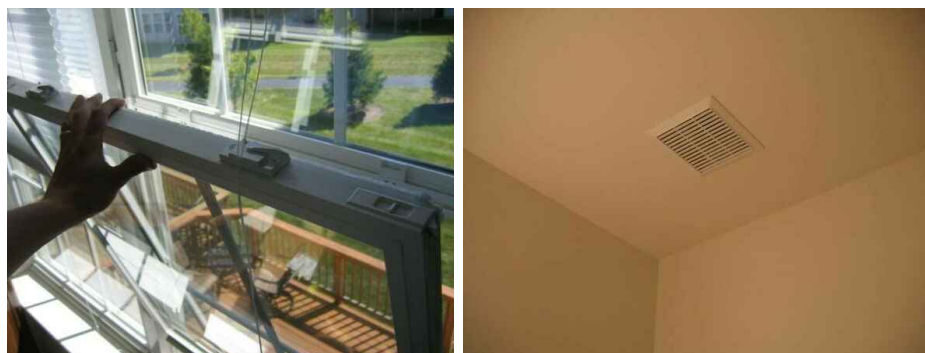
Bathroom Exhaust Fan / Window: Inspected Bath Exhaust Fans

I inspected the exhaust fans of the bathroom(s). All mechanical exhaust fans should terminate outside. Confirming that the fan exhausts outside is beyond the scope of a home inspection.

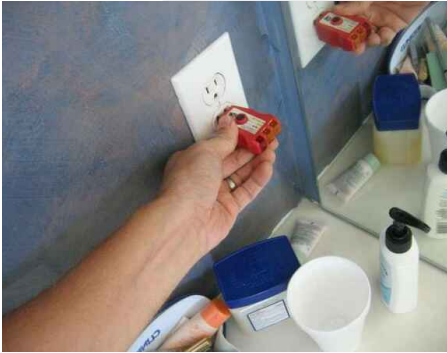
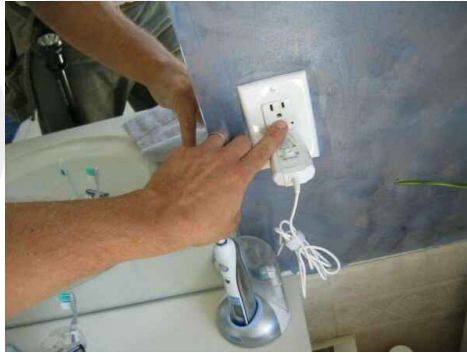
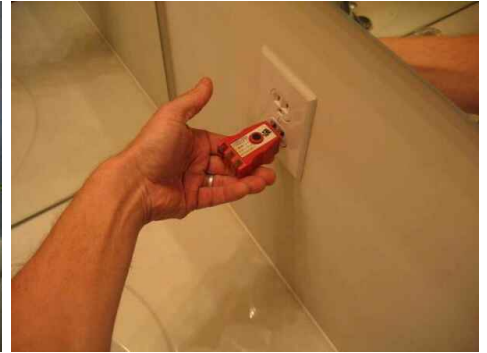
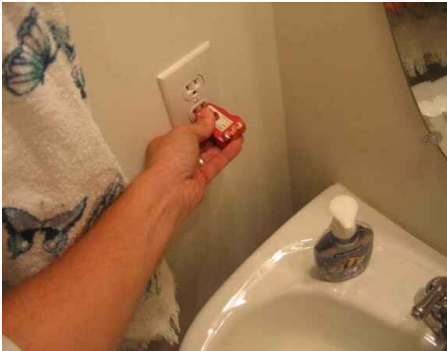
GFCI & Electric in Bathroom: GFCI-Protection Tested

I inspected the GFCI-protection at the receptacle near the bathroom sink by pushing the test button at the GFCI device or using a GFCI testing instrument.

All receptacles in the bathroom must be GFCI protected.

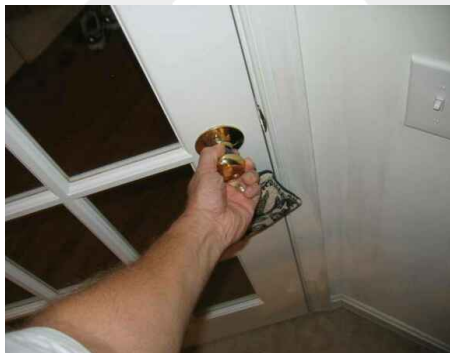
Doors: Doors Inspected

I inspected a representative number of doors according to the [Home Inspection Standards of Practice](#) by opening and closing them. I did not operate door locks and door stops, which is beyond the scope of a home inspection.

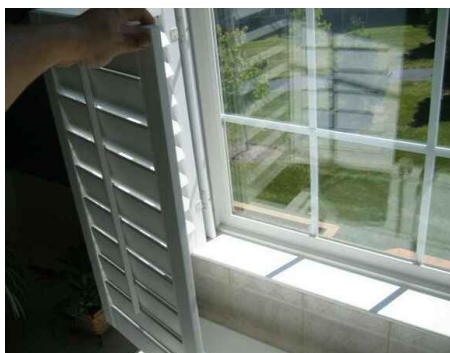
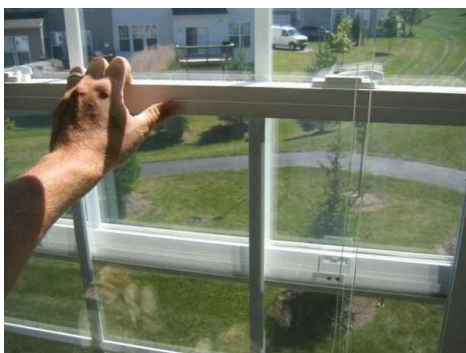
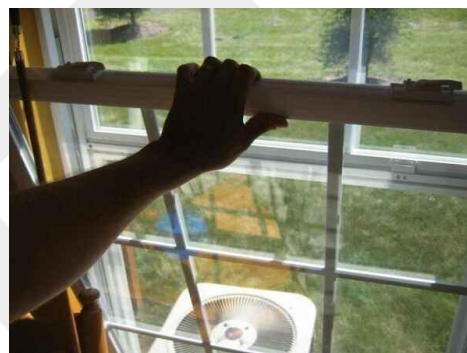
Windows: Windows Inspected

I inspected a representative number of windows according to the [Home Inspection Standards of Practice](#) by opening and closing them. I did not operate window locks and operation features, which is beyond the scope of a home inspection.

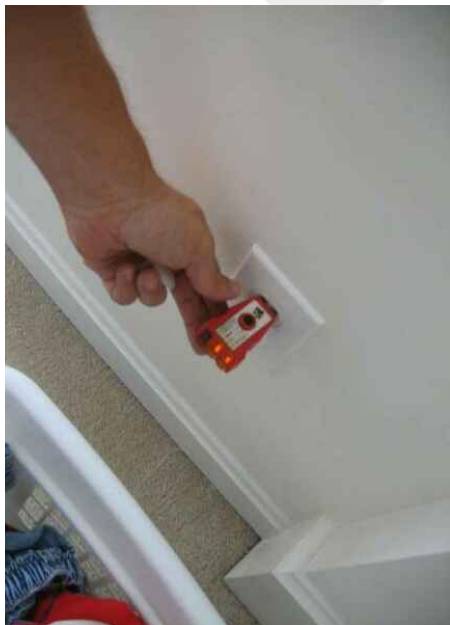
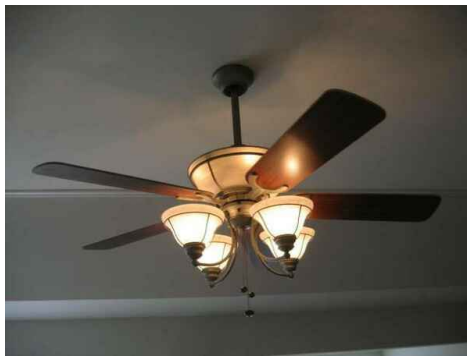
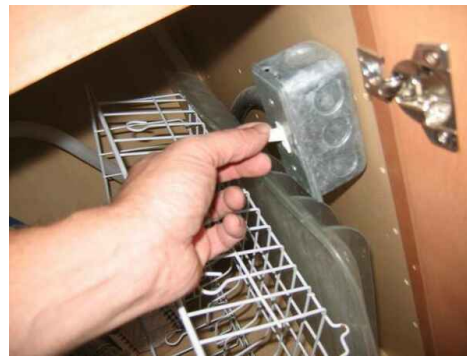
Switches, Fixtures & Receptacles: Inspected a Switches, Fixtures & Receptacles

I inspected a representative number of switches, lighting fixtures and receptacles.

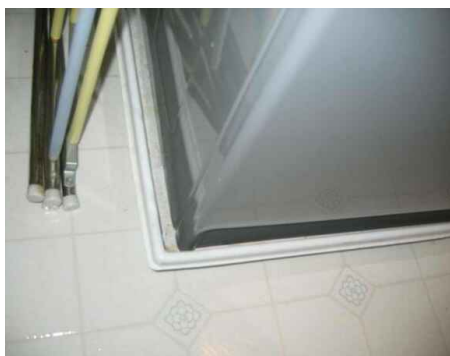
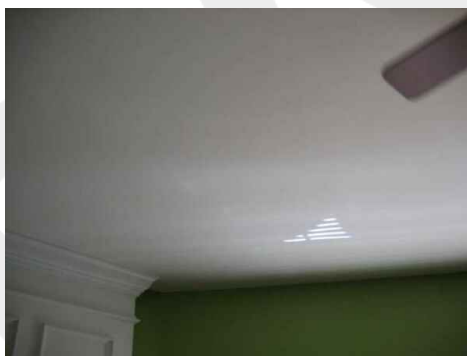
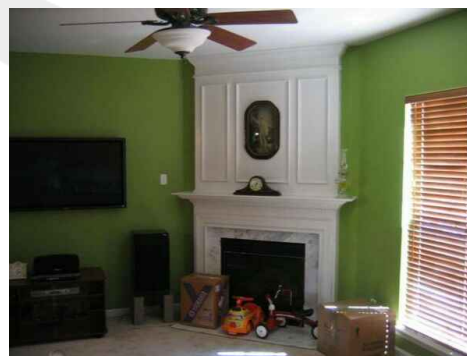
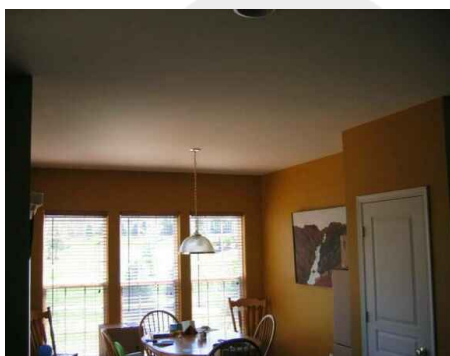
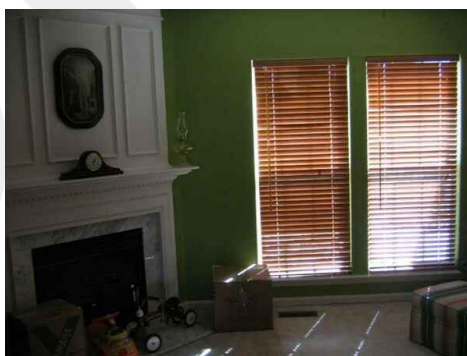
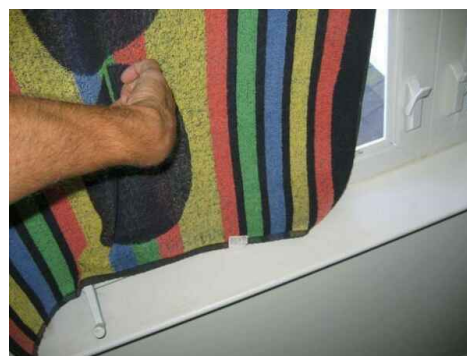
Floors, Walls, Ceilings: Floors, Walls, Ceilings Inspected

I inspected the readily visible surfaces of floors, walls and ceilings. I looked for material defects according to the [Home Inspection Standards of Practice](#).

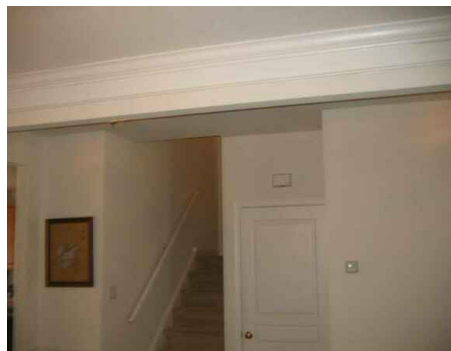
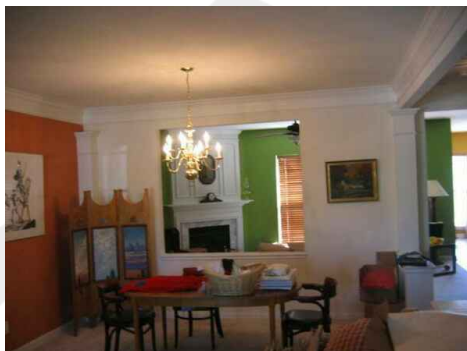
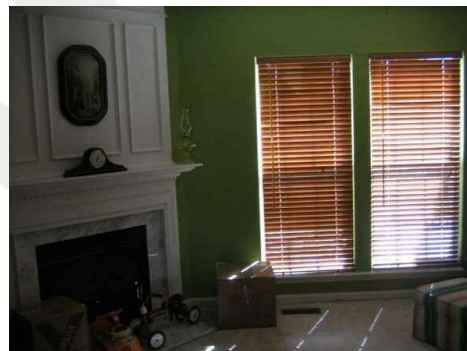
Stairs, Steps, Stoops, Stairways & Ramps: Stairs, Steps, Stoops, Stairways & Ramps Were Inspected

I inspected the stairs, steps, stoops, stairways and ramps that were within the scope of my home inspection.

All treads should be level and secure. Riser heights and tread depths should be as uniform as possible. As a guide, stairs must have a maximum riser of 7-3/4 inches and a minimum tread of 10 inches.

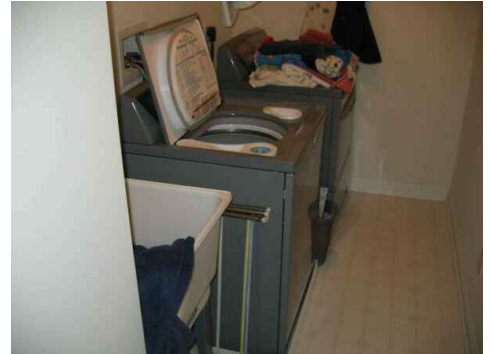
LAUNDRY

I did not inspect the clothes washer and dryer fully. These appliances are beyond the scope of a home inspection. I did not operate the appliances. The clothes dryer exhaust pipe must be inspected and cleaned every year to help prevent house fires.

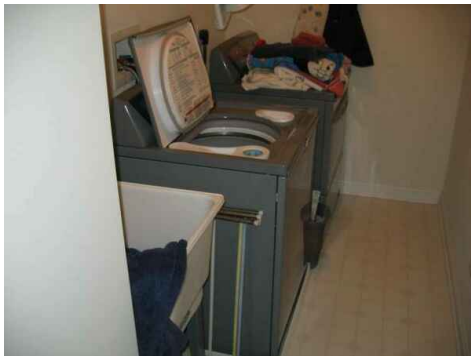
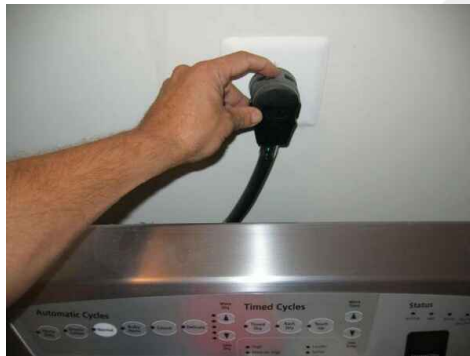
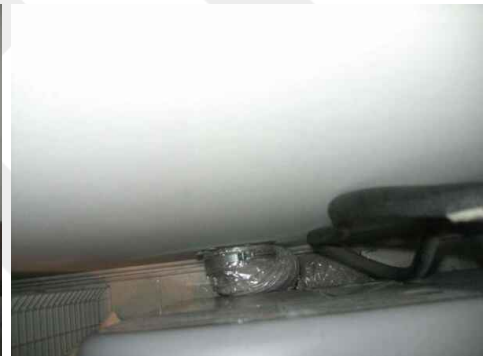
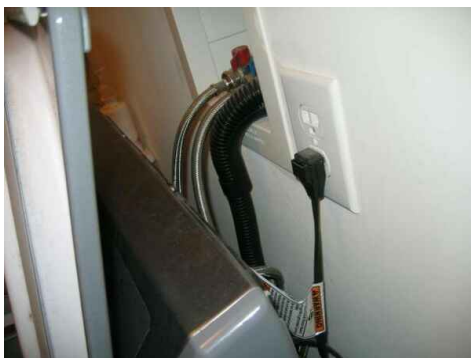
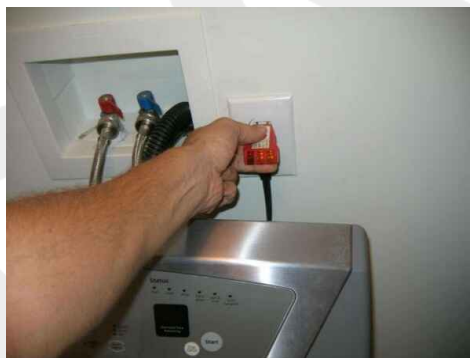
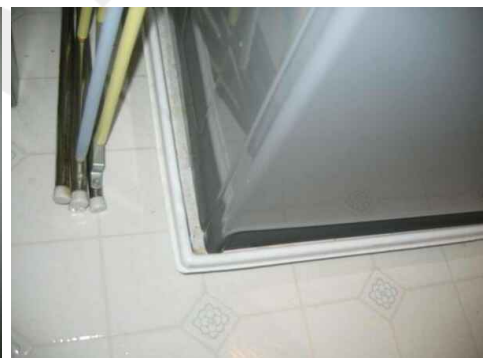
13.3.1 Laundry Room, Electric, and Tub

MISSING CATCH PAN UNDER WASHER

I observed that the clothes washer did not have a water leak catch pan. It is recommended.

Recommended DIY Project
