INSPECTION REPORT BY BIG BEN INSPECTIONS

123 Chamberlain St
Raleigh, NC 27607

Mary Jane
APRIL 13, 2023

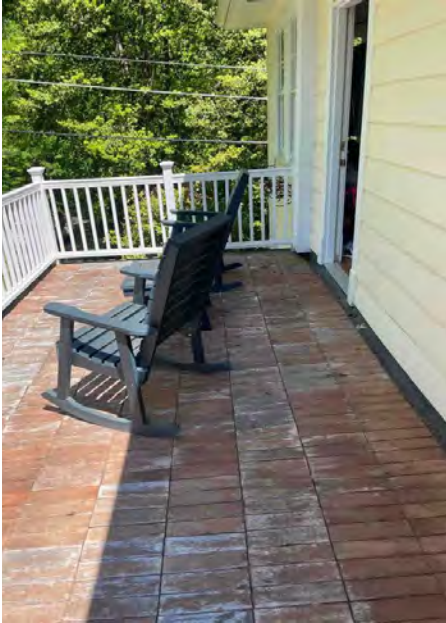
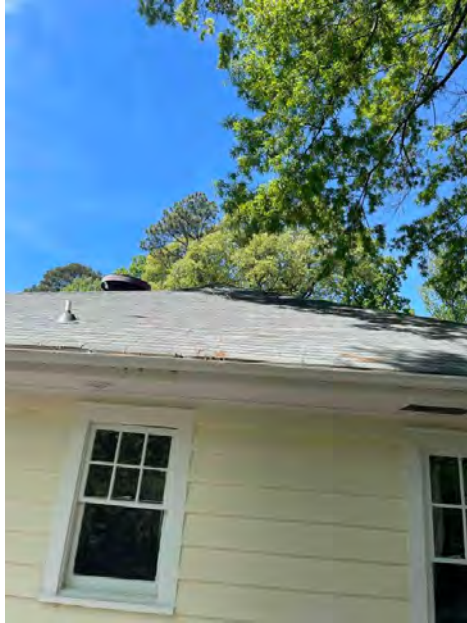
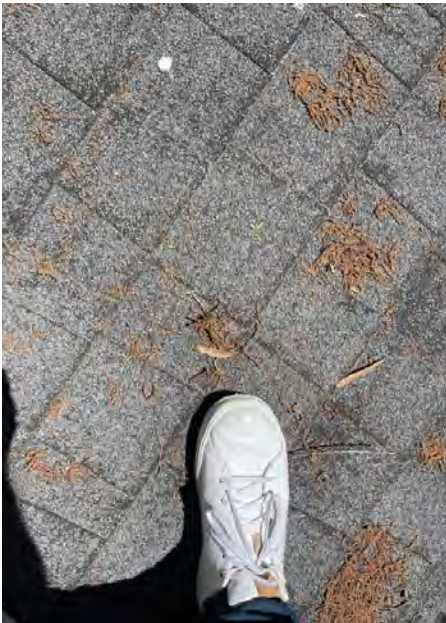
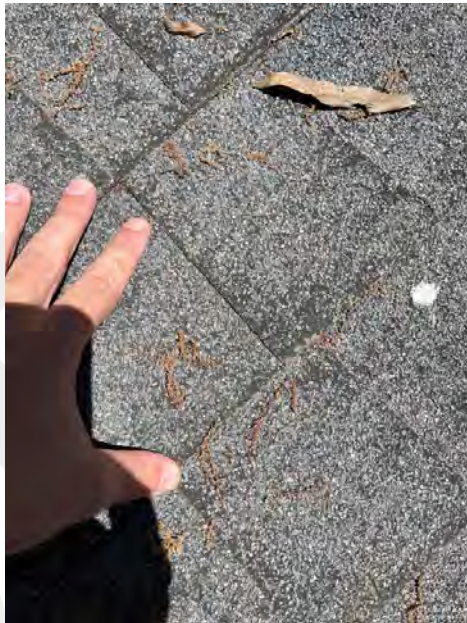
**Roof Covering: Roof Was Inspected**

I observed the roof-covering material and attempted to identify its type.

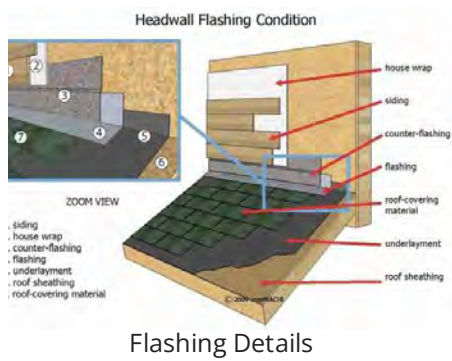
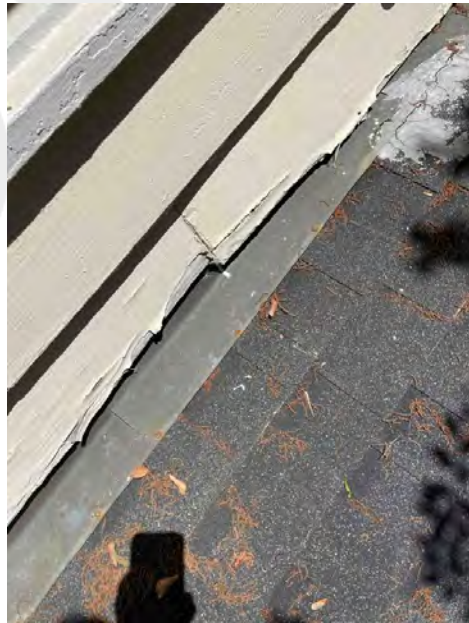
Flashing: Wall Intersections

I looked for flashing where the roof covering meets a wall or siding material. There should be step and counter flashing installed in these locations. This is not an exhaustive inspection of all flashing areas.

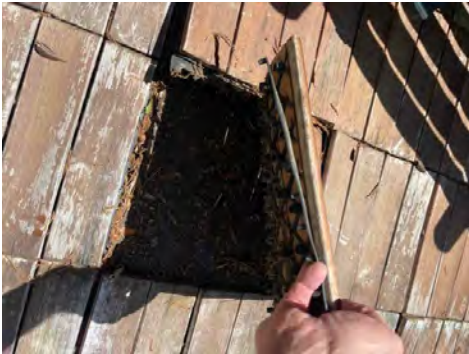
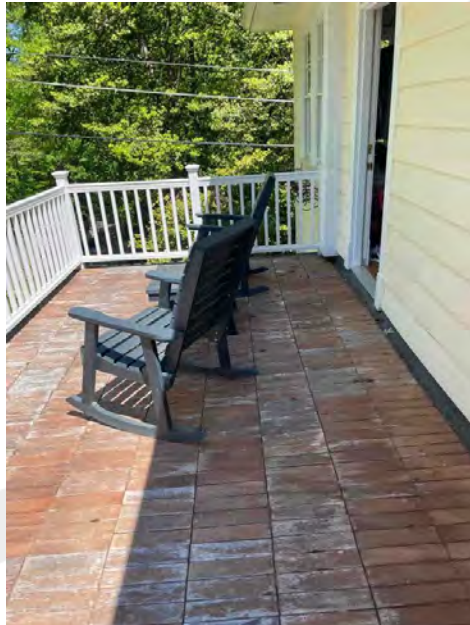
2.1.2 Roof Covering

FASTENING DEFECT AT ROOF COVERING

Contact a qualified roofing professional.

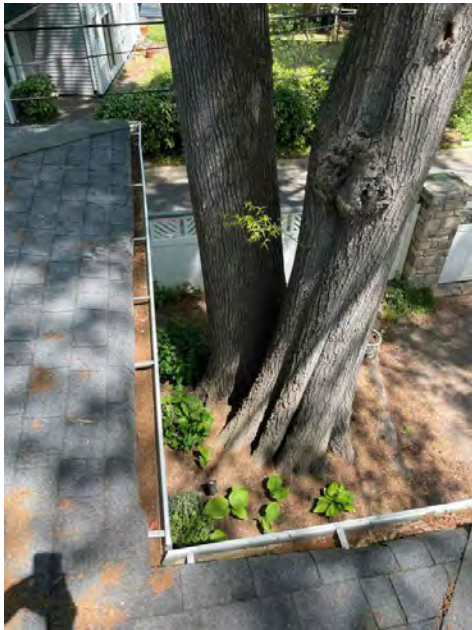
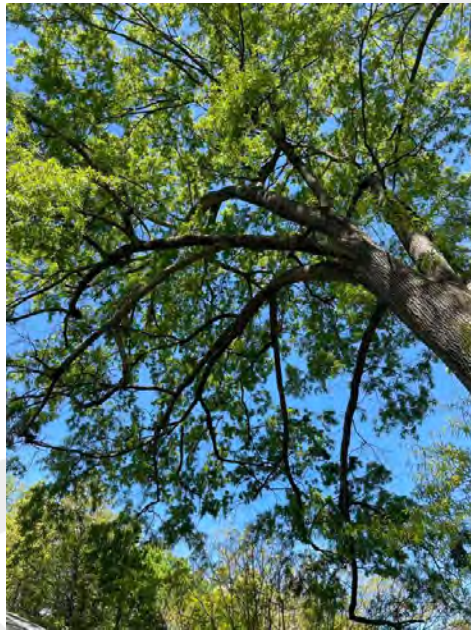
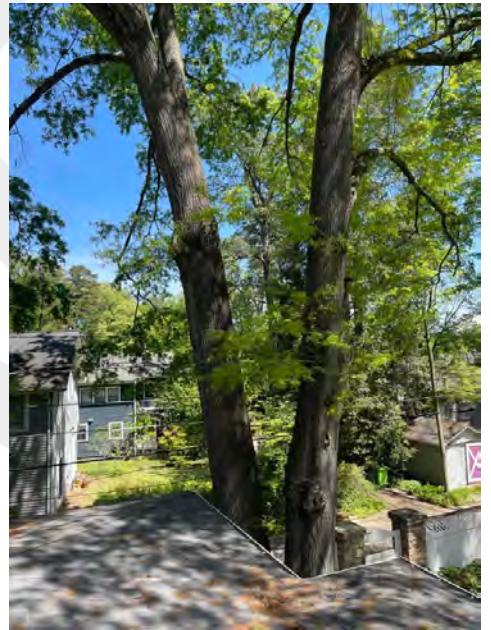
I observed indications that a tree and or tree branch where overhanging the roof and maybe in contact with it.

Contact a qualified tree service company.

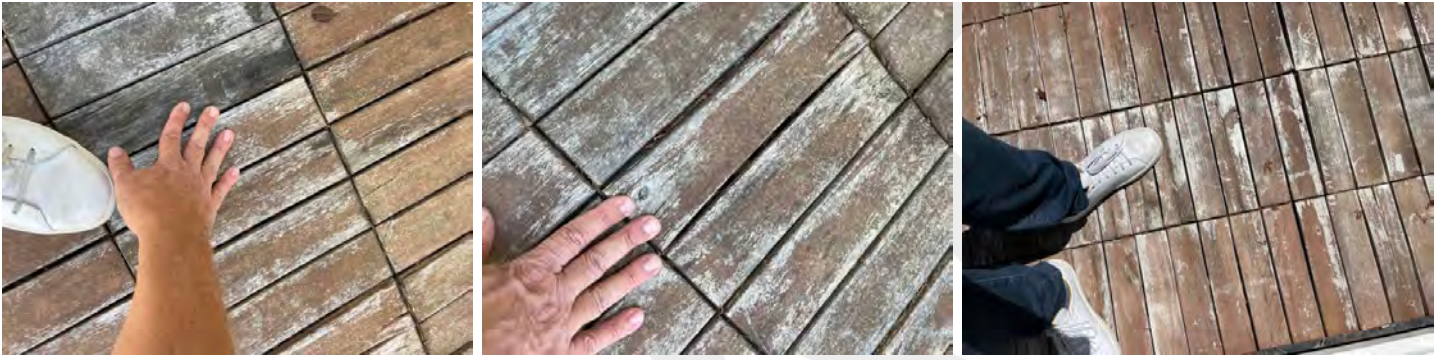
2.1.5 Roof Covering

OLD SYSTEM

I observed during my inspection that the system appeared to be old and at the end of its service life. It may not be reliable. Ask the homeowner or occupant about its recent performance. Regular maintenance and monitoring of its condition is recommended. Budgeting for repairs and future replacement is recommended. [InterNACHI's Standard Estimate Life Expectancy Chart for Homes](#)

Recommend monitoring.

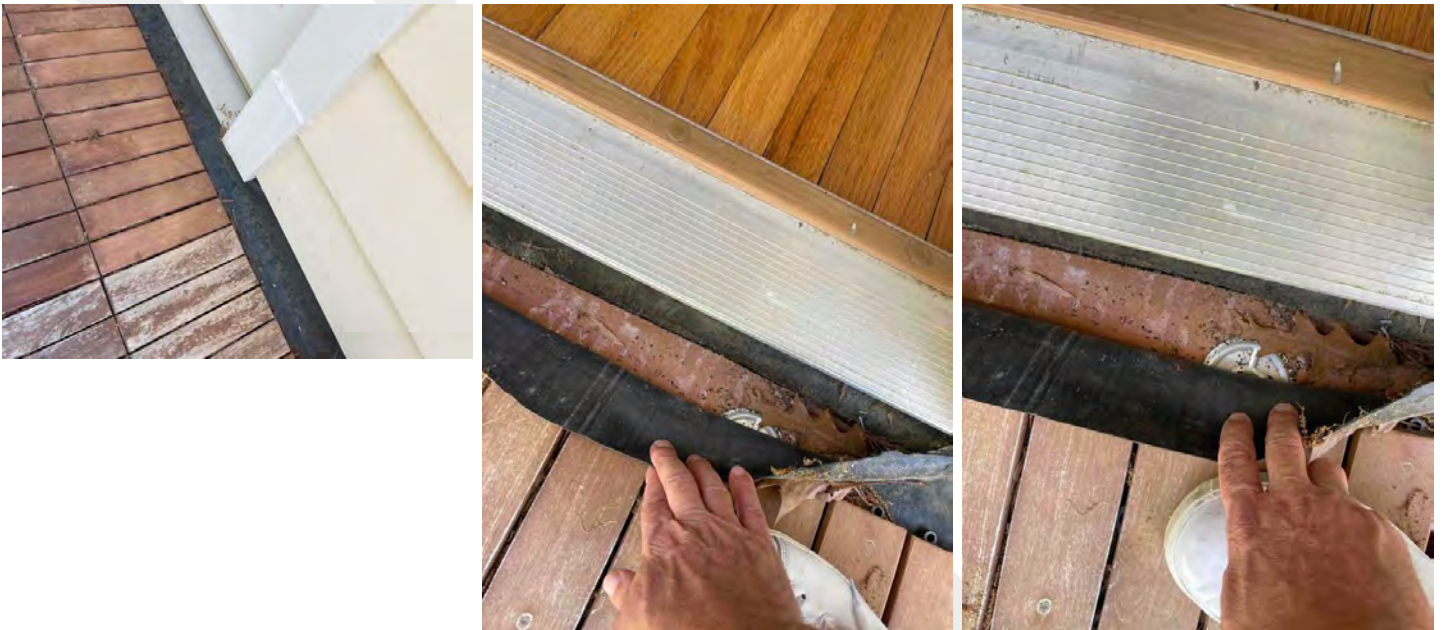
2.2.1 Flashing

MISSING FLASHING

I observed areas where flashing was missing. Not installed. Improper installation of flashing. These areas of missing flashing are prone to water penetration. Flashing is installed to provide protection against roof leaks and to divert water away from certain areas. Correction and further evaluation is recommended.

Contact a qualified roofing professional.

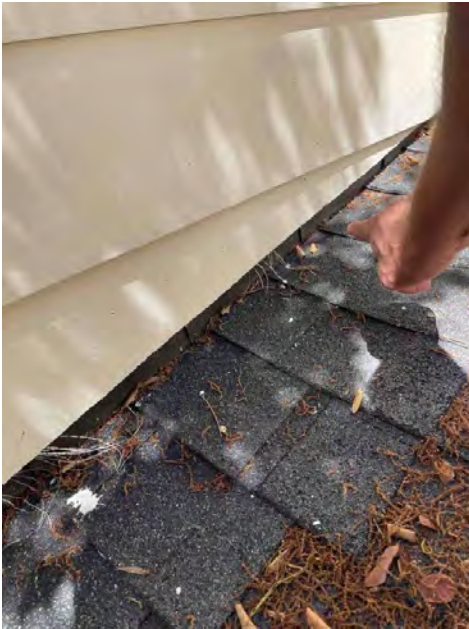
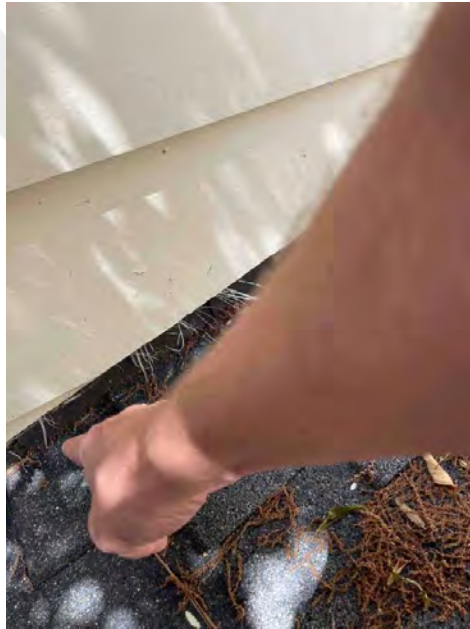
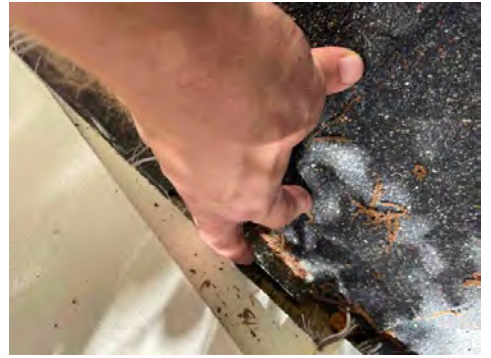
2.1.3 Roof Covering

CRACKED AND DAMAGED ROOF COVERING

Contact a qualified roofing professional.

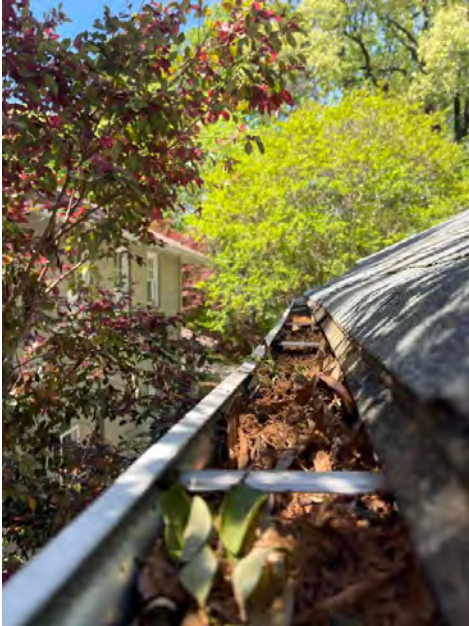
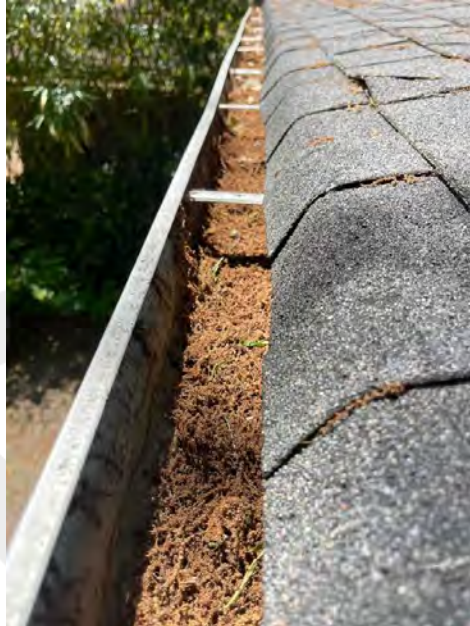
2.4.1 Gutters & Downspouts

DEBRIS IN GUTTERS

Minor Defect

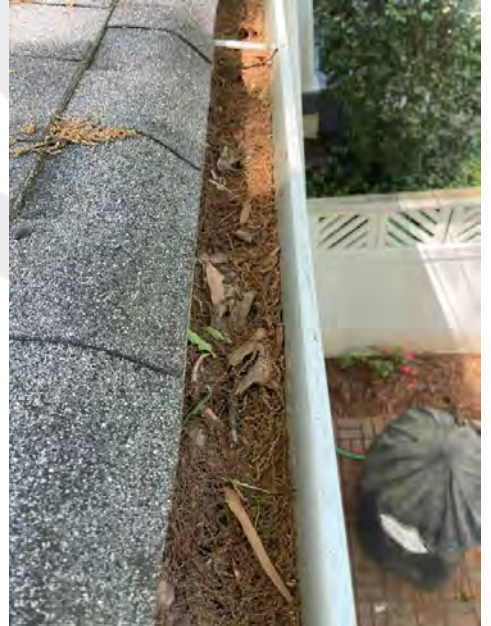
I observed debris in the gutter. Cleaning and maintenance is recommended.

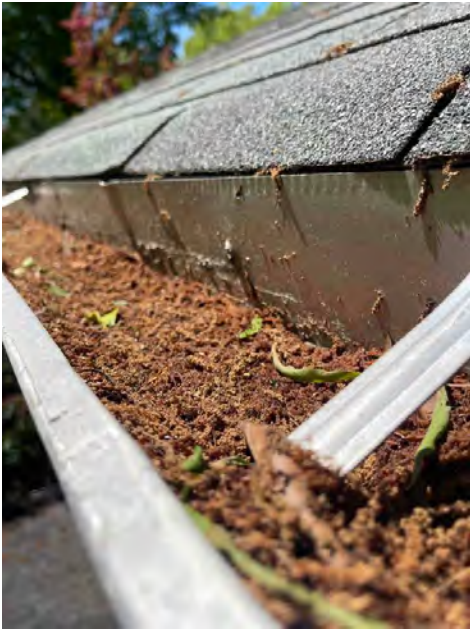
2.4.2 Gutters & Downspouts

GUTTER DAMAGED

Contact a qualified gutter contractor

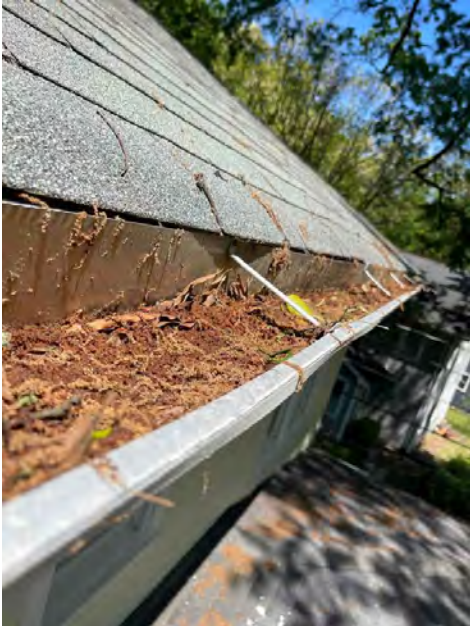
2.4.3 Gutters & Downspouts

GUTTER LOOSE

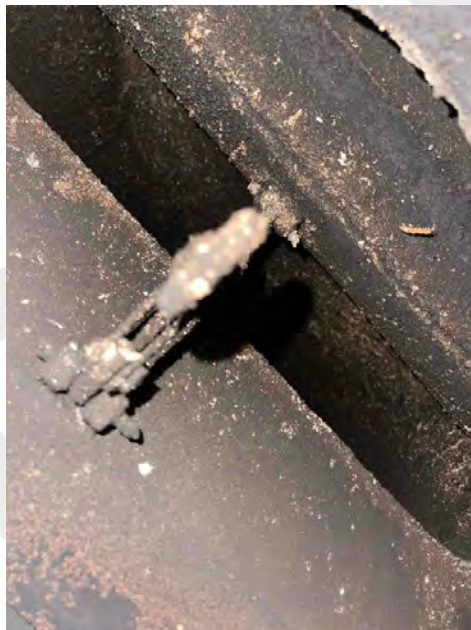
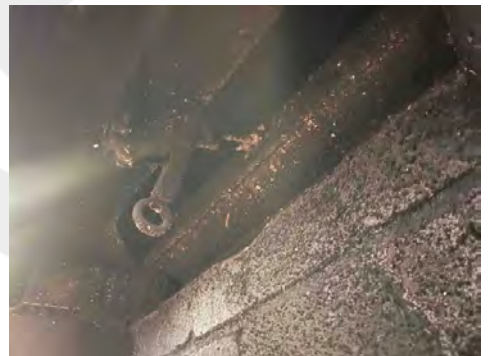
3.4.2 Fireplace

DEFECT AT DAMPER DOOR

Major Defect

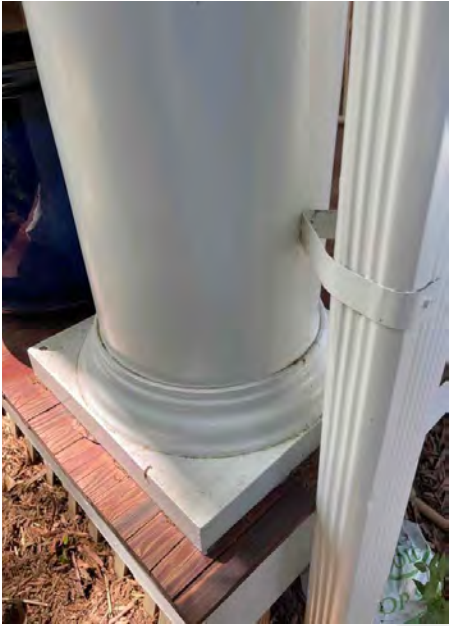
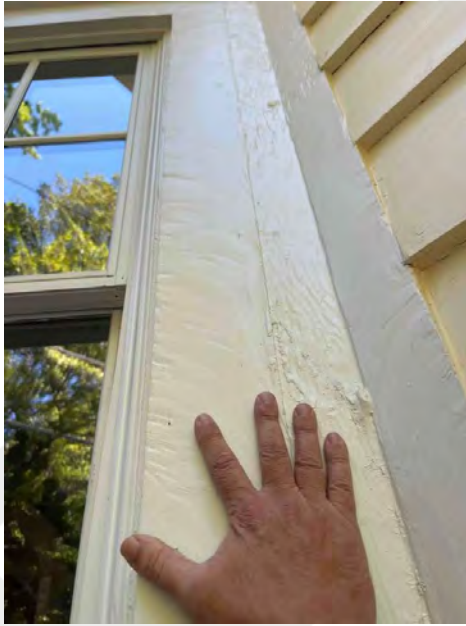
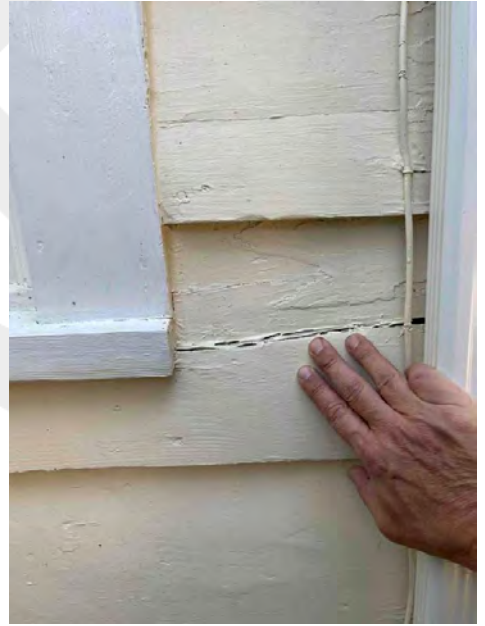
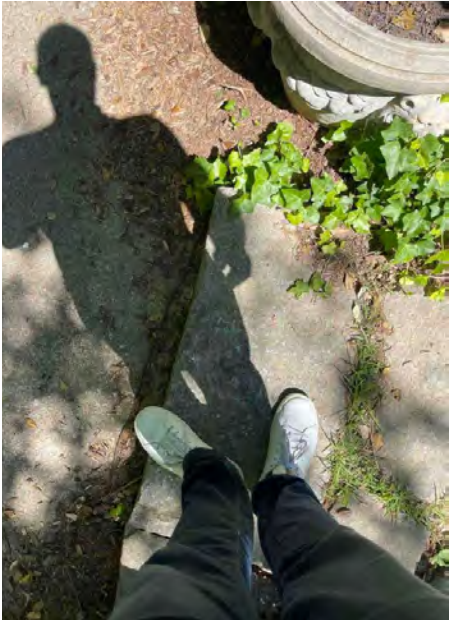
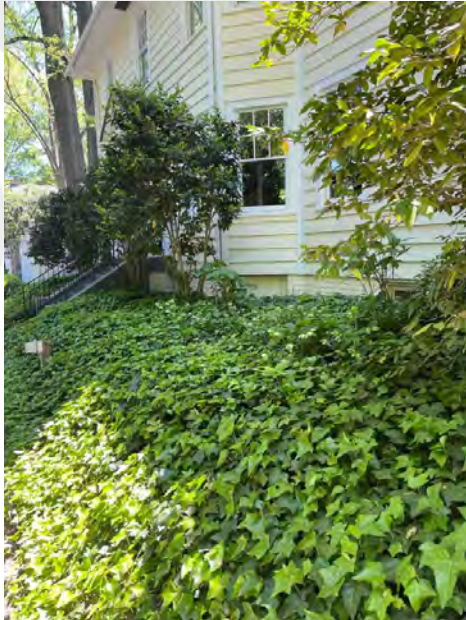
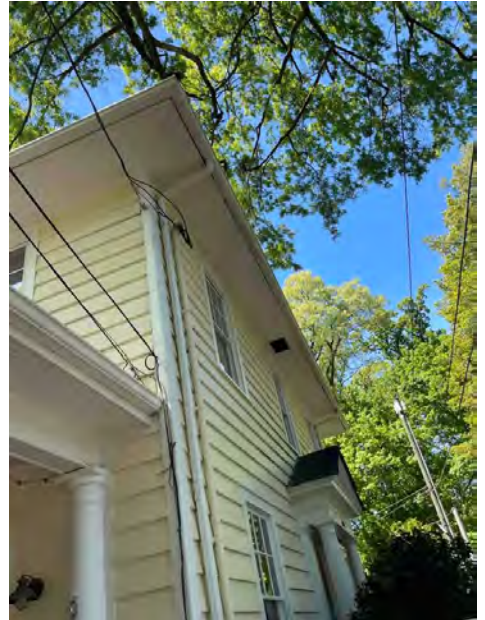
General: Exterior Was Inspected

I inspected the exterior of the house.

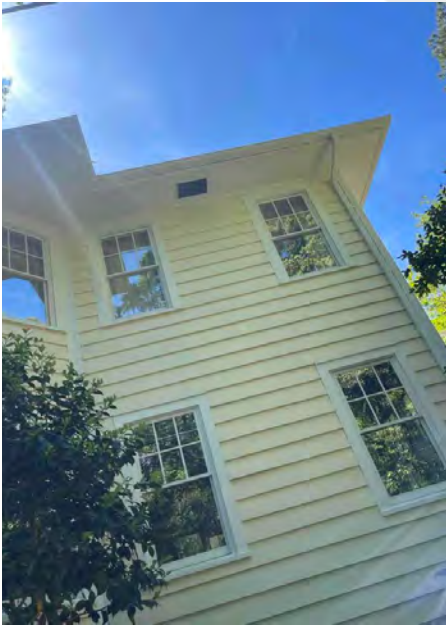
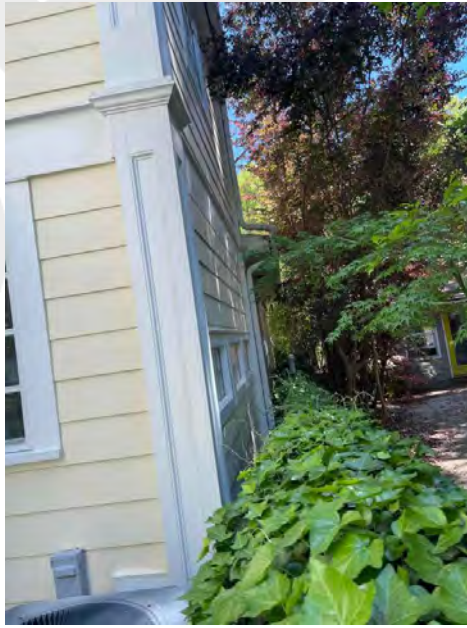
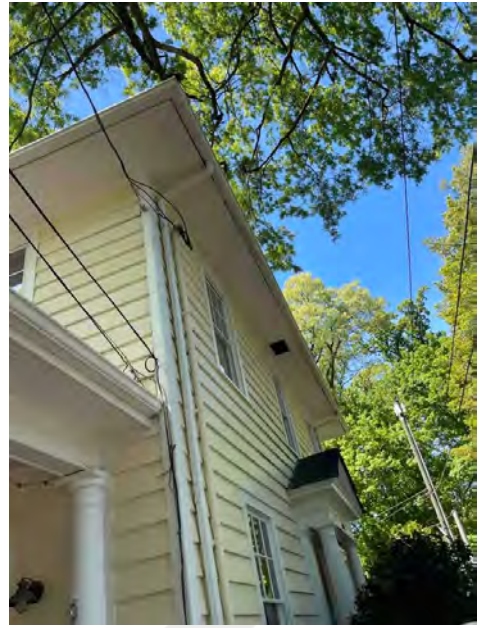
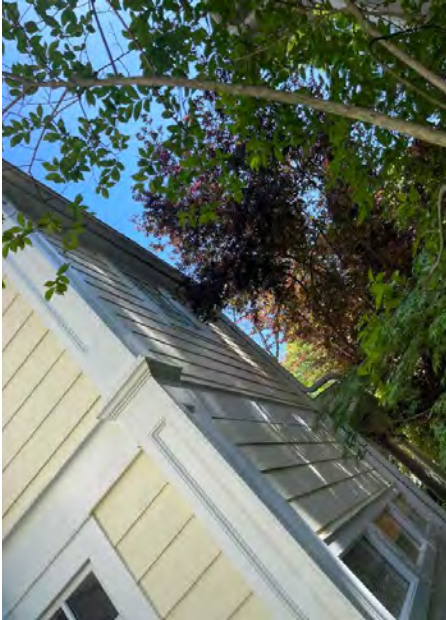
Eaves, Soffits & Fascia: Eaves, Soffits and Fascia Were Inspected

I inspected the eaves, soffits and fascia. I was not able to inspect every detail, since a home inspection is limited in its scope.

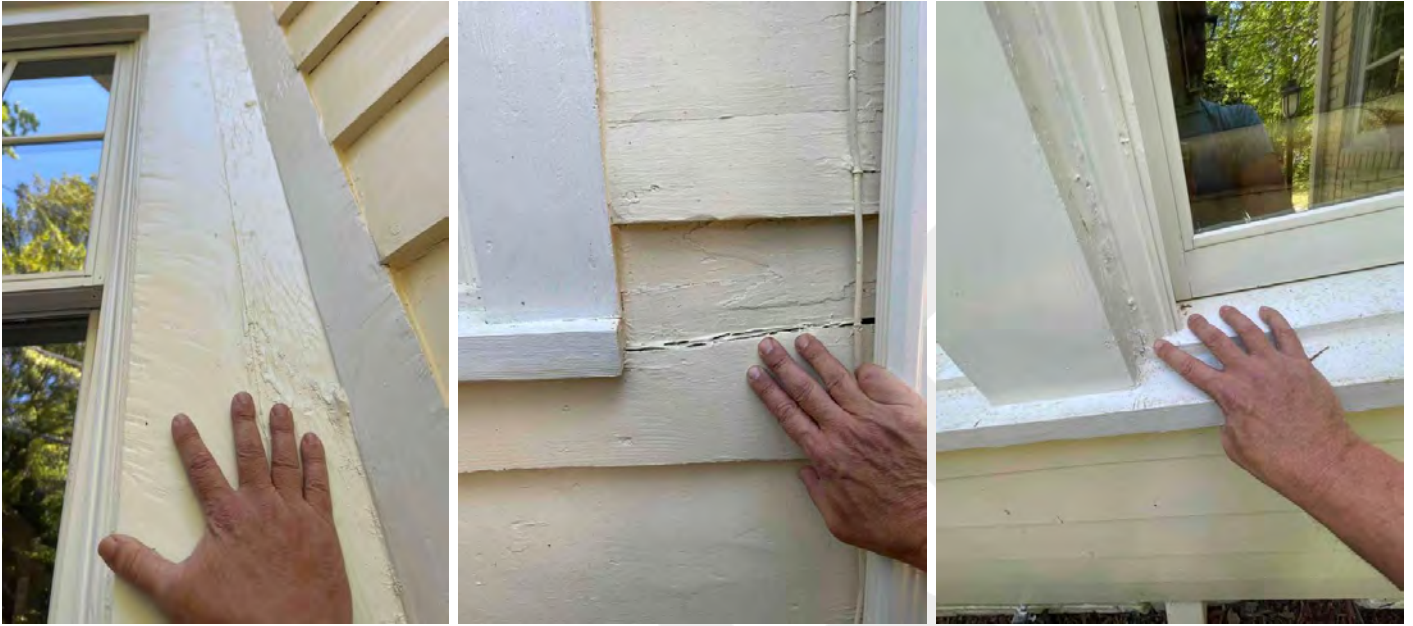
Wall-Covering, Flashing & Trim: Worn Out Areas of Exterior Wall-Covering

I observed indications of worn out areas, delayed maintenance, or aging.

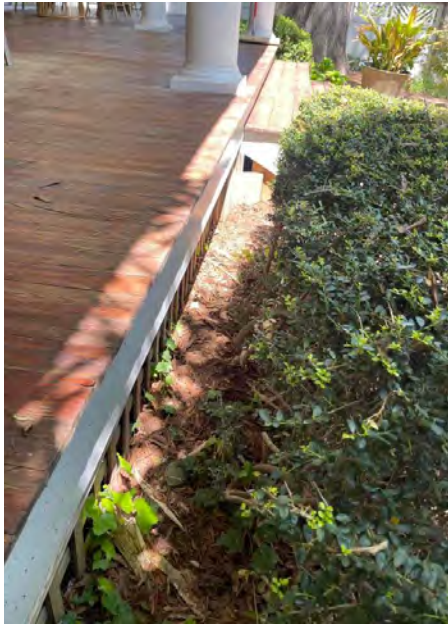
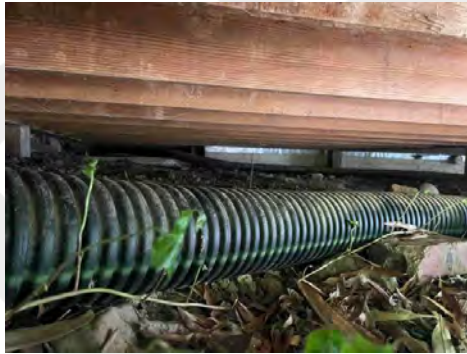
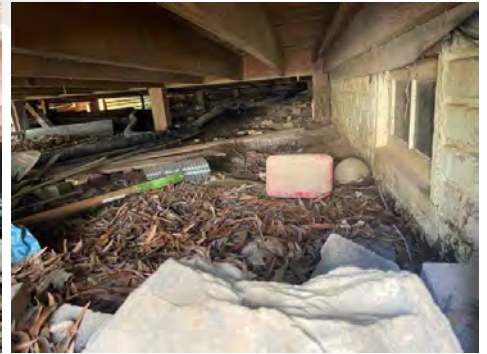
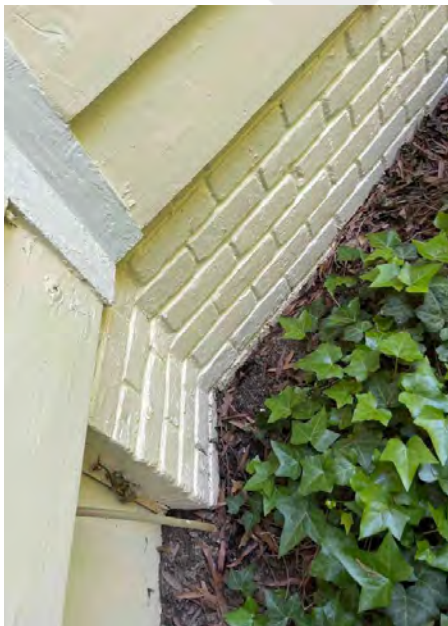
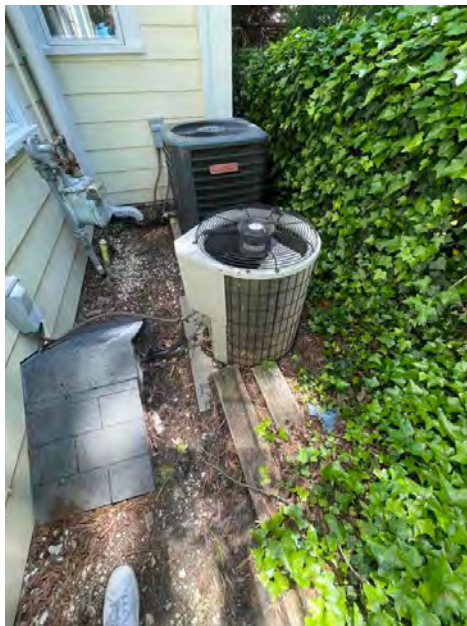
Vegetation, Surface Drainage, Retaining Walls & Grading: Vegetation, Drainage, Walls & Grading Were Inspected

I inspected the vegetation, surface drainage, retaining walls and grading of the property, where they may adversely affect the structure due to moisture intrusion.

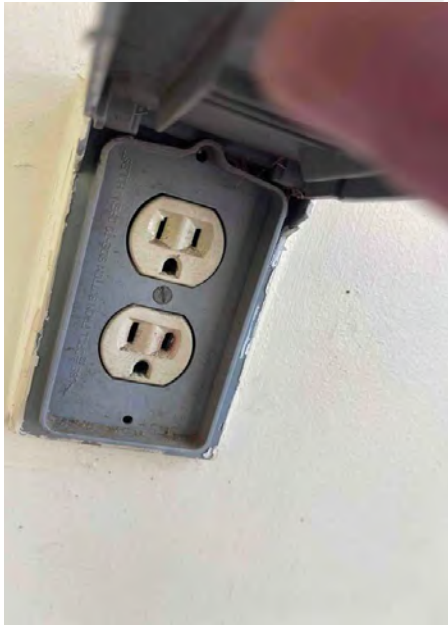
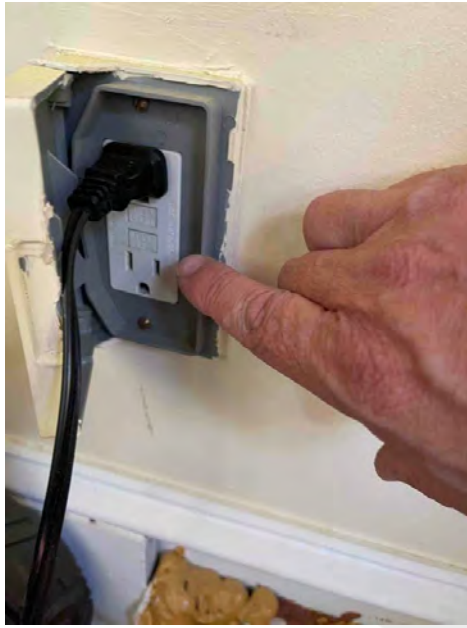
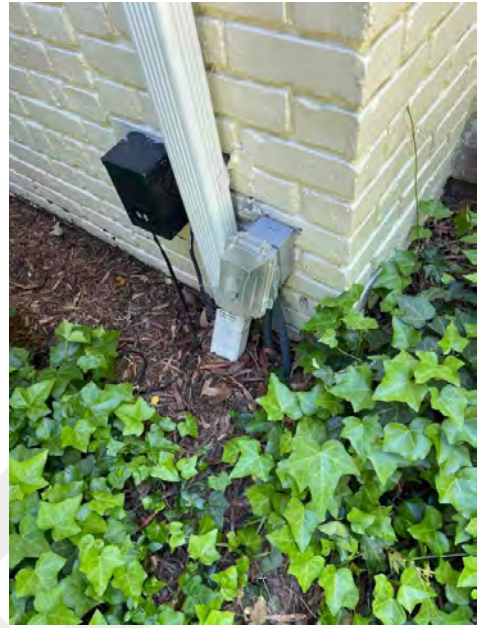
GFCIs & Electrical: Inspected GFCIs

I inspected ground-fault circuit interrupter receptacles and circuit breakers observed and deemed to be GFCIs using a GFCI tester, where possible.

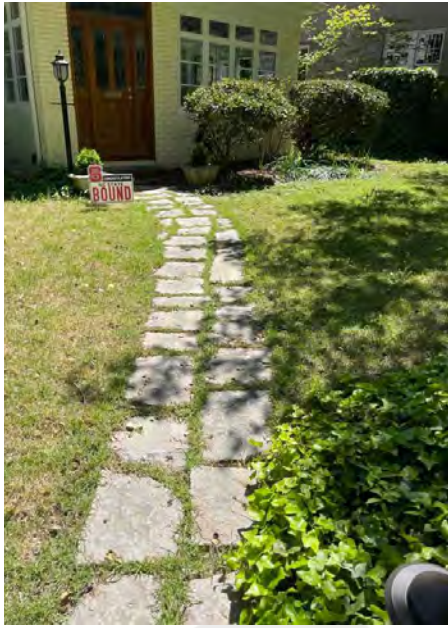
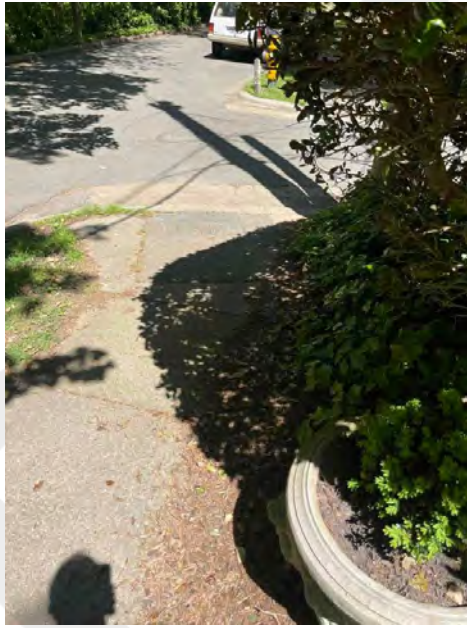
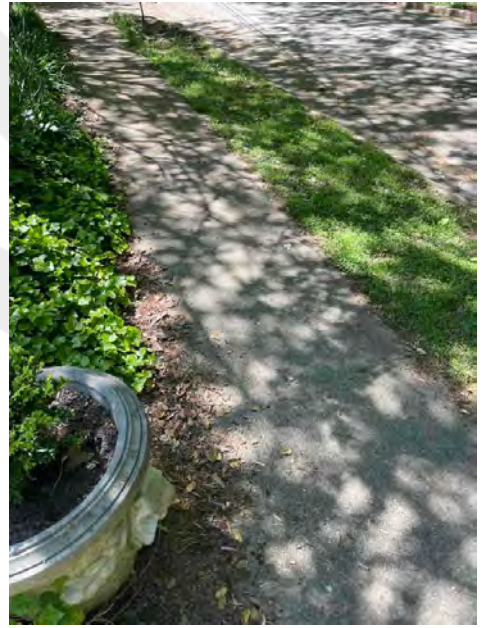
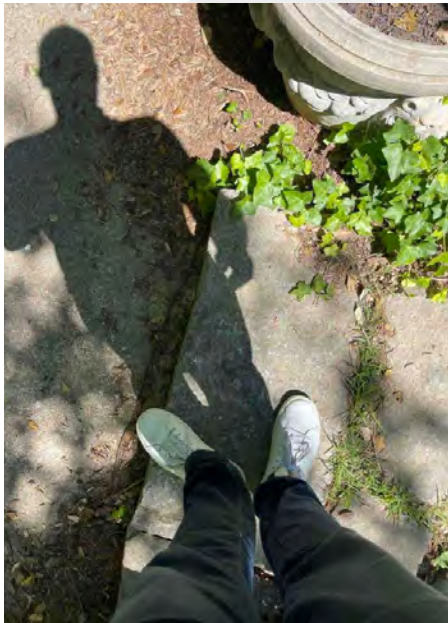
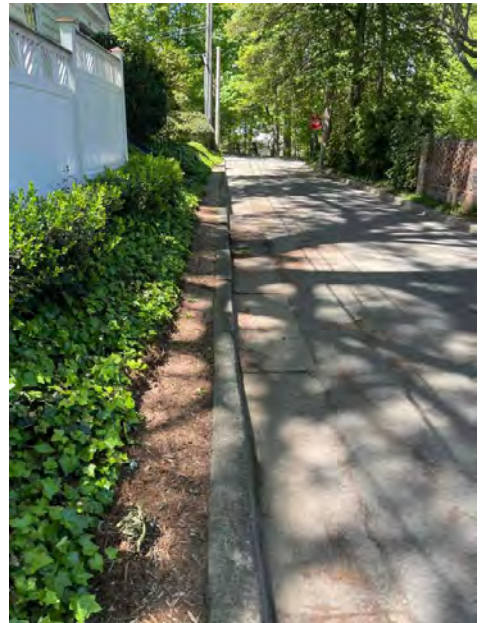
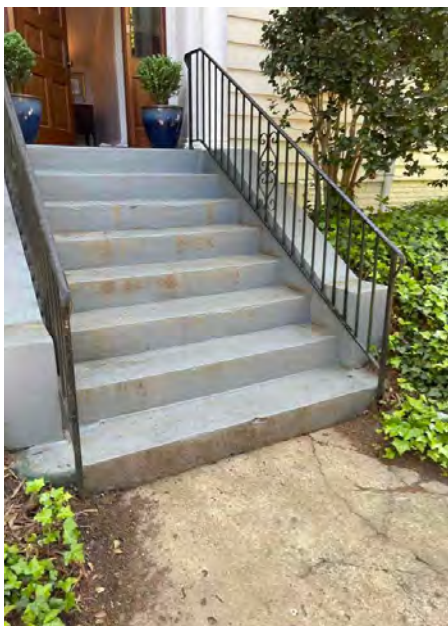
Walkways & Driveways: Walkways & Driveways Were Inspected

I inspected the walkways and driveways that were adjacent to the house. The walkways, driveways, and parking areas that were far away from the house foundation were not inspected.

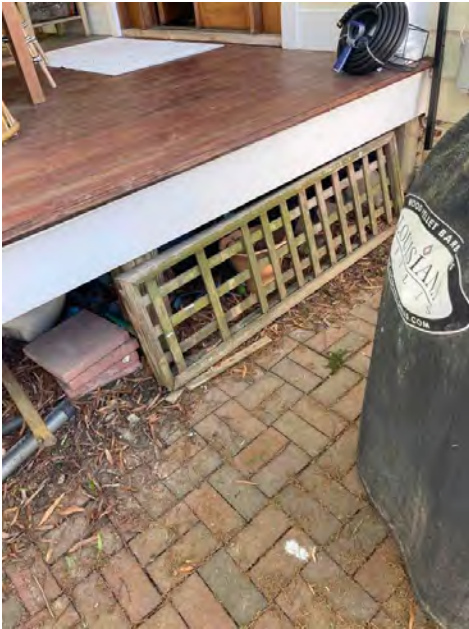
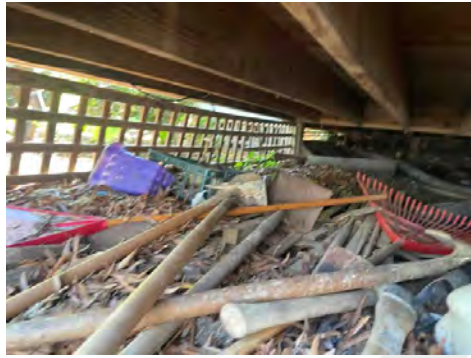
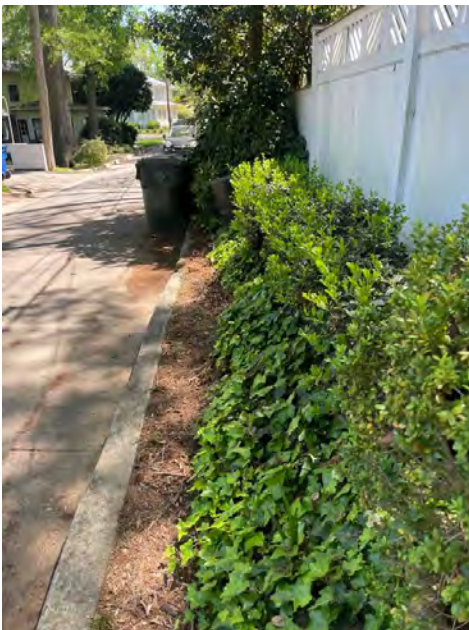
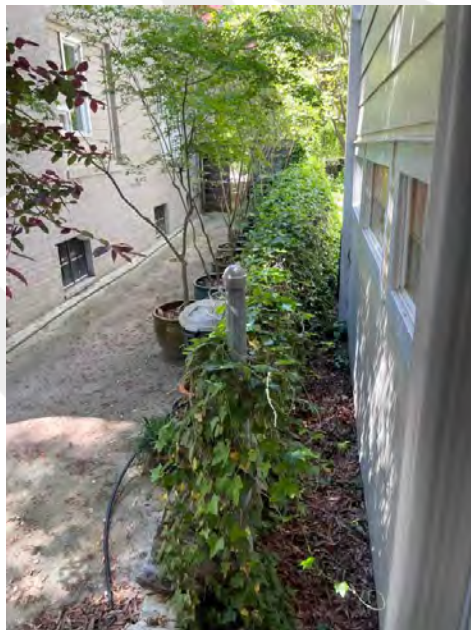
Limited access, Vegetation

The inspection of the exterior of the house was restricted, and the visual-only inspection was limited.

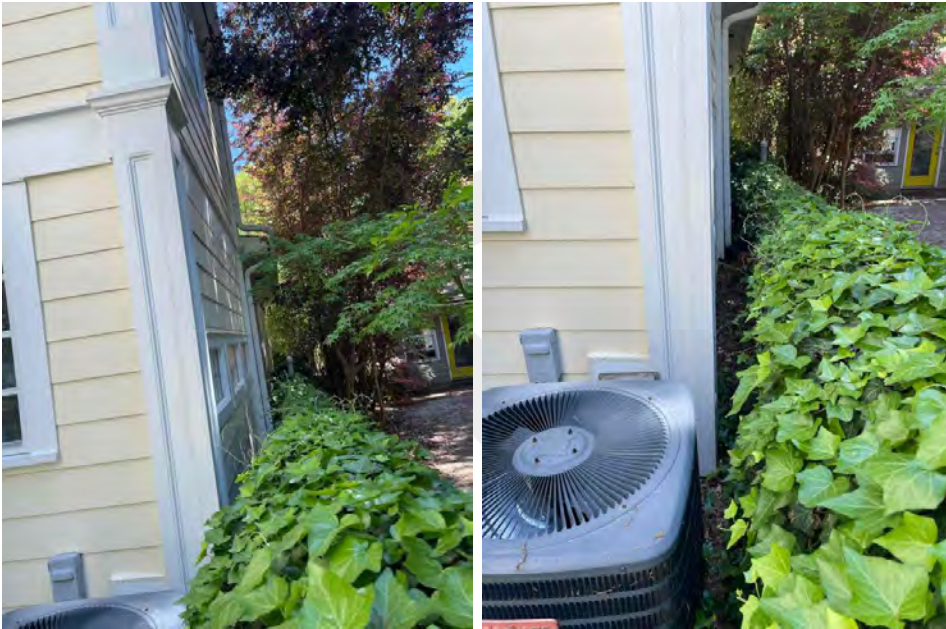
Eaves, Soffits & Fascia

INSPECTION WAS RESTRICTED

I did not inspect all of the eaves, soffit, and fascia. It's impossible to inspect those areas closely during a home inspection. A home inspection is not an exhaustive evaluation. My inspection of the exterior was limited. I did not reach and access closely every part of the eaves, soffit, and fascia.

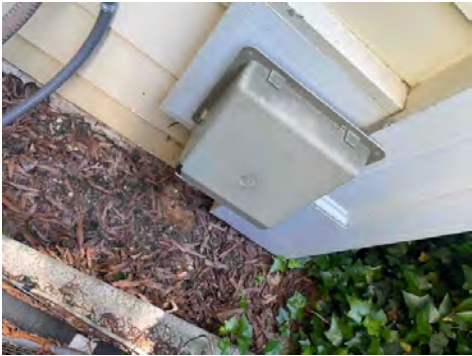
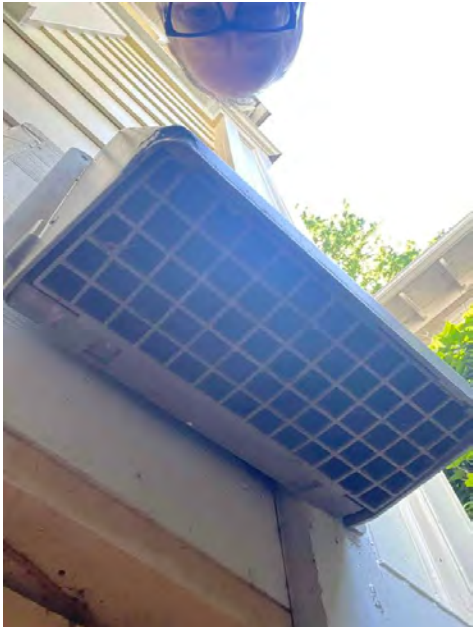
UNIDENTIFIED HOODS

I observed some exterior exhaust hoods, but I was unable to identify them as to what their purpose was.

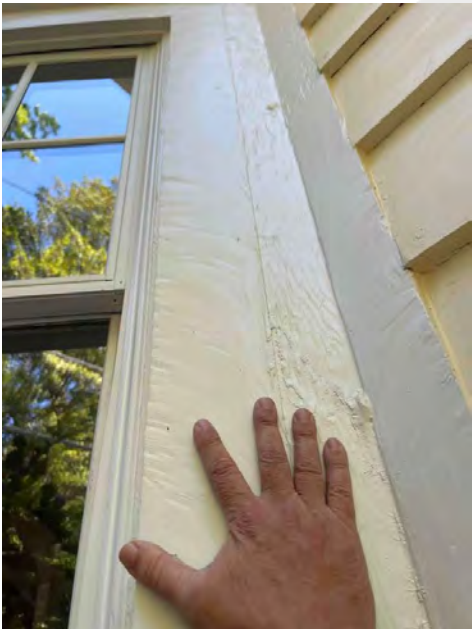
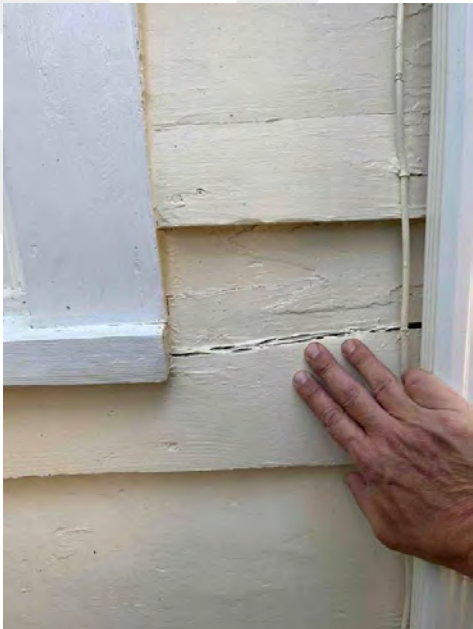
4.3.1 Wall-Covering, Flashing & Trim

CRACKING - MINOR

Siding showed cracking in one or more places. Recommend monitoring.

Recommended DIY Project

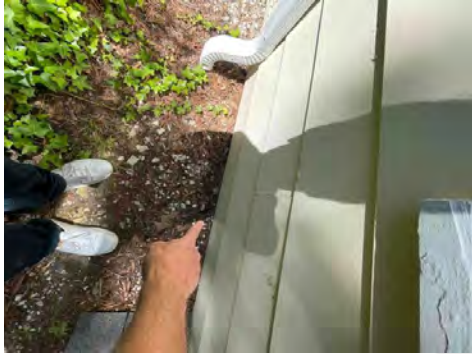
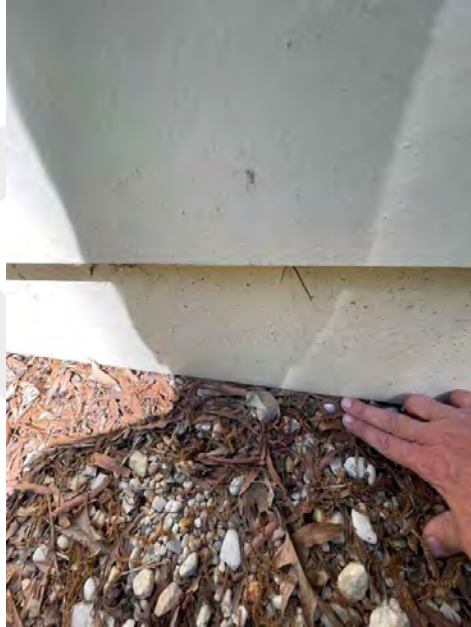
4.3.2 Wall-Covering, Flashing & Trim

INADEQUATE GROUND CLEARANCE

Correction and further evaluation is recommended.

Contact a qualified siding specialist.

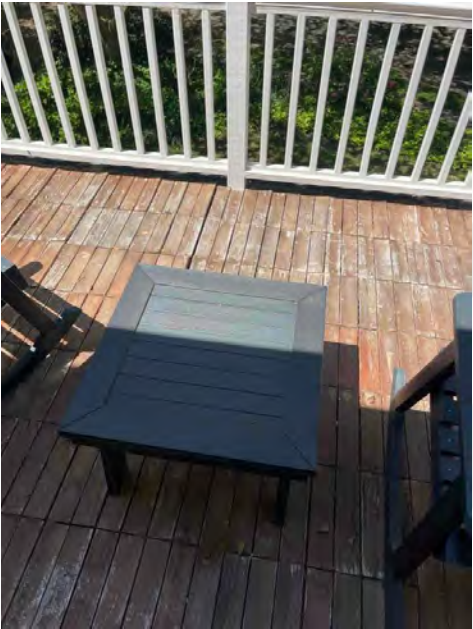
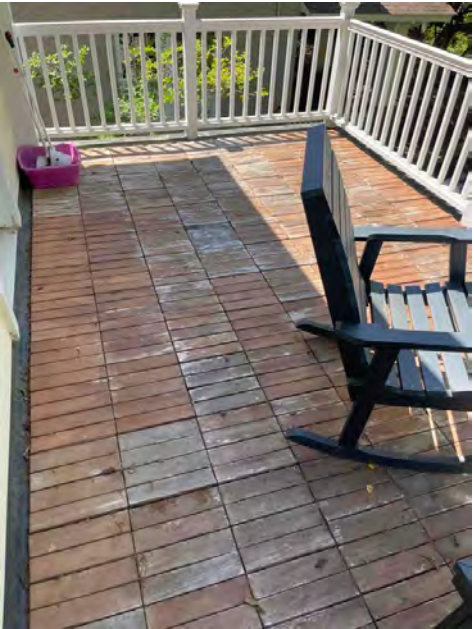
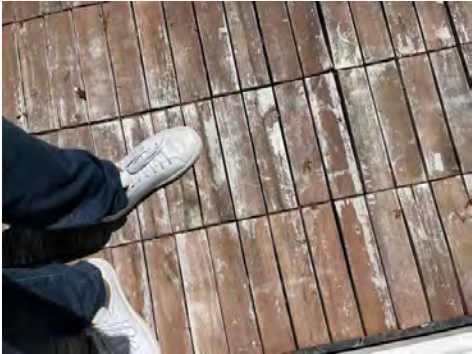
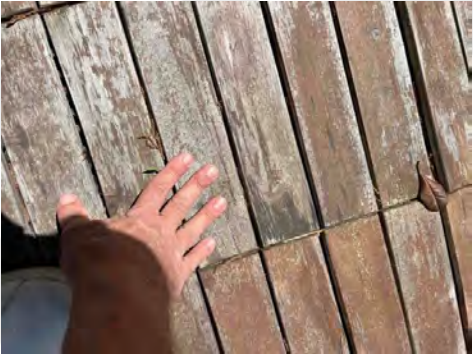
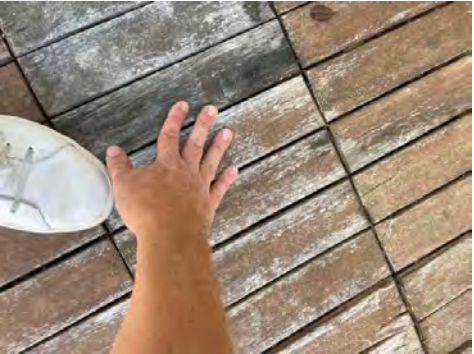
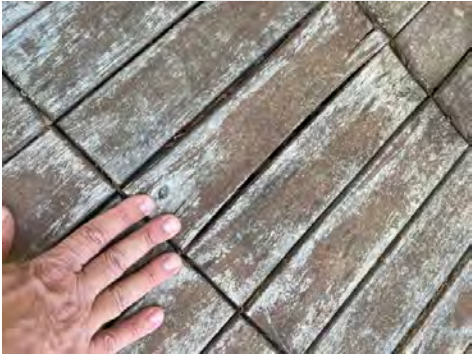
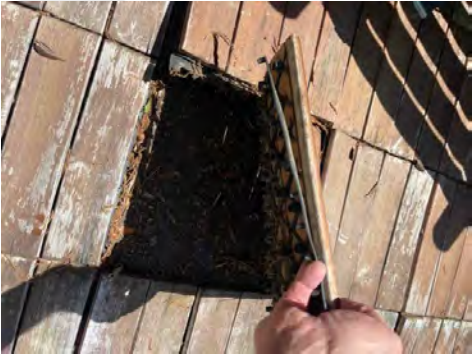
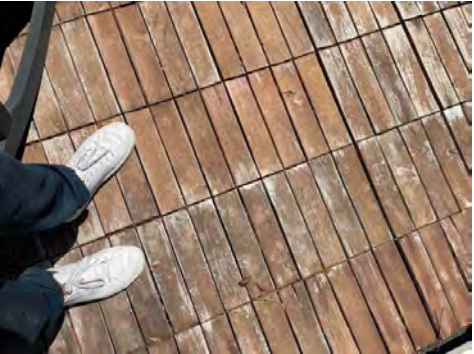
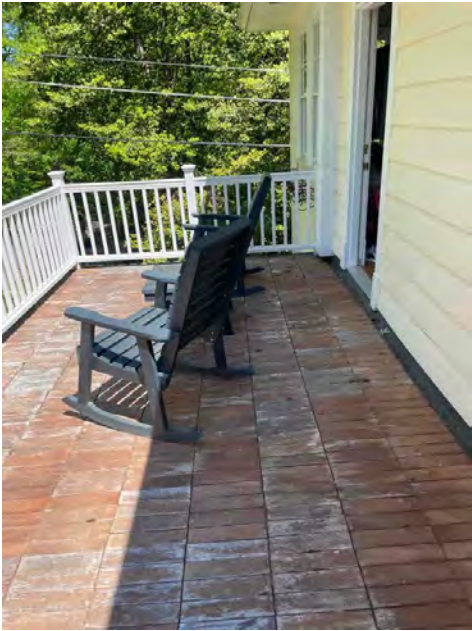
4.8.1 Porches, Patios, Decks, Balconies & Carports

DETERIORATED CONDITION AT DECK

I observed indications of deteriorated conditions at the deck components.

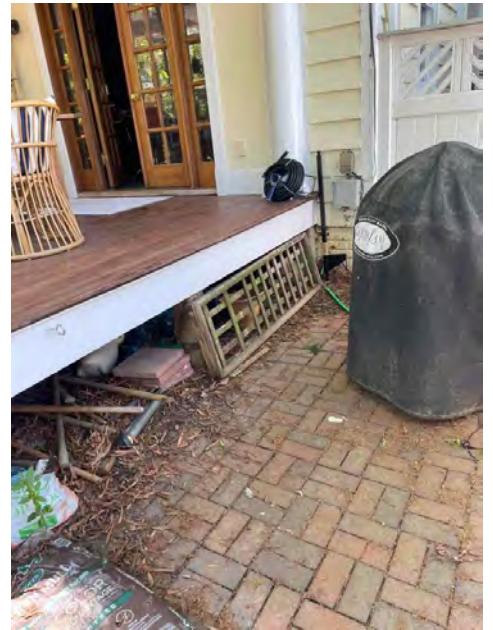
MISSING HANDRAIL

I observed a missing handrail.

There is more than one step here, and I recommend installing a handrail for safety.

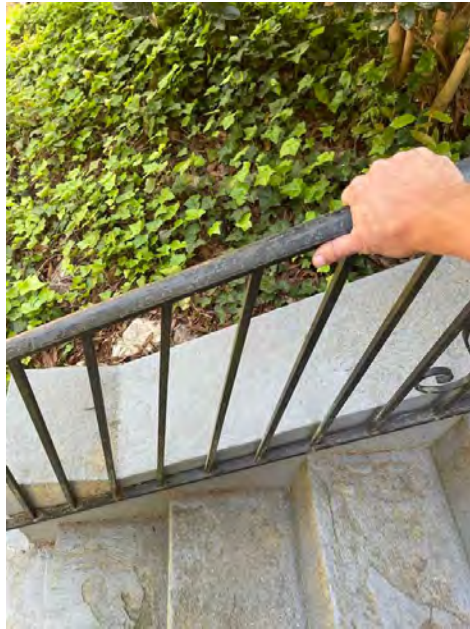
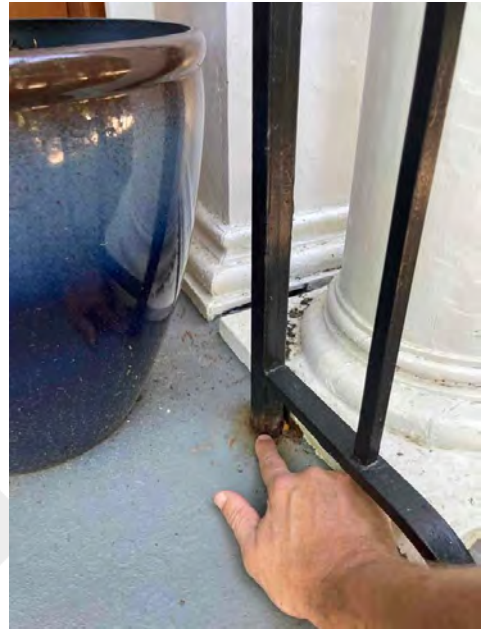
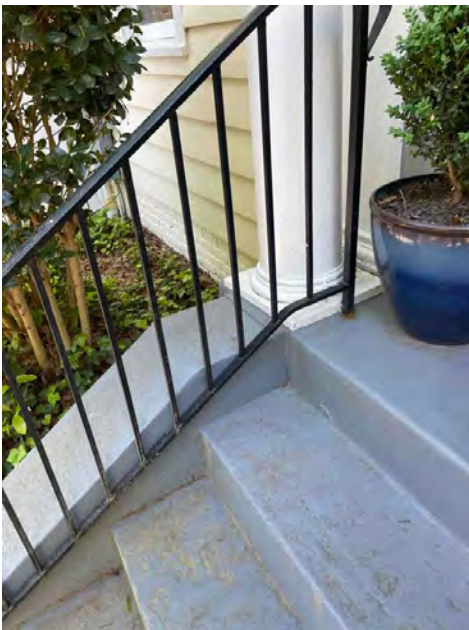
4.9.2 Railings, Guards & Handrails

LOOSE RAILING COMPONENT

I observed a loose railing component. This condition is a safety hazard.

Correction and further evaluation is recommended.

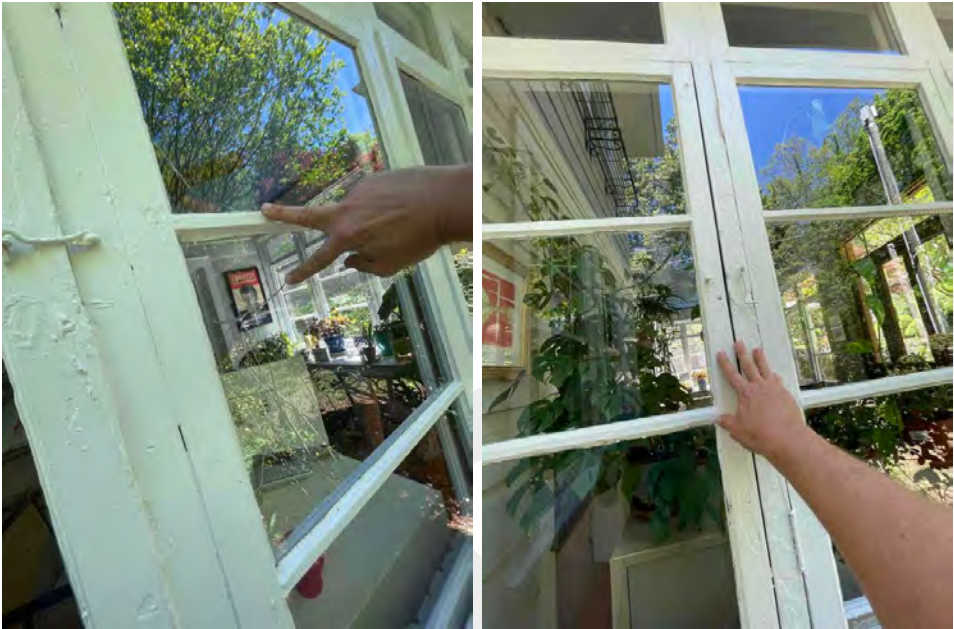
4.10.1 Windows

CRACKED WINDOWPANE

I observed a cracked glass windowpane.

Correction and further evaluation is recommended.

Contact a qualified window repair/installation contractor.
