INSPECTION REPORT BY BIG BEN INSPECTIONS

123 Chamberlain St
Raleigh, NC 27607

Mary Jane
APRIL 13, 2023

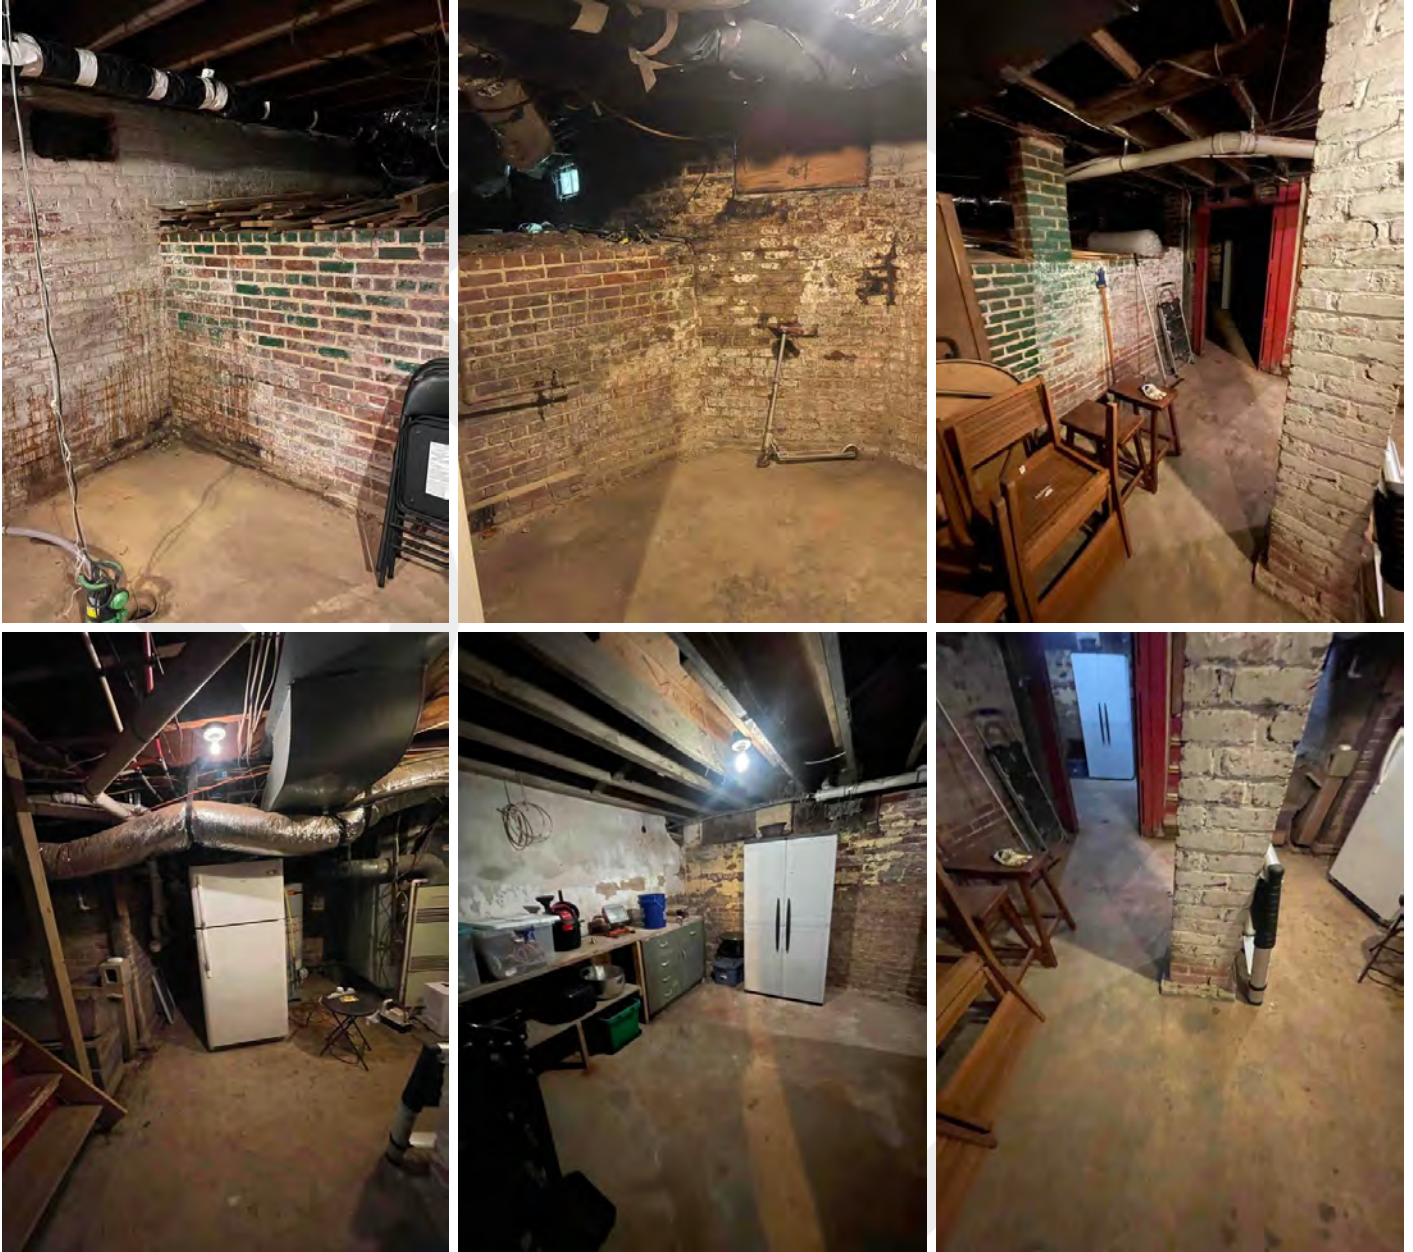
The basement can be a revealing area in the house and often provides a general picture of how the entire structure works. In most basements, the structure is exposed overhead, as are the HVAC distribution system, plumbing supply and DWV lines, and the electrical branch-circuit wiring. I inspected those systems and components.

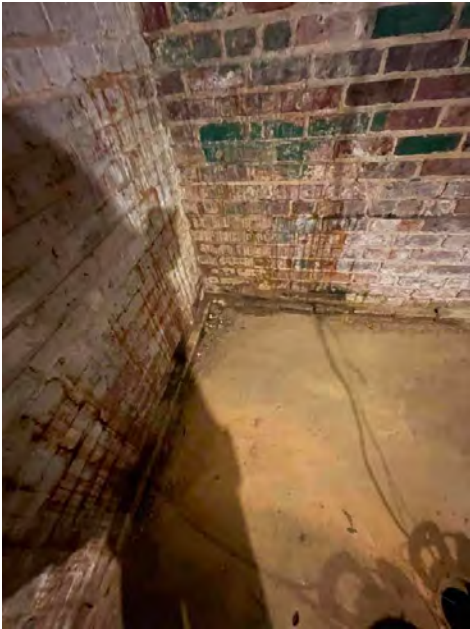
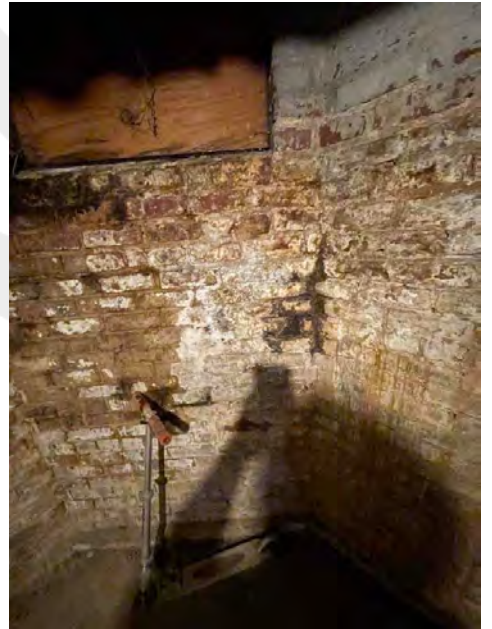
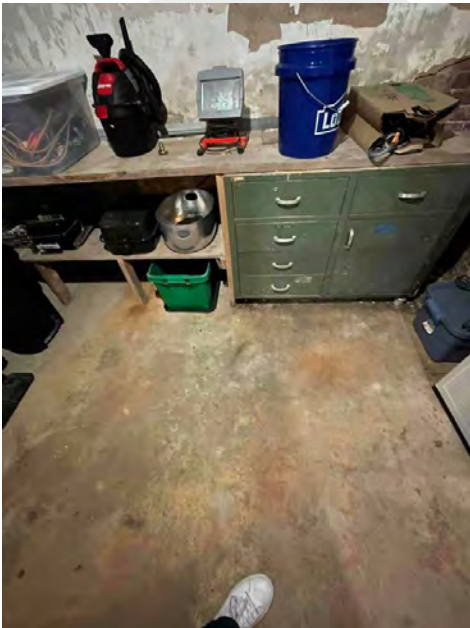
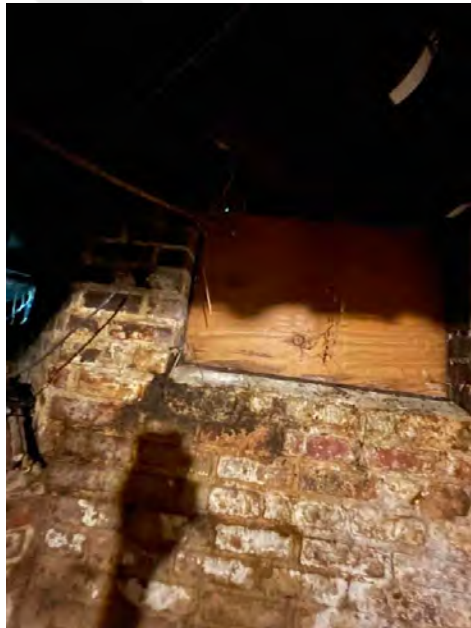
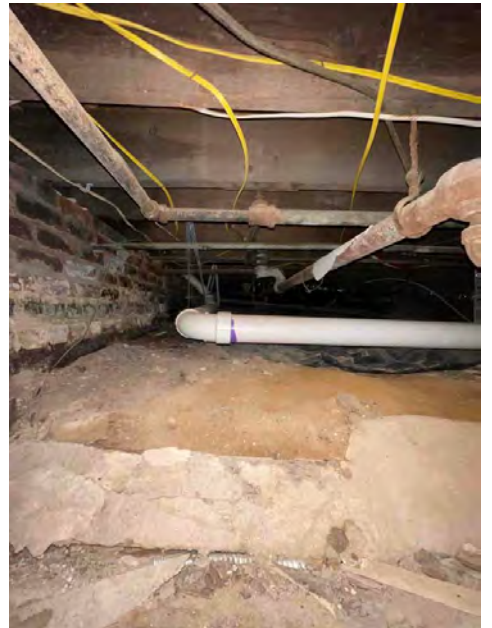
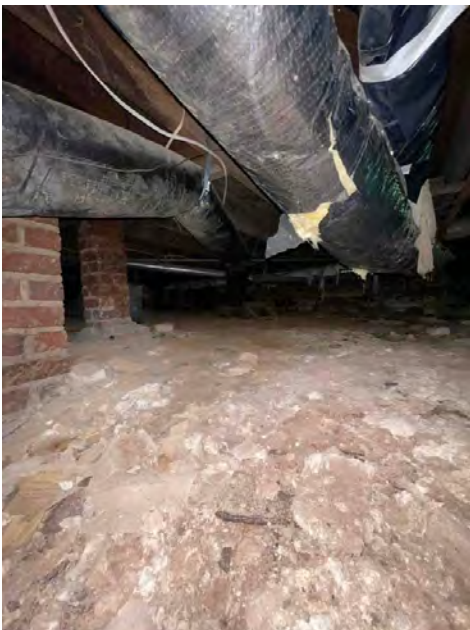
ACTIVE WATER PENETRATION OBSERVED

I observed indications of active water penetration into the house.

Correction and further evaluation is recommended.

Contact a qualified professional.

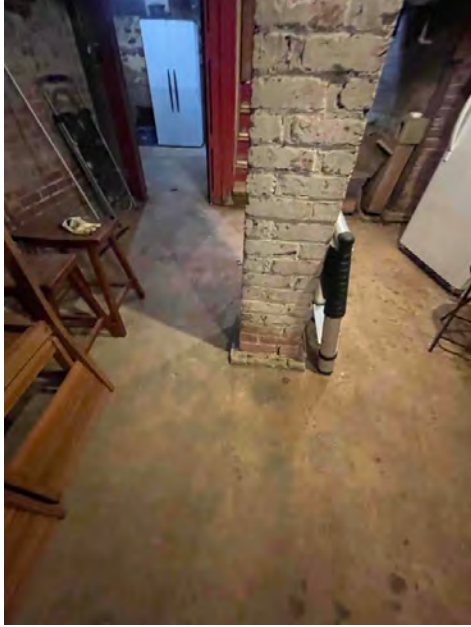
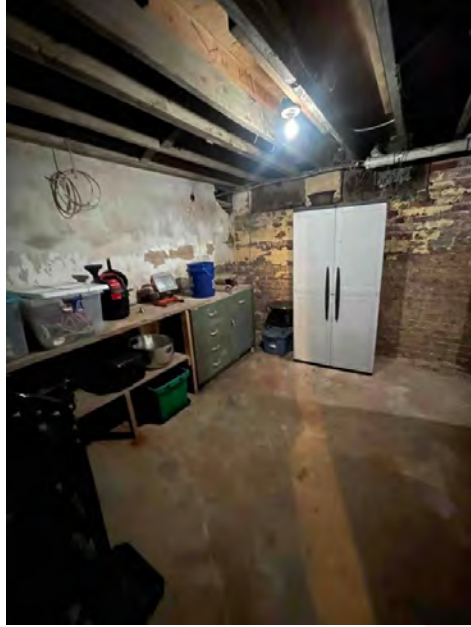
5.1.3 Basement

PRIOR WATER PENETRATION OBSERVED

I observed indications that sometime in the past, there was water penetration or intrusion into the house. Correction and further evaluation is recommended.

Recommend monitoring.

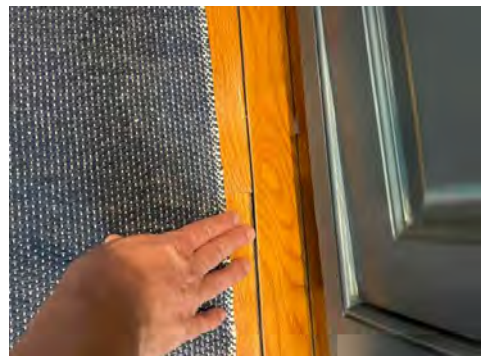
5.1.4 Basement

POSSIBLE FOUNDATION MOVEMENT - UNLEVEL FLOOR

I observed indications of possible foundation movement at an unlevel floor area. Correction and further evaluation is recommended.

Contact a qualified general contractor.

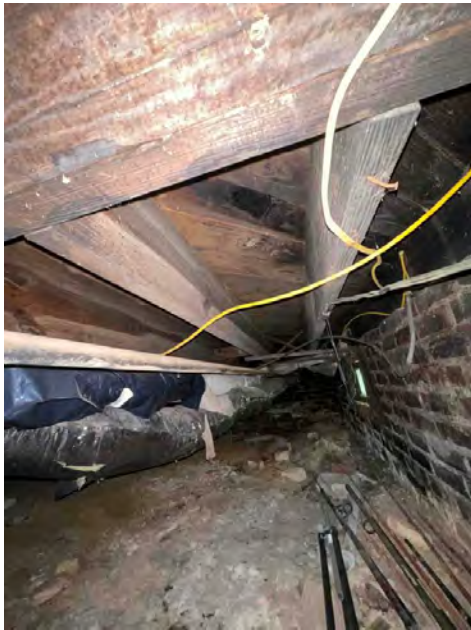
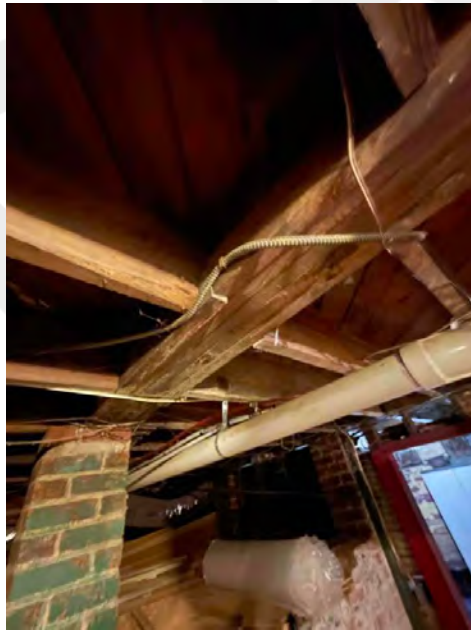
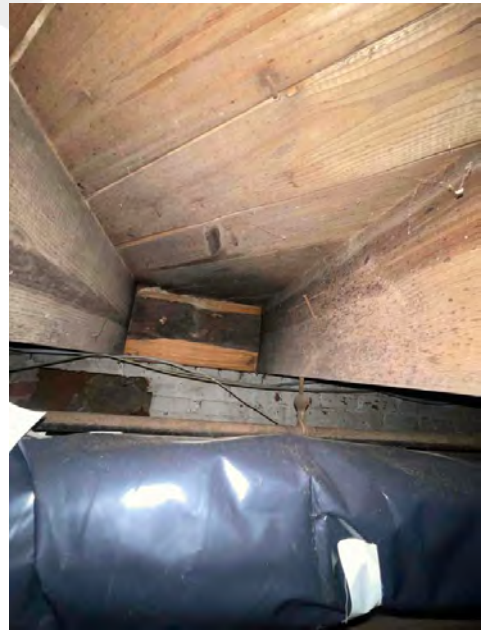
5.2.1 Insulation in Foundation/Basement Area

I observed indications of the general absence of insulation in the foundation area.

Contact a qualified insulation contractor.

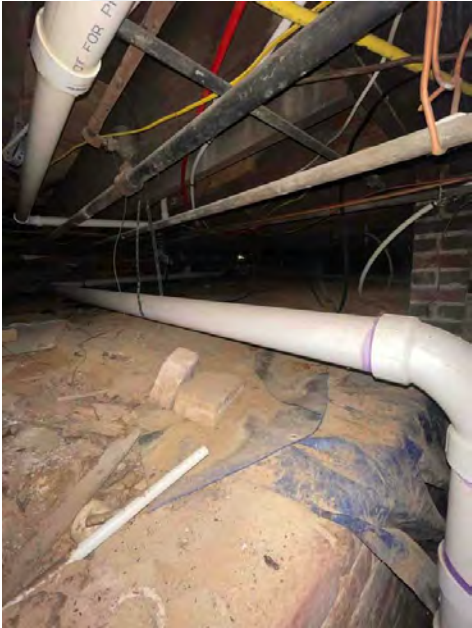
I observed indications of active water penetration into the crawlspace. Correction and further evaluation is recommended.

Recommendation
Contact a qualified professional.

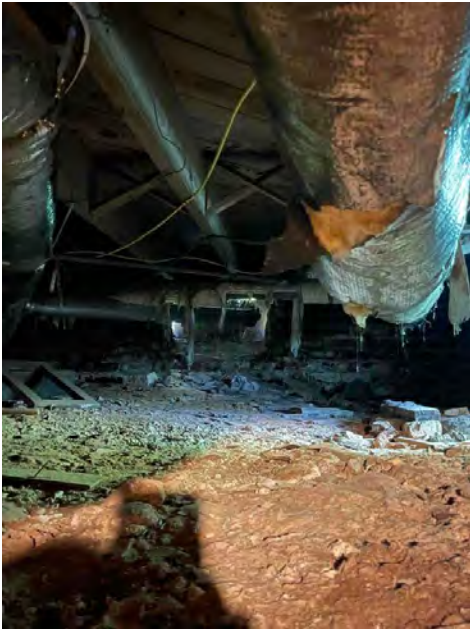
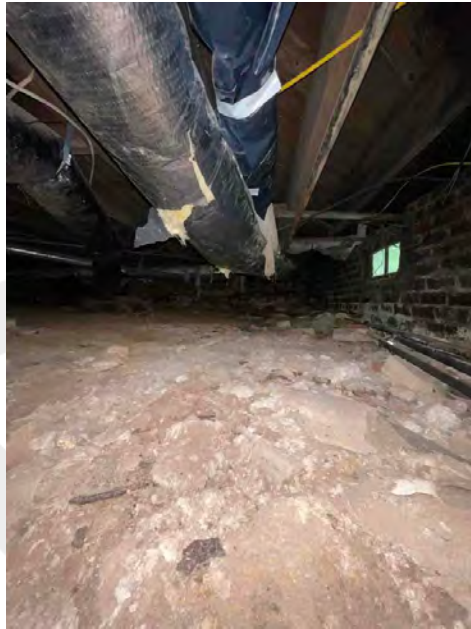
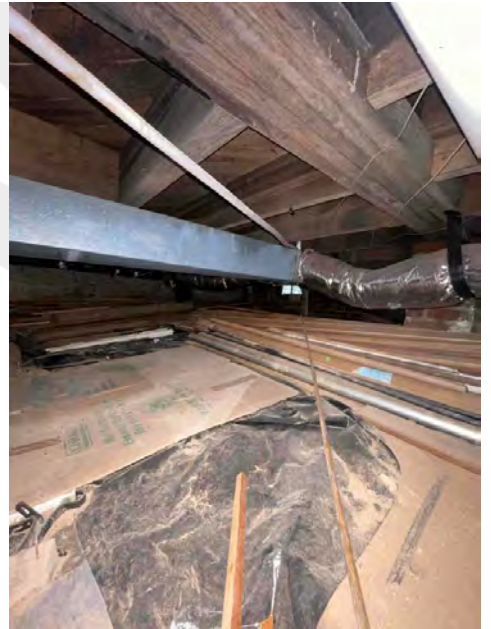
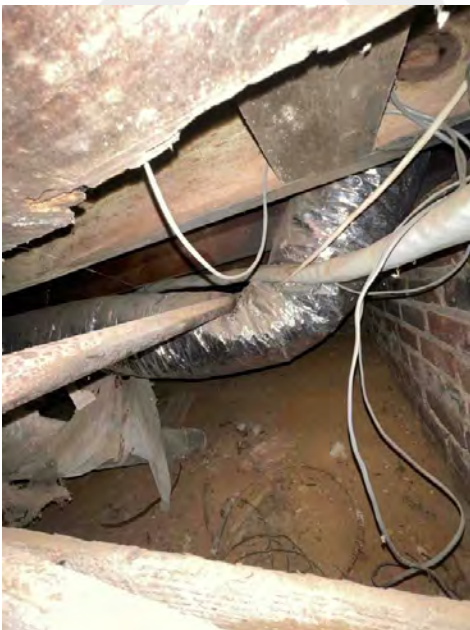
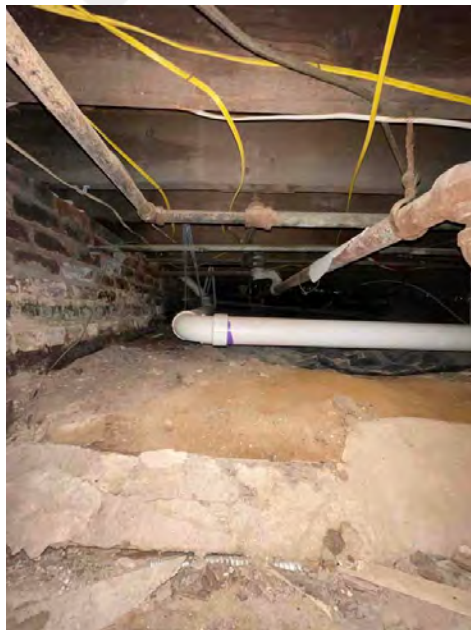
ACTIVE WATER PENETRATION OBSERVED

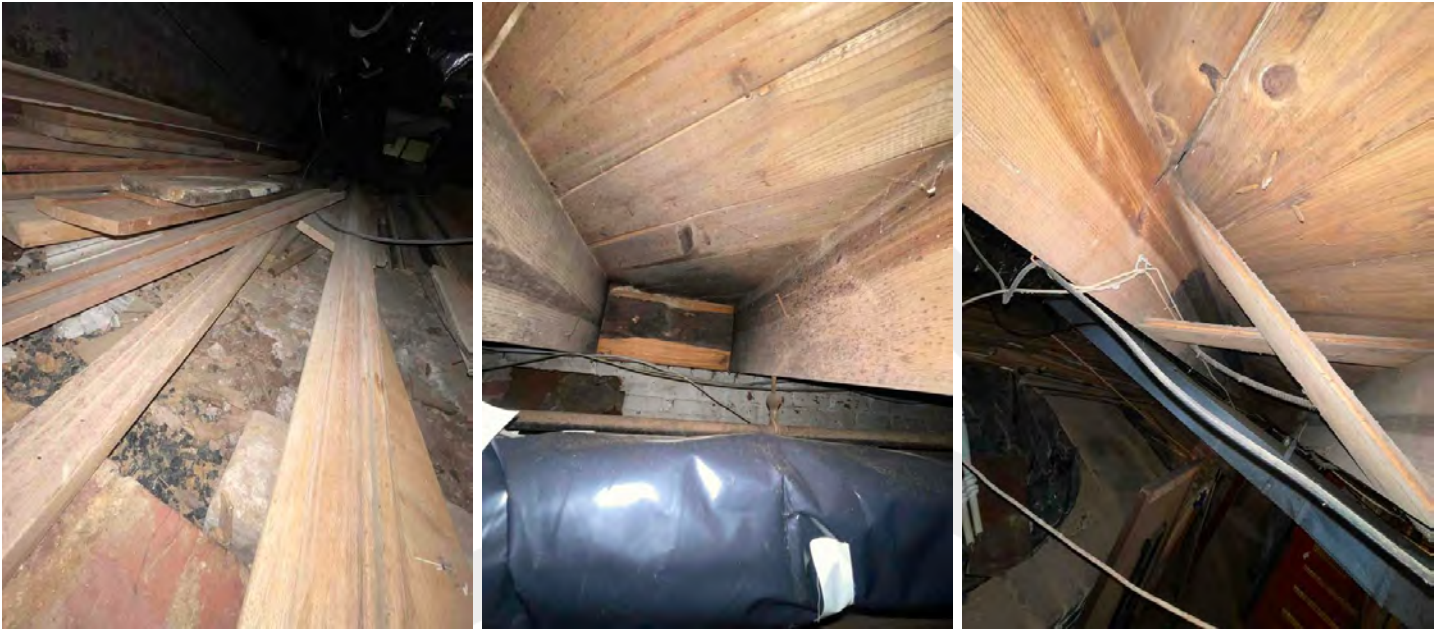
I observed indications of the general absence of insulation in the unfinished crawlspace area.

Contact a qualified insulation contractor.

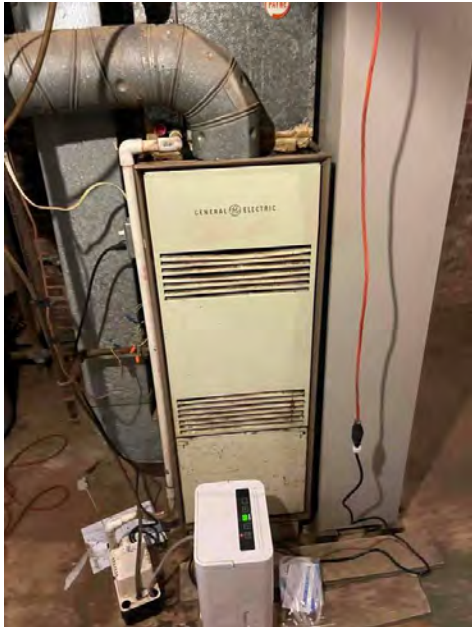
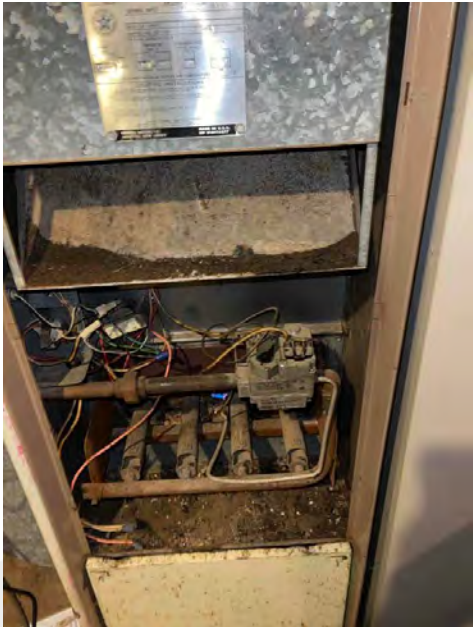
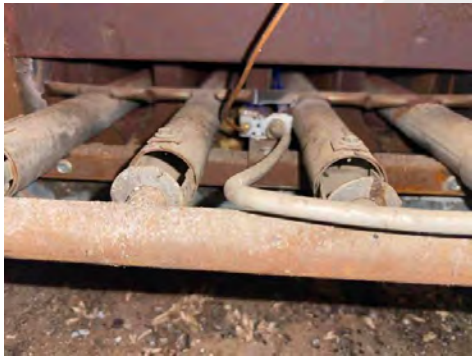
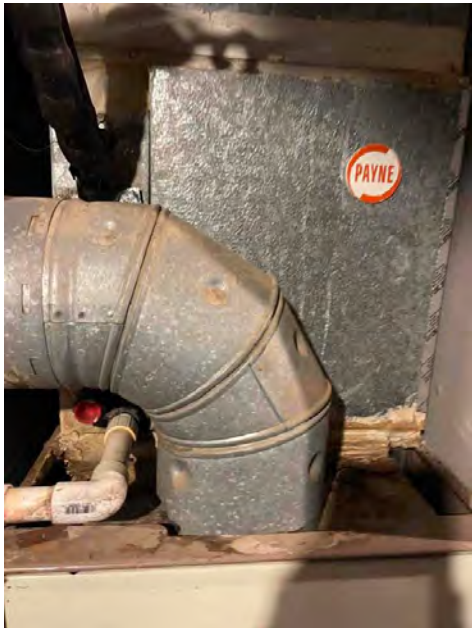
I observed indications of delayed maintenance at the heating system. The system should be cleaned and inspected by a HVAC professional every year. Correction and further evaluation is recommended.

Recommendation
Contact a qualified heating and cooling contractor

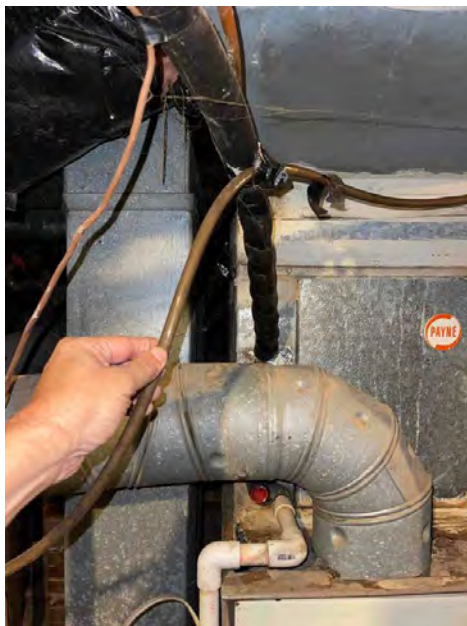
I observed a discharge pipe apparently connected to the condensate pump installed at the cooling system.

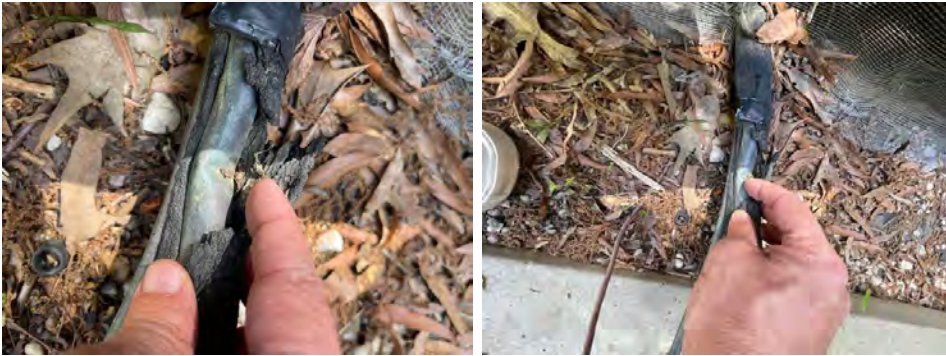
DEFECT AT COOLING SYSTEM

I observed a defect at the cooling system. Suction line was damaged.

Contact a qualified HVAC professional.

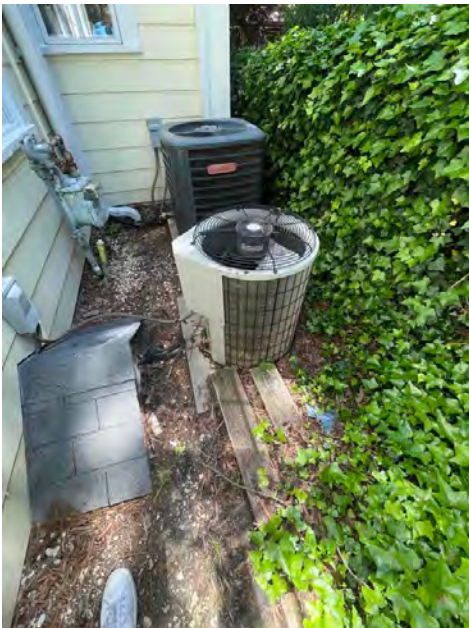
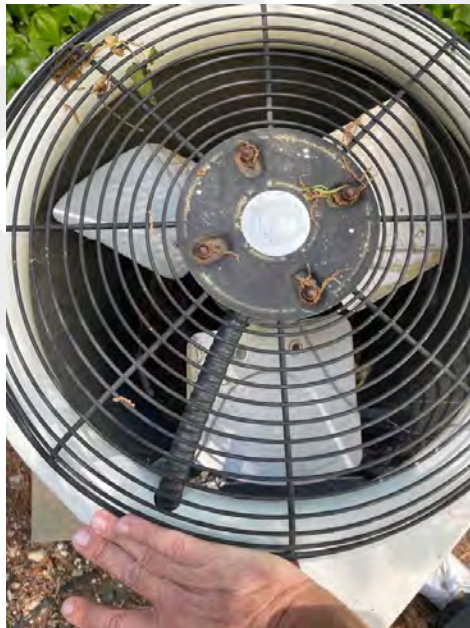
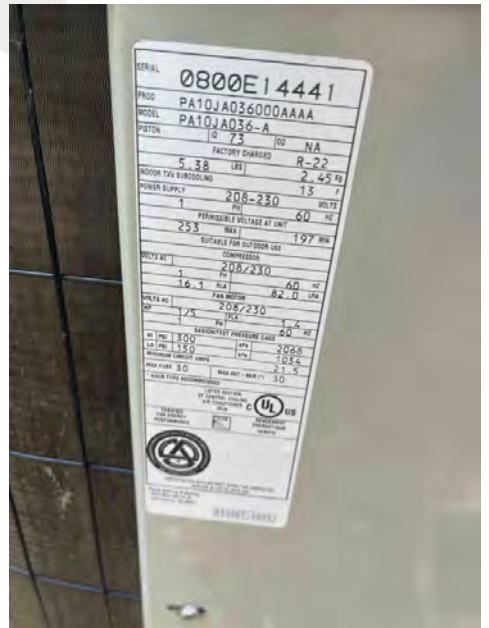
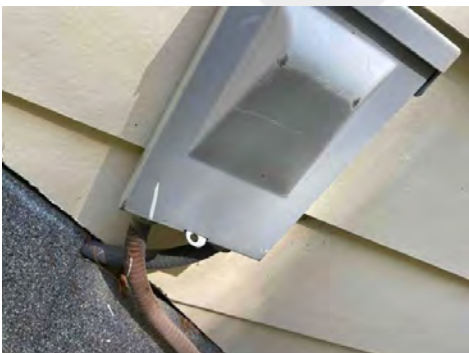
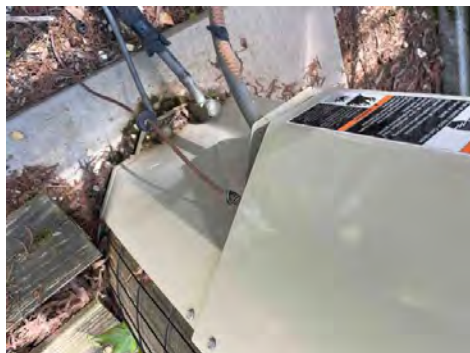
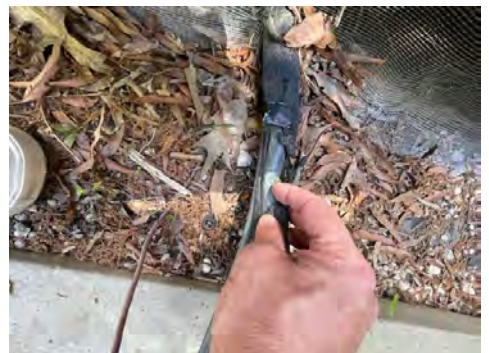
I observed during my inspection that the system appeared to be old and at the end of its service life. It may not be reliable. Ask the homeowner or occupant about its recent performance. Regular maintenance and monitoring of its condition is recommended. Budgeting for repairs and future replacement is recommended. [InterNACHI's Standard Estimate Life Expectancy Chart for Homes](#)

Recommend monitoring.

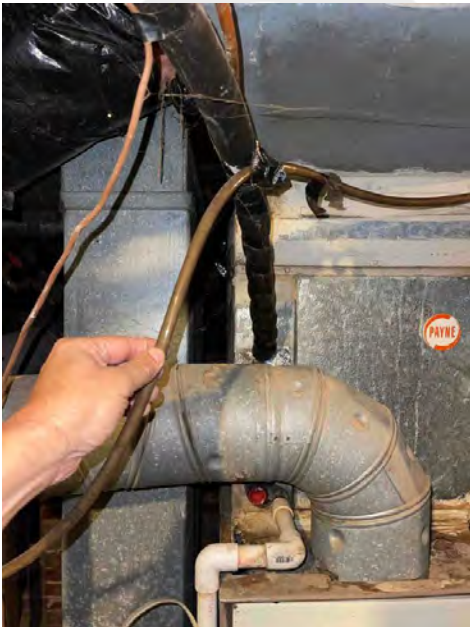
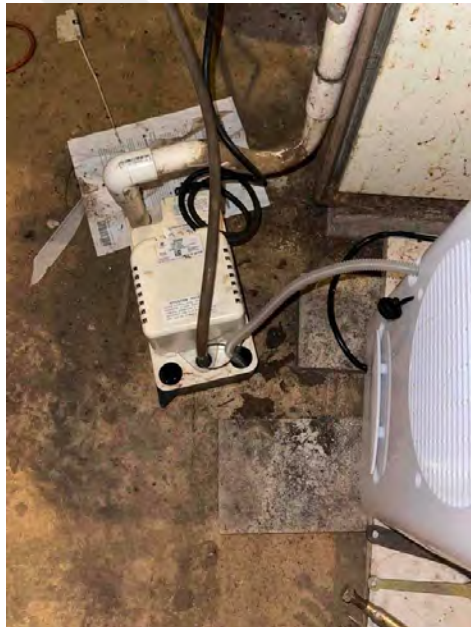
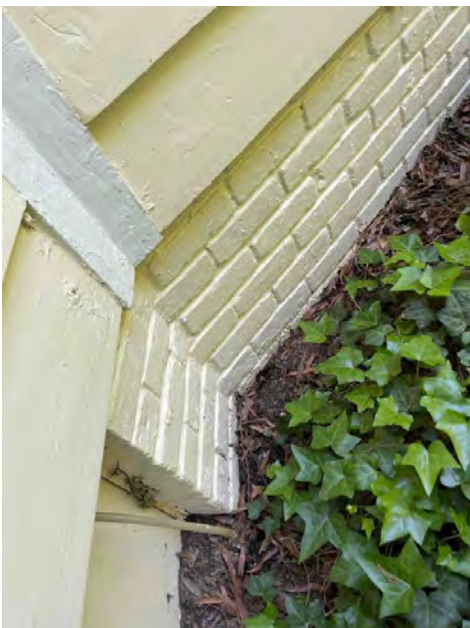
CONDENSATE DISCHARGE SHOULD BE EXTENDED

The condensate discharge pipe should be extended so that the water is diverted far enough away from the house foundation.

Contact a qualified professional.

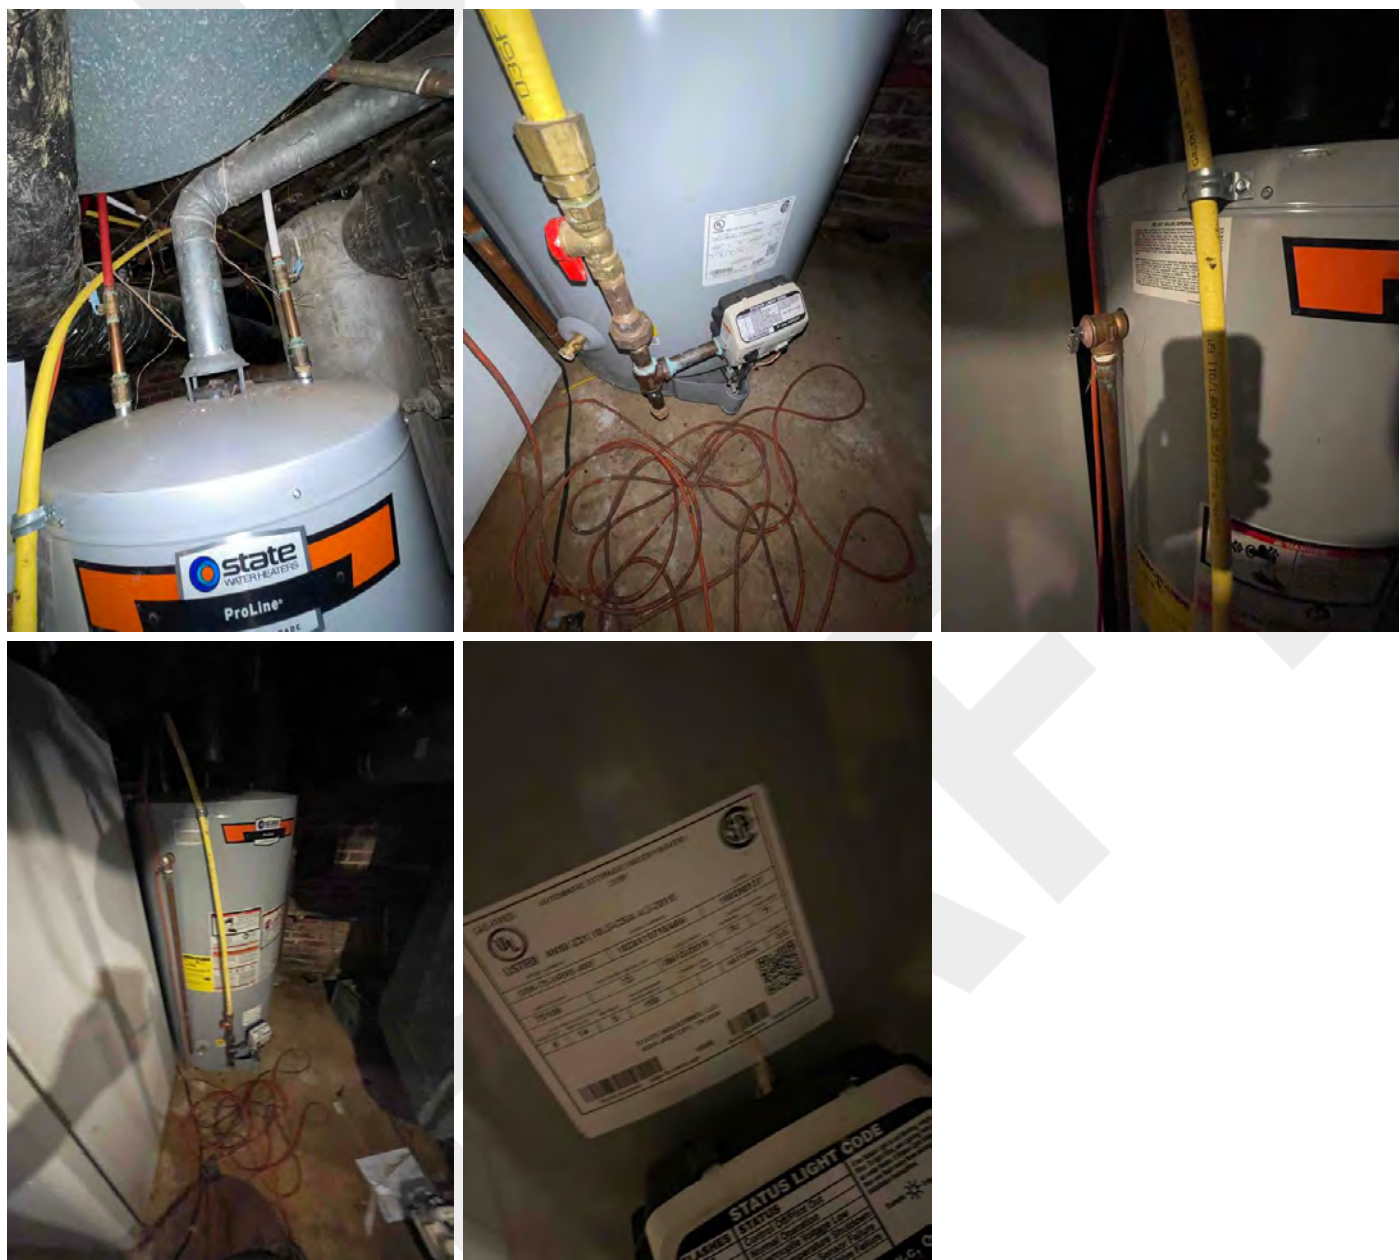
Gas-Fired Hot Water Tank

I inspected for the main source of the distributed hot water to the plumbing fixtures (sinks, tubs, showers). I recommend asking the homeowner for details about the hot water equipment and past performance.

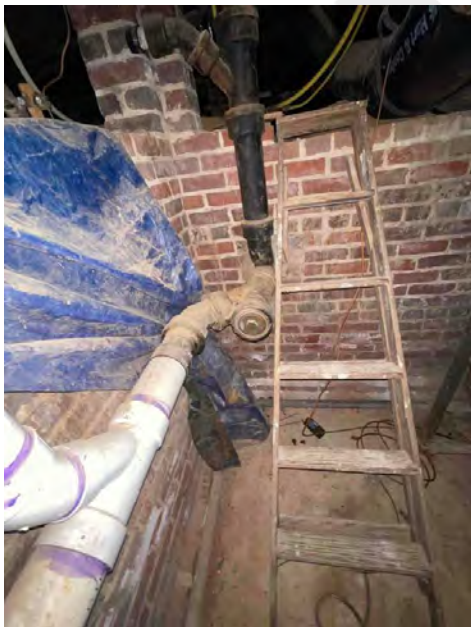
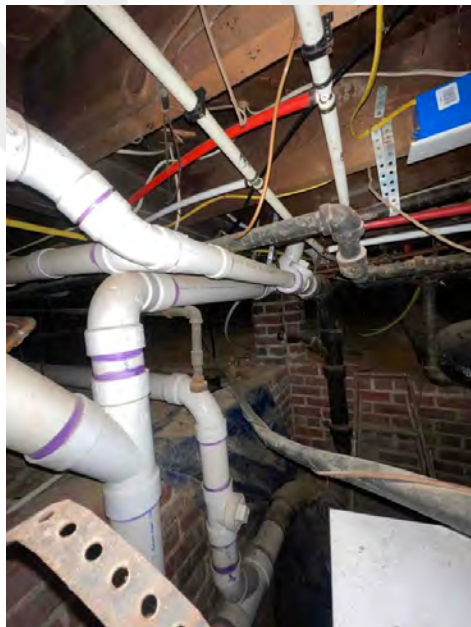
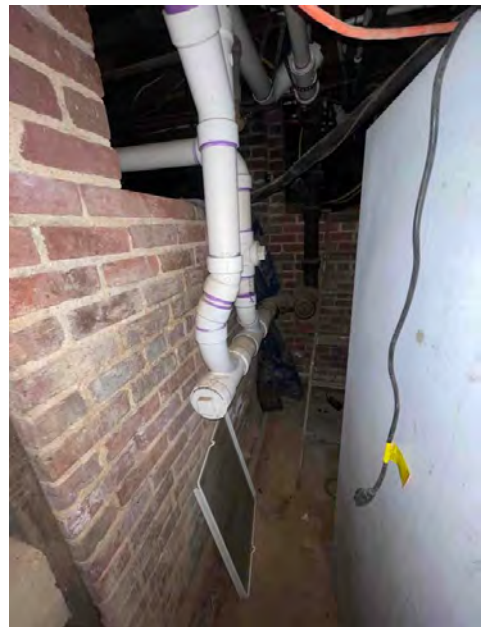
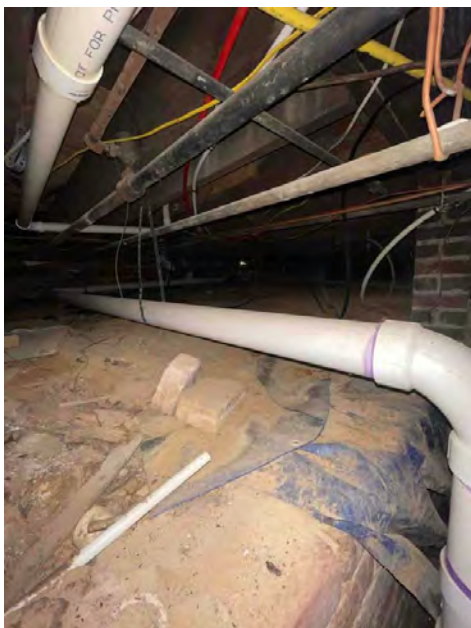
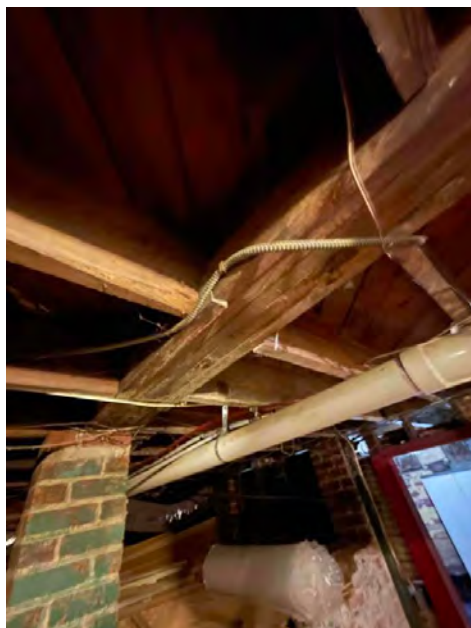
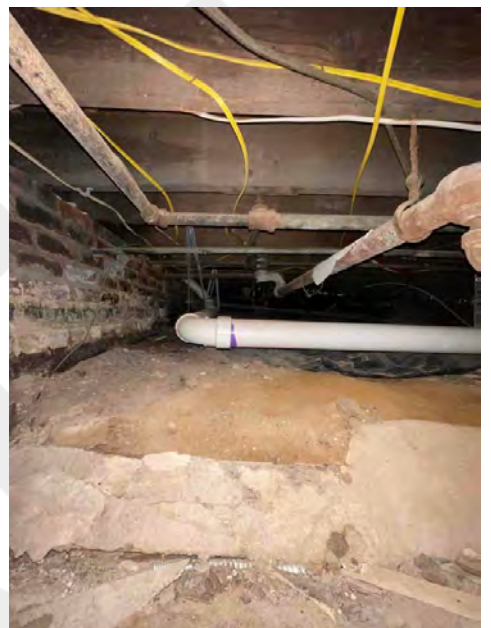
NOT ALL PIPES WERE INSPECTED

The inspection was restricted because not all of the pipes were exposed, readily accessible, and observed. For example, most of the drainage pipes were hidden within the walls.

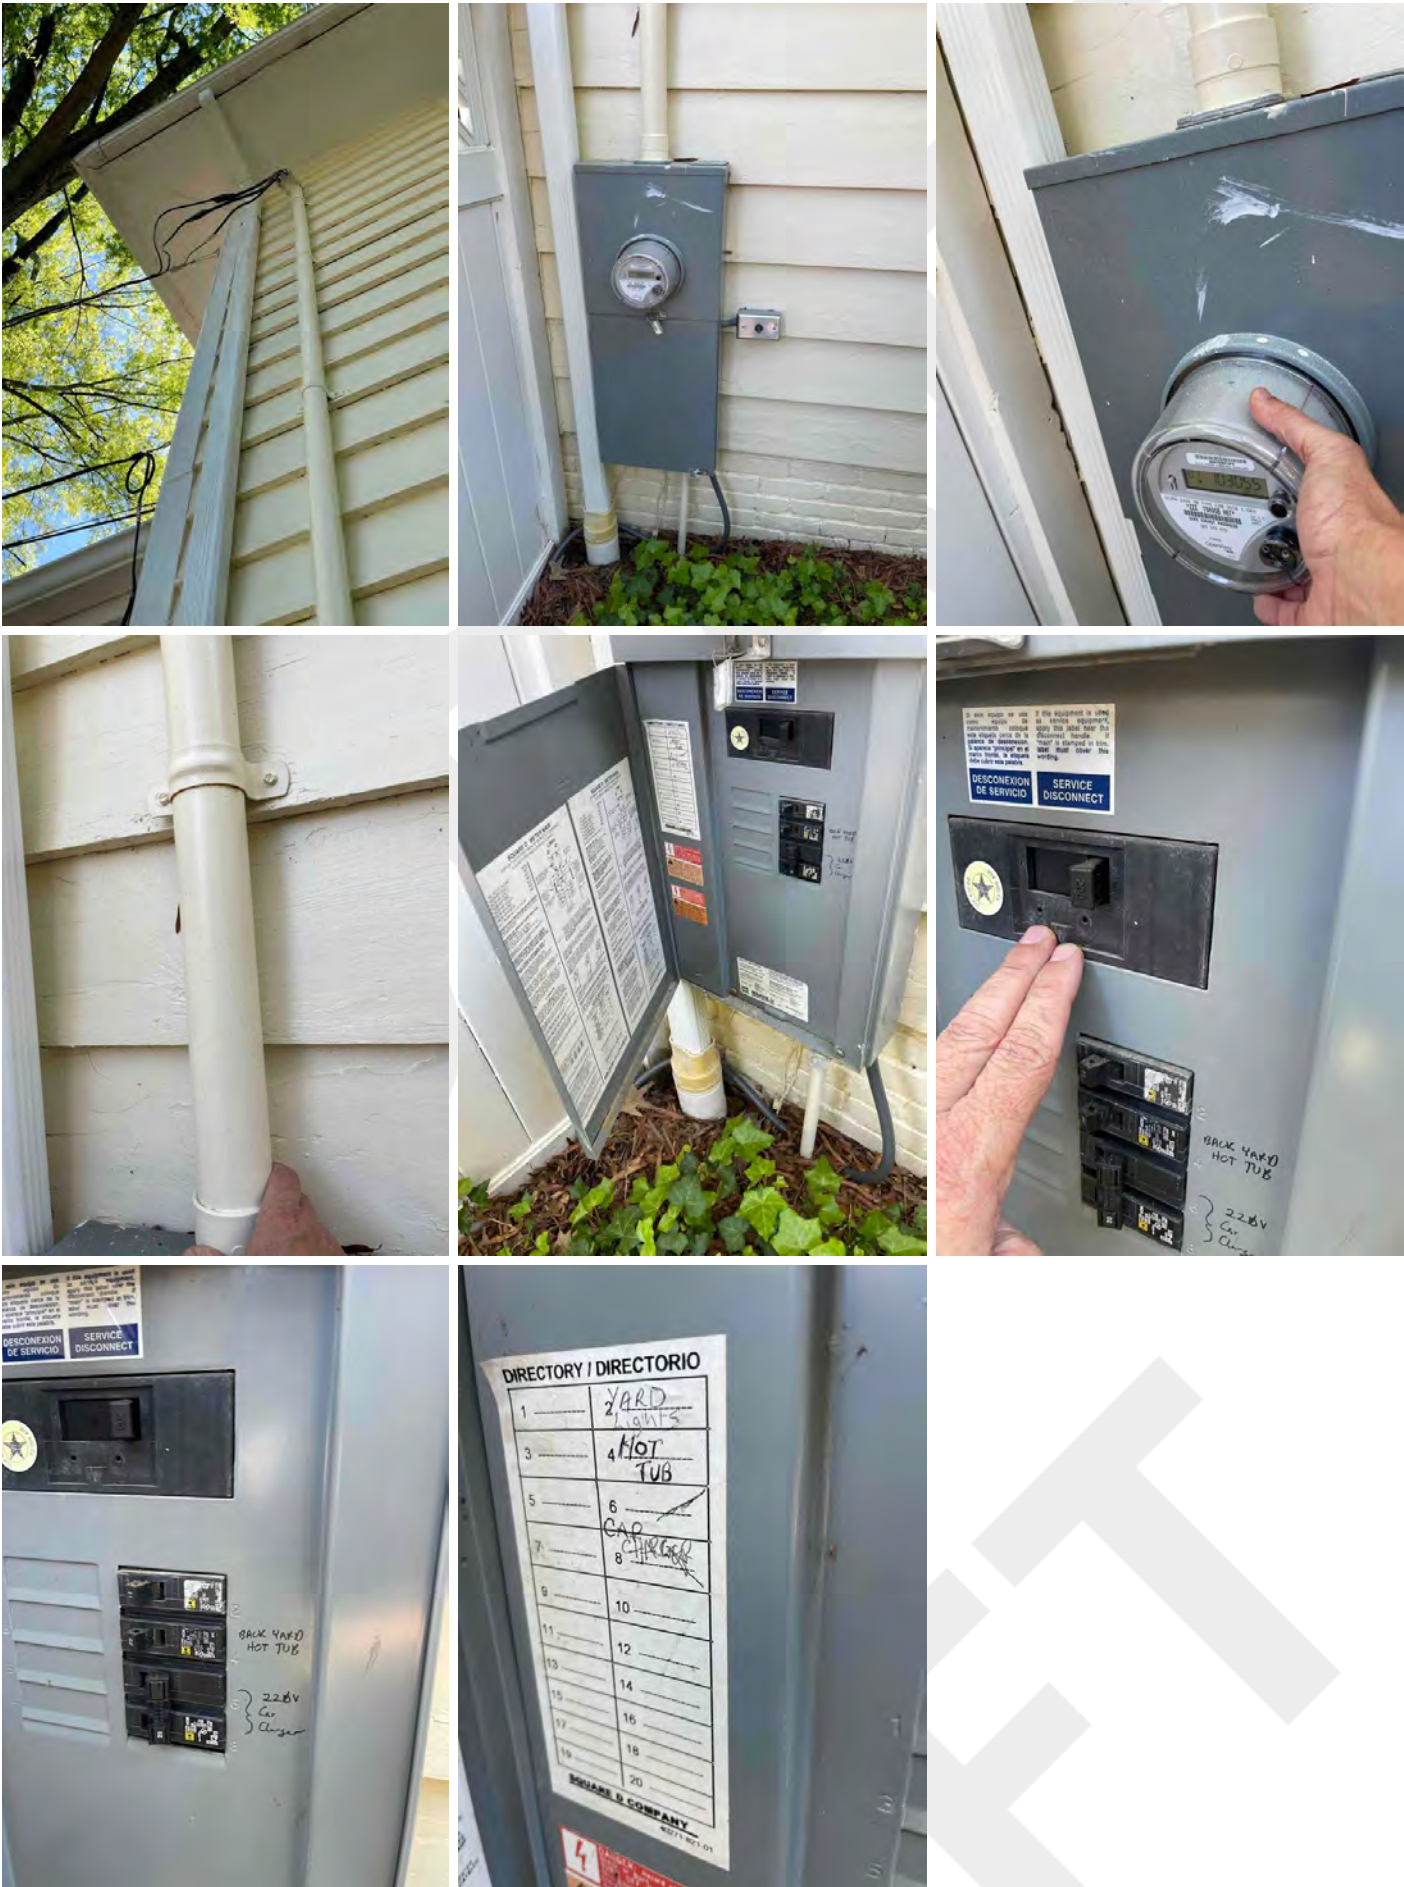
Electric Meter & Base: Inspected the Electric Meter & Base

I inspected the electrical electric meter and base.

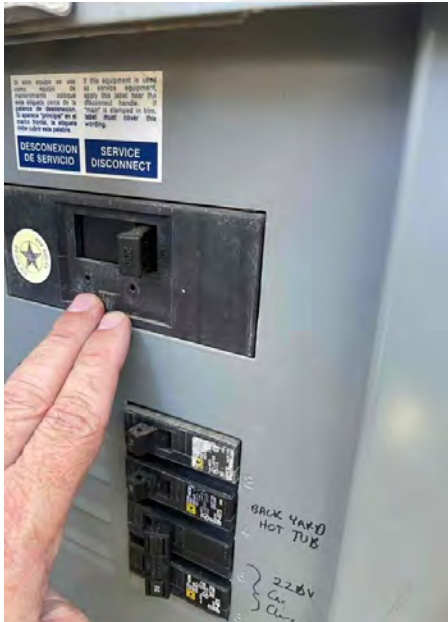
Main Service Disconnect: Main Disconnect Rating, If Labeled

I observed indications of the main service disconnect's amperage rating. It was labeled.

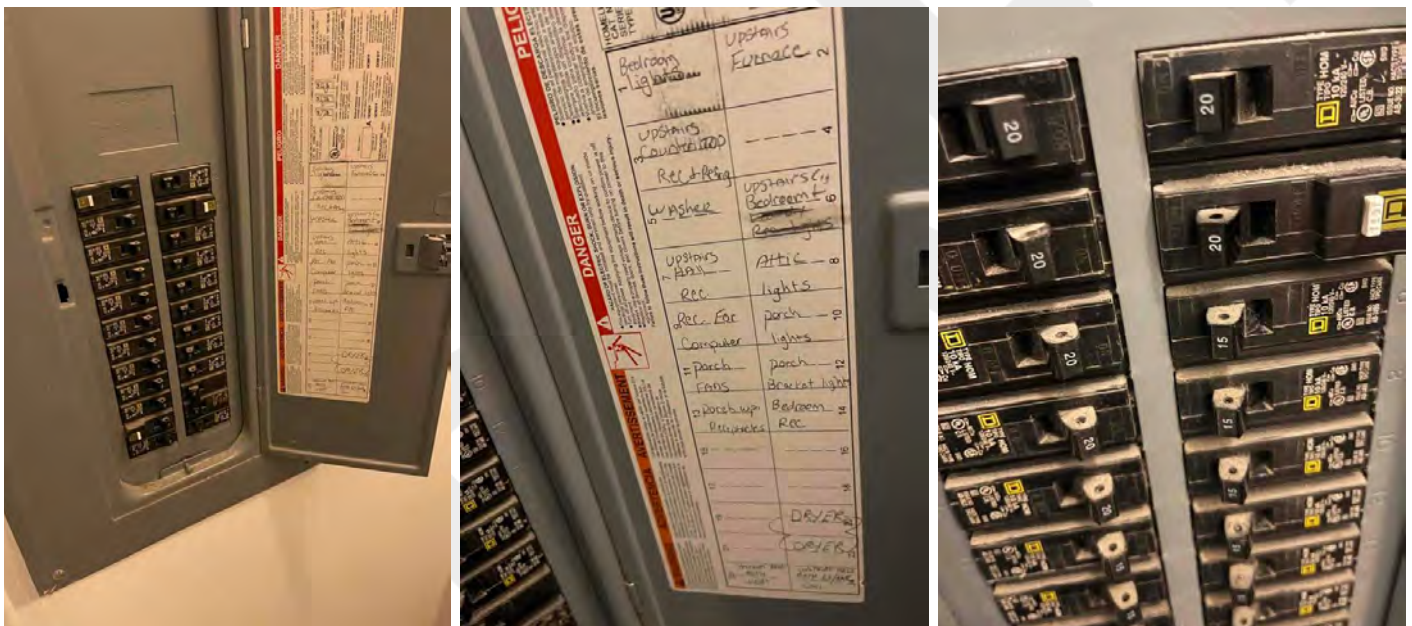
I inspected the electrical subpanel and over-current protection devices (circuit breakers and fuses).

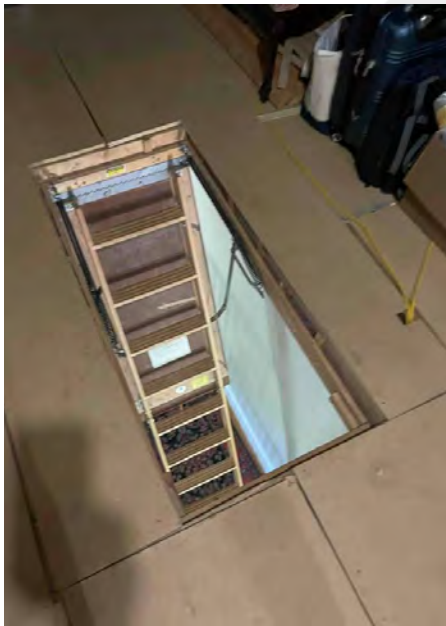
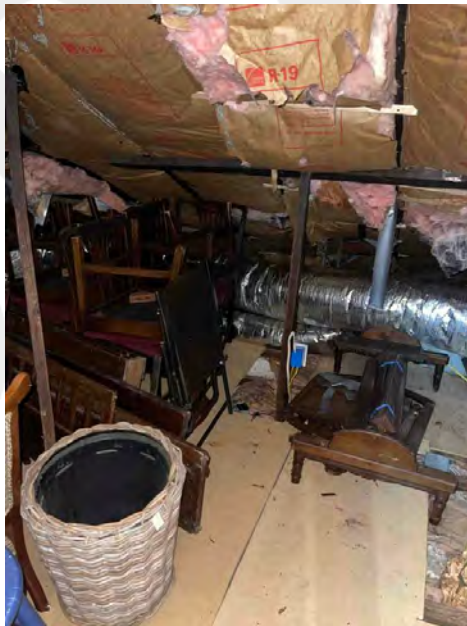
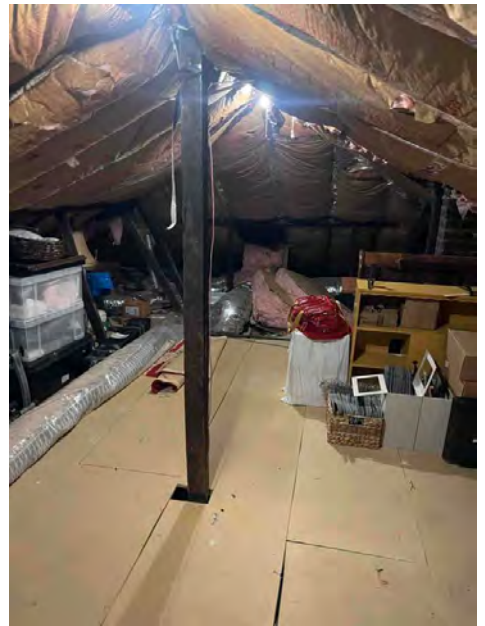
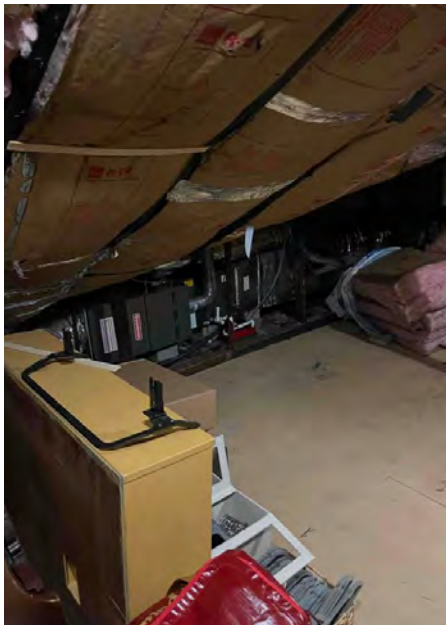
Structural Components & Observations in Attic: Structural Components Were Inspected

Structural components were inspected from the attic space according to the [Home Inspection Standards of Practice](#).

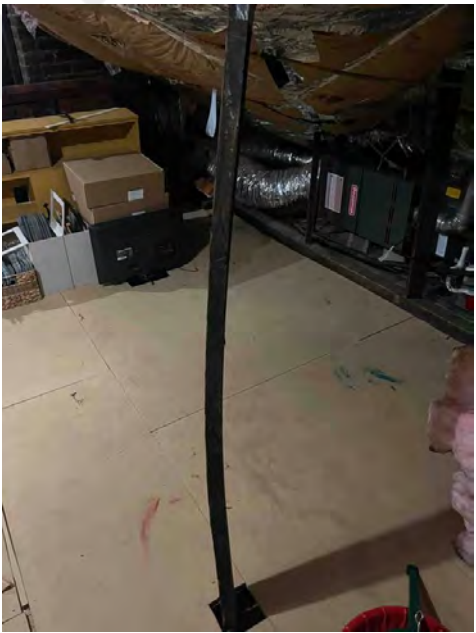
I observed a major structural defect in the attic. Bending structural support from the attic to the roof structure.

Recommendation
Contact a qualified carpenter.

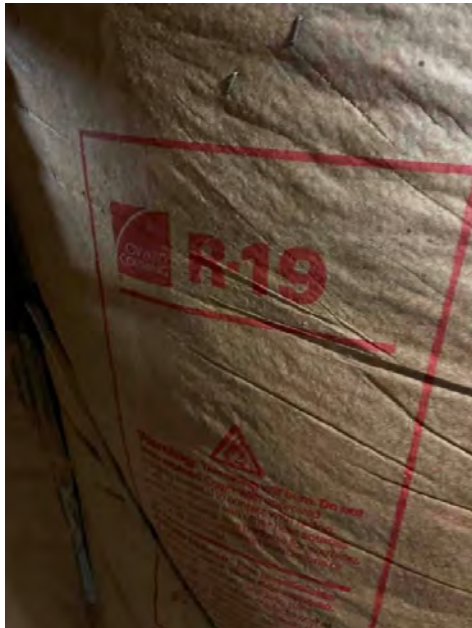
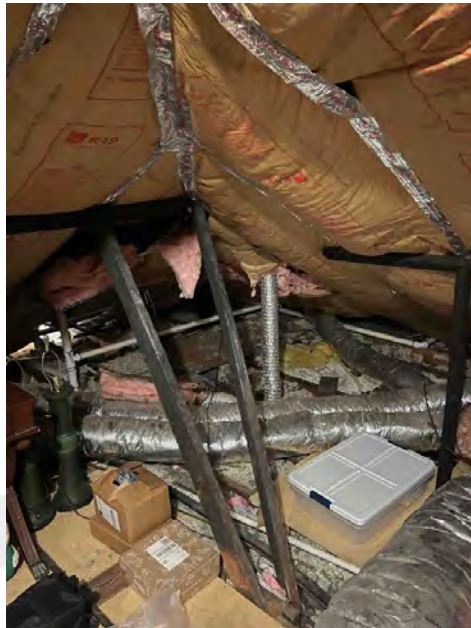
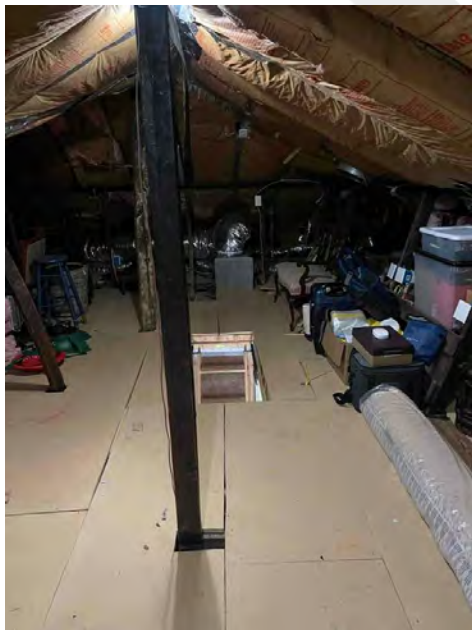
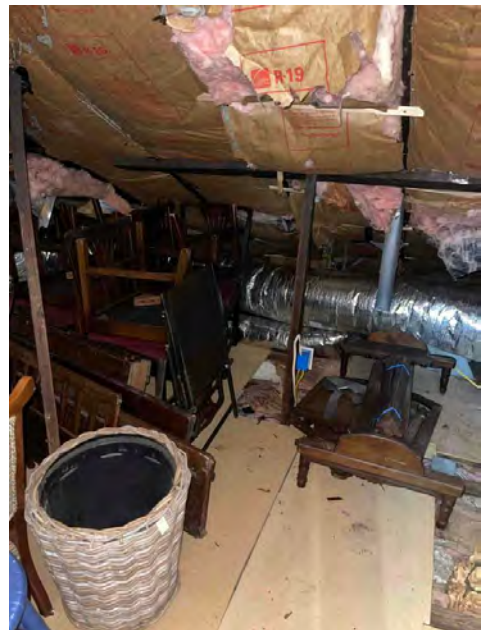
ADDITIONAL INSULATION RECOMMENDED

I recommend air sealing and adding insulation to the areas that need more insulation.

Contact a qualified insulation contractor.
