INSPECTION REPORT BY BIG BEN INSPECTIONS

123 Chamberlain St
Raleigh, NC 27607

Mary Jane
APRIL 13, 2023

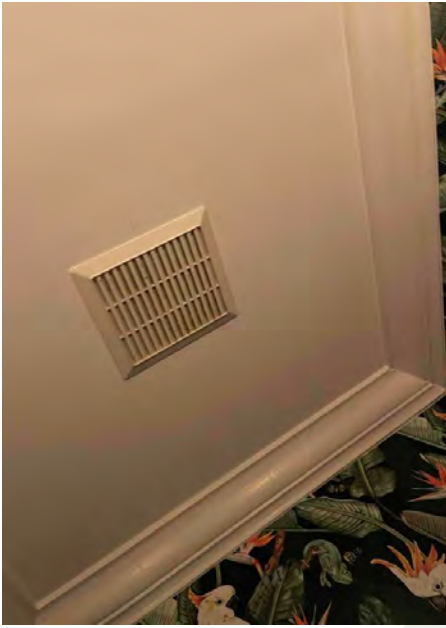
Bathroom Exhaust Fan / Window: Inspected Bath Exhaust Fans

I inspected the exhaust fans of the bathroom(s). All mechanical exhaust fans should terminate outside. Confirming that the fan exhausts outside is beyond the scope of a home inspection.

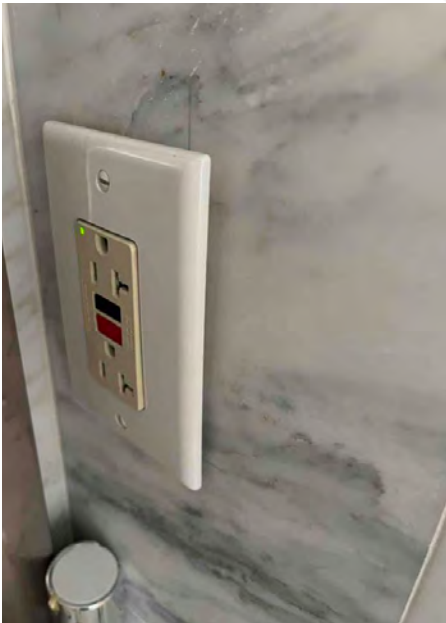
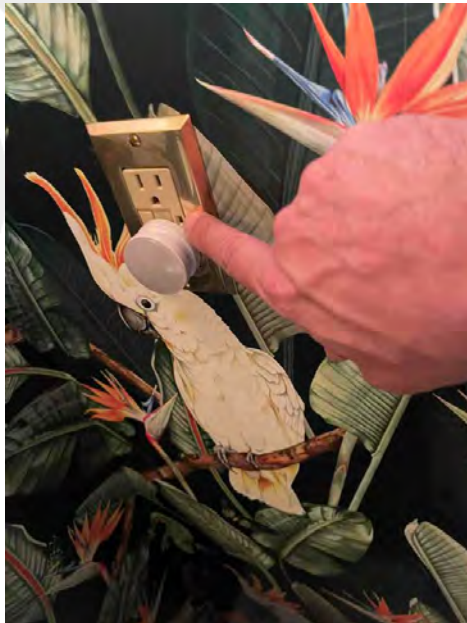
**GFCI & Electric in Bathroom: GFCI-Protection Tested**

I inspected the GFCI-protection at the receptacle near the bathroom sink by pushing the test button at the GFCI device or using a GFCI testing instrument.

All receptacles in the bathroom must be GFCI protected.

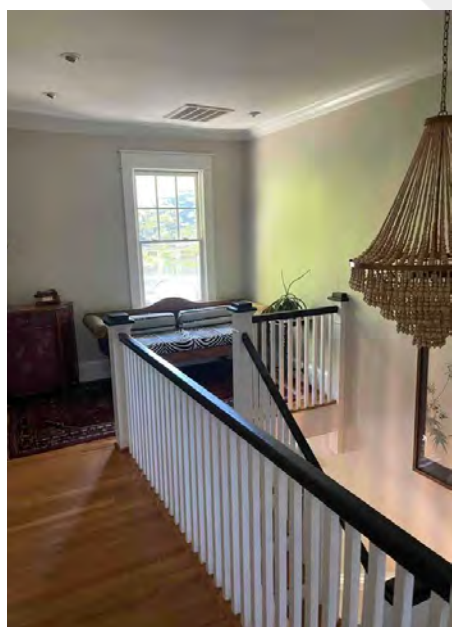
I inspected the stairs, steps, stoops, stairways and ramps that were within the scope of my home inspection.

All treads should be level and secure. Riser heights and tread depths should be as uniform as possible. As a guide, stairs must have a maximum riser of 7-3/4 inches and a minimum tread of 10 inches.

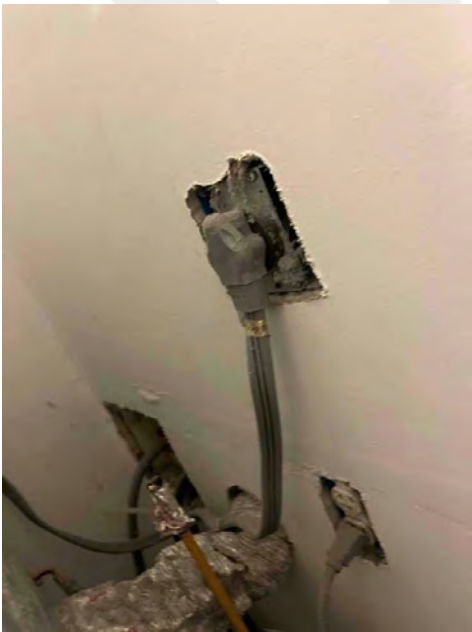
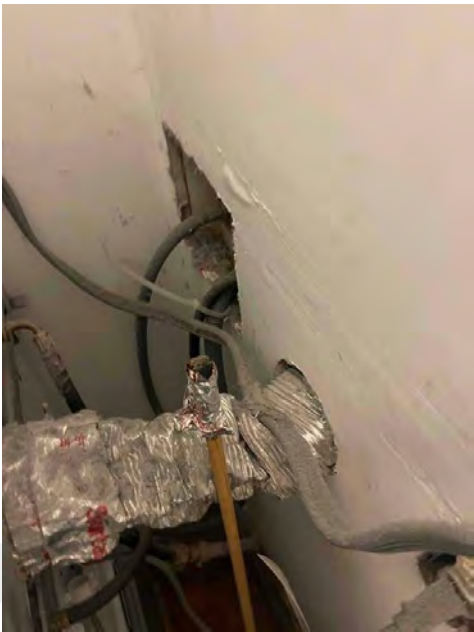
I observed hoses that were not reliable. Not pressure tested. Replacement of the hoses is recommended.

Recommendation
Recommended DIY Project

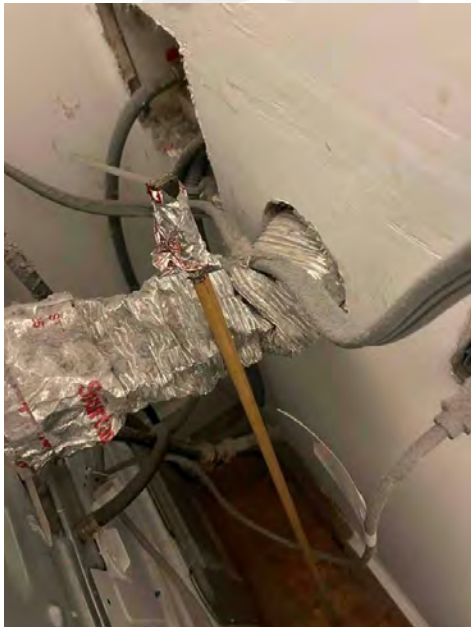
DAMAGED DRYER EXHAUST PIPE

I observed indications of a damaged exhaust pipe of the clothes dryer.

Contact a qualified appliance repair professional.

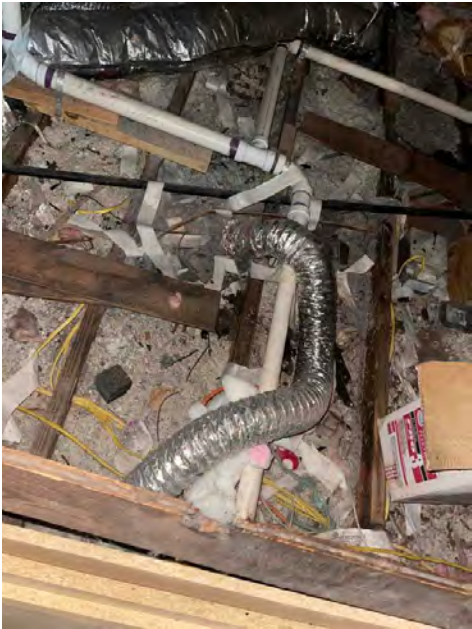
DRYER NOT EXHAUSTING OUTSIDE

I observed indications that the clothes dryer is not exhausting outside.

Contact a qualified appliance repair professional.

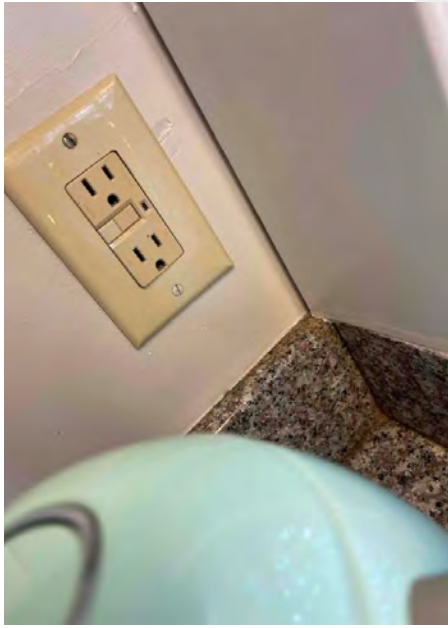
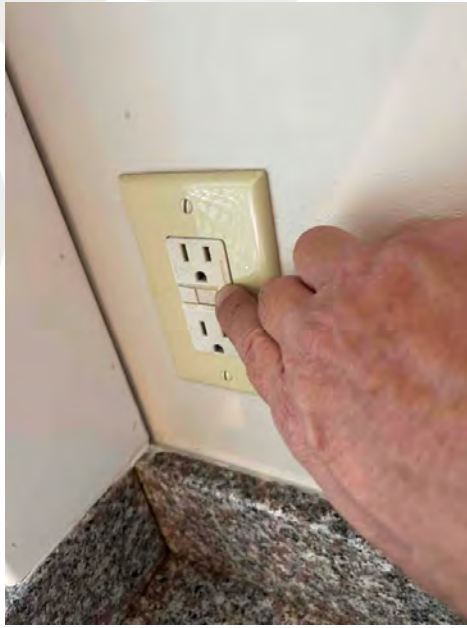
GFCI: GFCI Tested

I observed ground fault circuit interrupter (GFCI) protection in the kitchen.
