The lake assessments are created in partnership with Hillsborough County and the Florida Center for Community Design and Research
LAKE ASSESSMENT DOCUMENT

Lake Carlton 8/8/00 Watershed: Rocky/ Brushy Creek

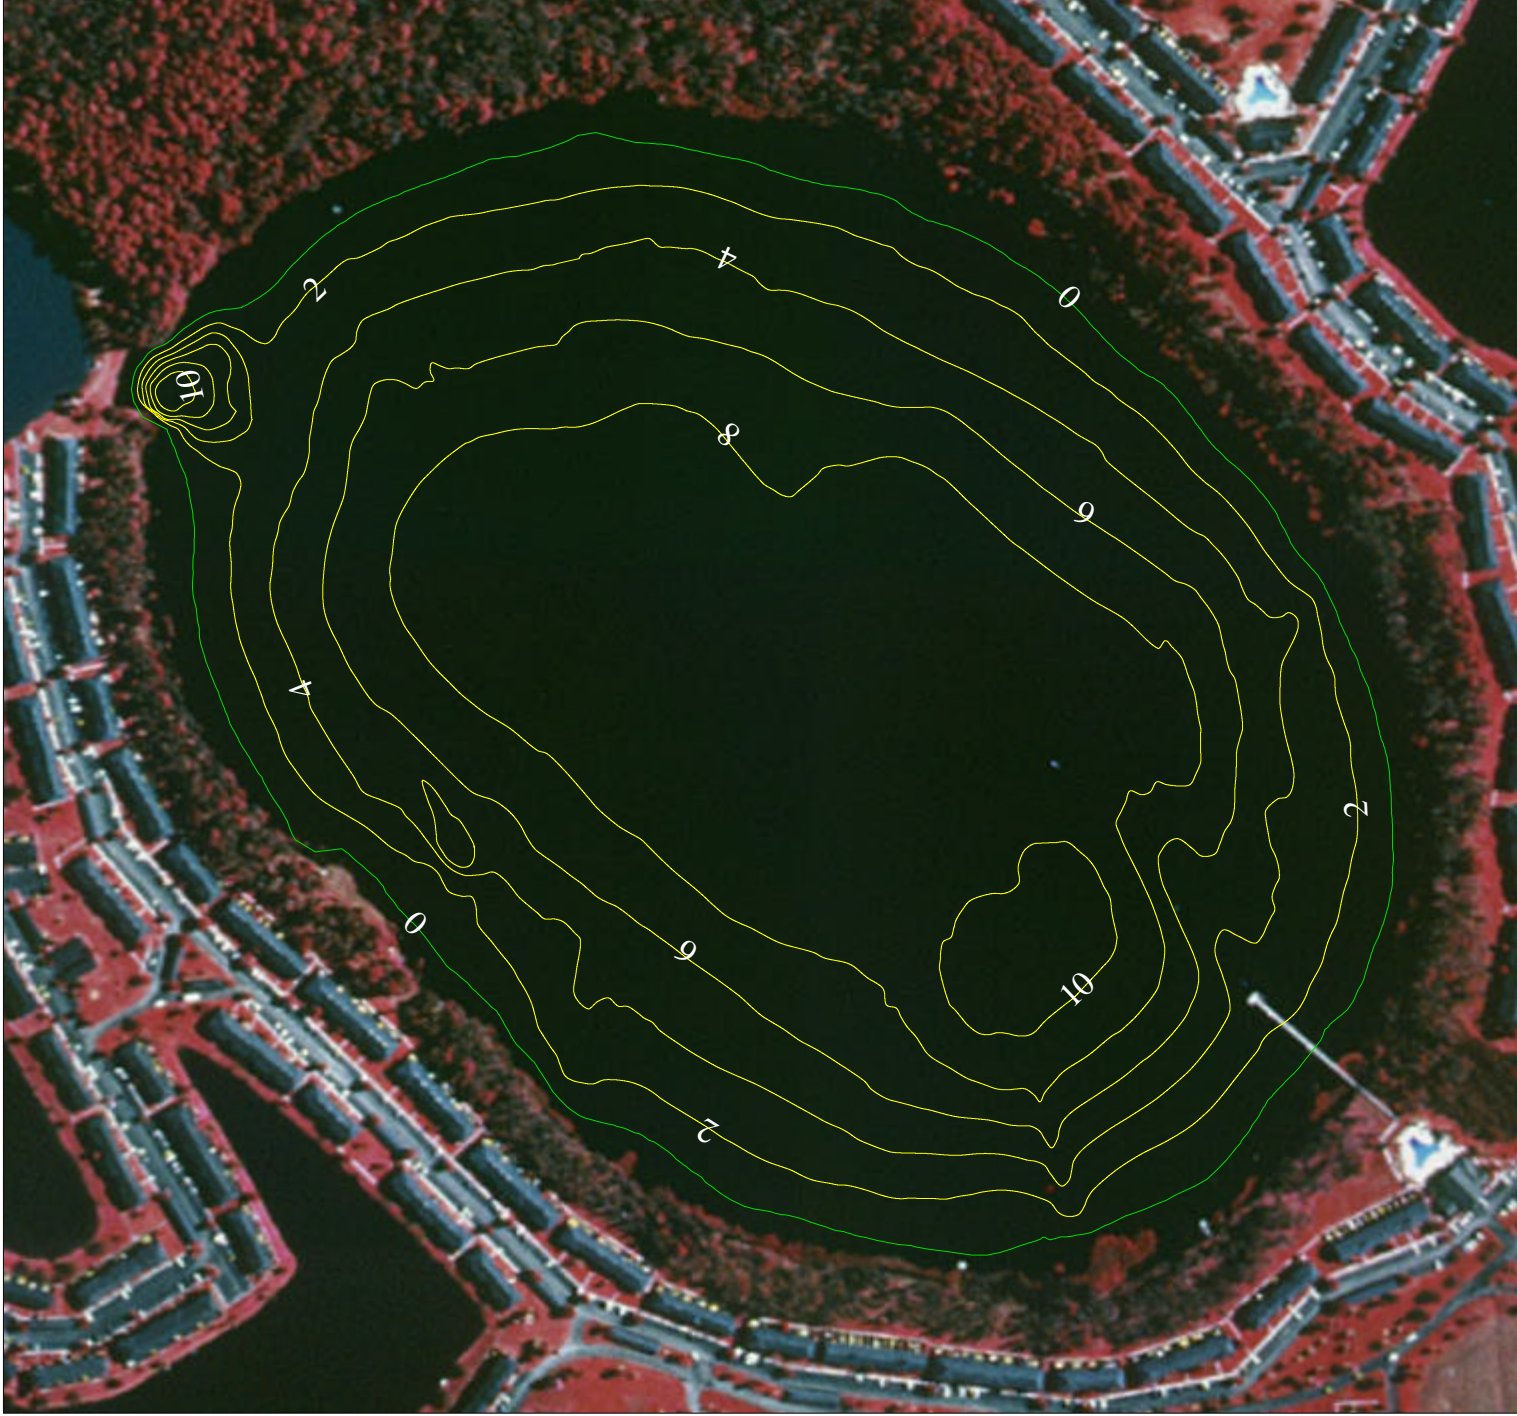
Lake Carlton

Survey Date: August 8, 2000

Lake water level was 50.02 ft above sea level when the lake was surveyed. Contours are expressed in absolute depth below this level.

Digital orthophotos by United States Geological Survey. All contours generated by Florida Center for Community Design and Research based on survey data provided by the Hillsborough County Lake Management Program.

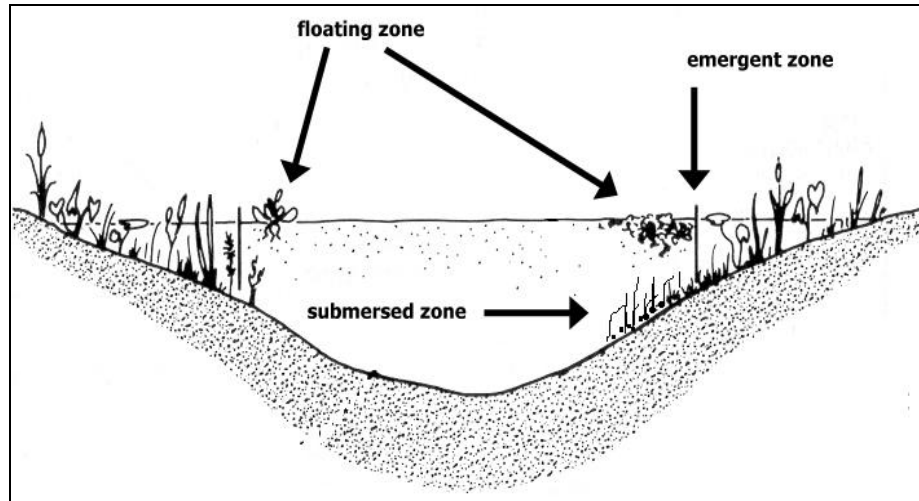
In addition to an overall survey of the types of plants on a lake, an estimate of the standing crop (biomass) of the lake has been obtained for many lakes. This was done by calculating the average weight of the vegetation within a quarter-meter square quadrat tossed haphazardly into three zones (see Figure) at each sampling site around the lake: (1) the emergent zone, (2) the floating zone and (3) the submersed zone. The average weight of the plants (Table 4) from all sampling sites and the dominant type of vegetation (Table 5) are provided. If data tables are not shown, no standing crop estimates were obtained for this lake.
