The Allegheny Ridge Wind Project on the Allegheny Front is in an Important Bird Area. These photos were taken in the headwaters of Bob's Creek, which is classified as a class A "wild trout stream" by PA Fish and Boat Commission and serves as a high quality, cold-water fishery. Photos were taken in late March, 2008, unless specified otherwise.

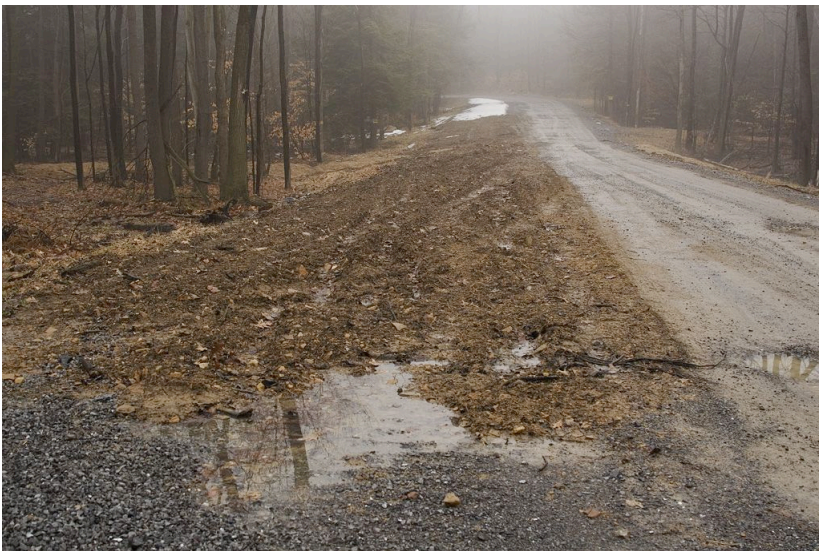
Soil that was spread on top of the gravel along this section of the road is eroding away.

Fiber mats were used to stabilize the banks along this watercourse.

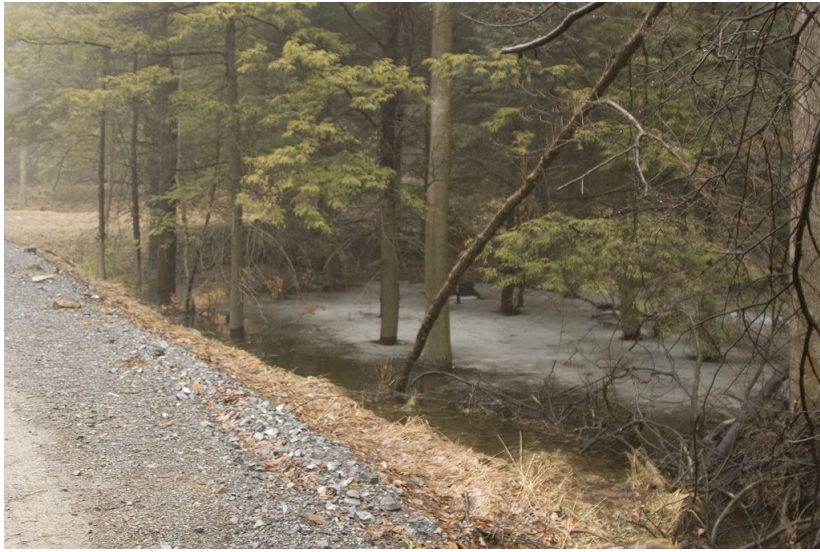
The new roadway blocks the natural flow of surface water in this area. Trees not adapted to such wet conditions are dying.

Since this section of roadway was not “crowned” properly, it serves as the main channel for runoff.

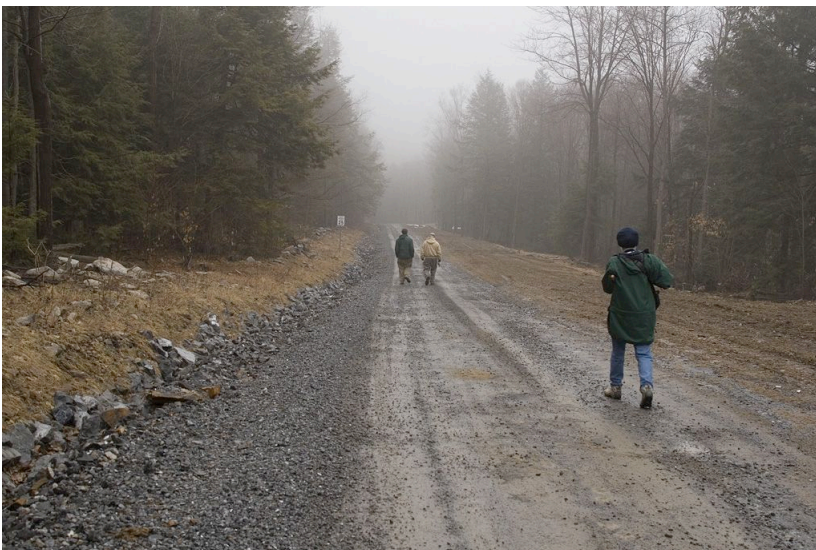
Wide, 100 – 150 ft. corridors cut through the forest, act as avenues for invasive plants and animals, and impede natural migrations of invertebrates and amphibians.

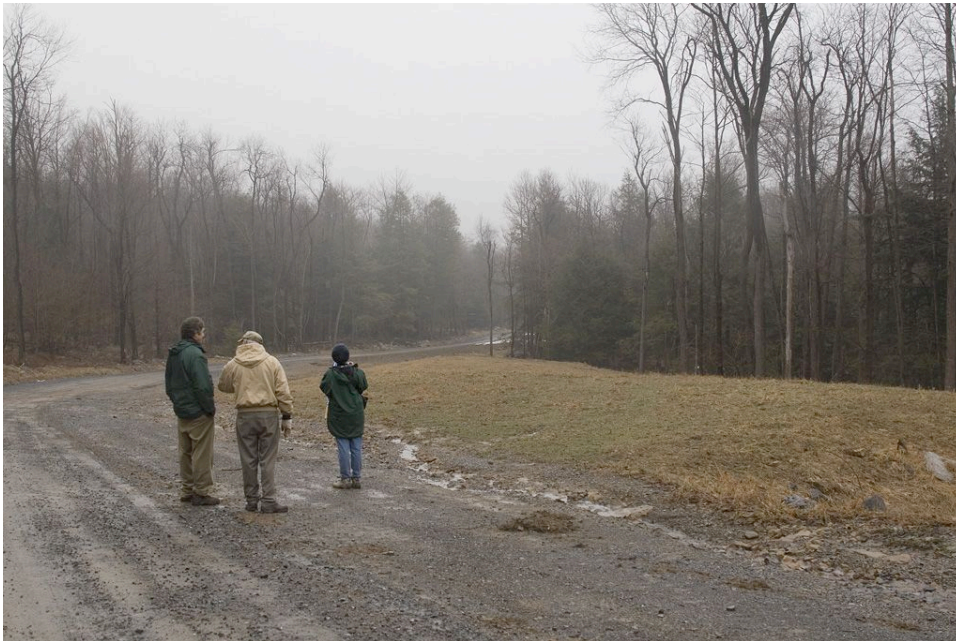
The needless cutting of the forest on this curve of road served as a dumping area for the rock and soil from a steep bank cut on the other side of the road. This area was also used as a dumping group for stumps. Note that water is channeled onto the road due to improper sloping of the mounded dirt.

This clearing measured 150 feet wide.

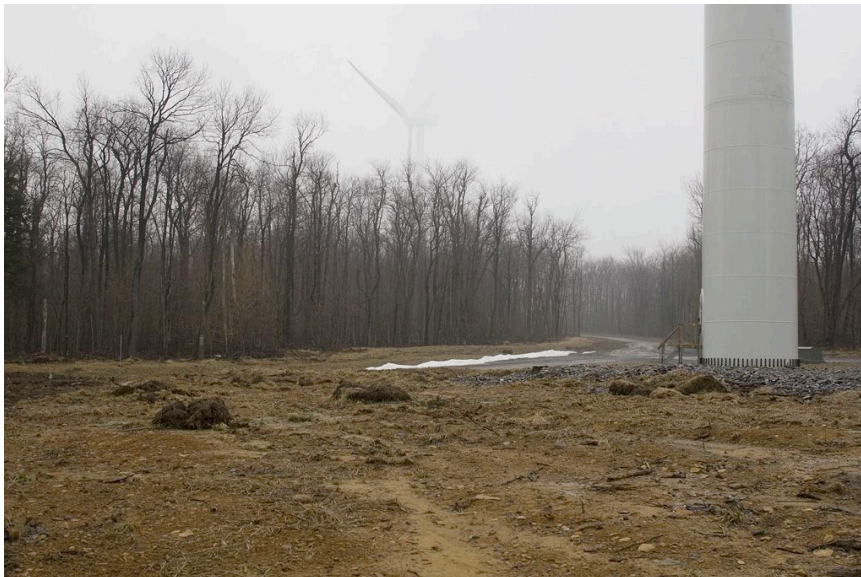
Straw bales were placed in this disturbed area around a turbine, but were never used to stabilize the soil.

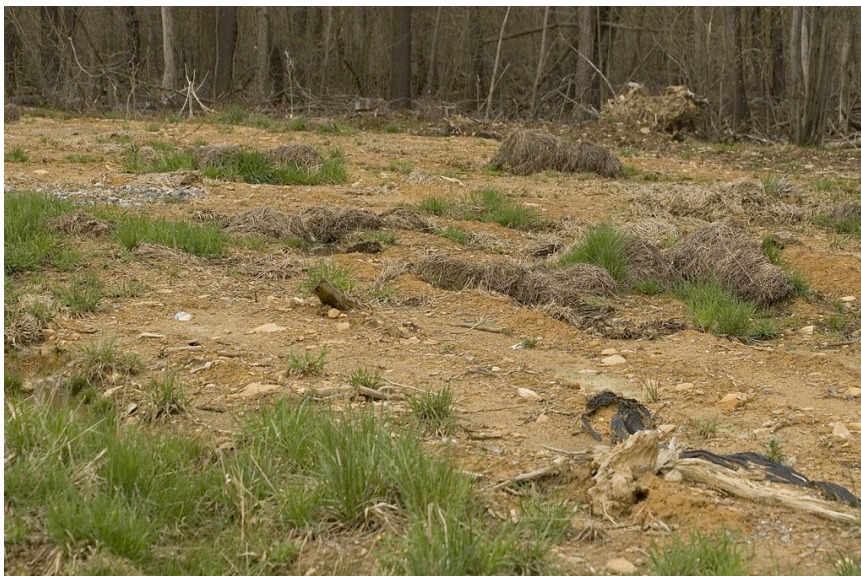
This is the same area showing the rotting straw bales, but taken one month later than the preceding photo.

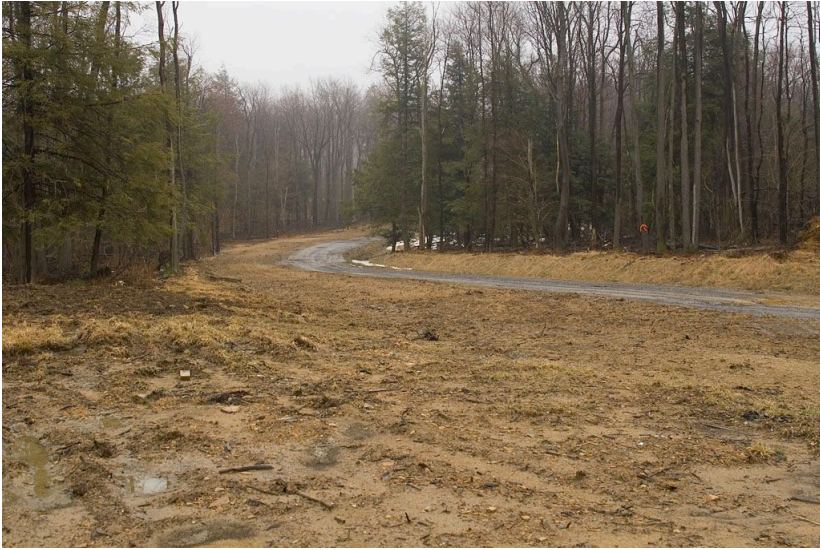
Are these best management practices? Runoff is channeled into a ditch along the road with 433 yards between culverts. Where is the wildlife mix that is supposed to be seeded as a ground cover?

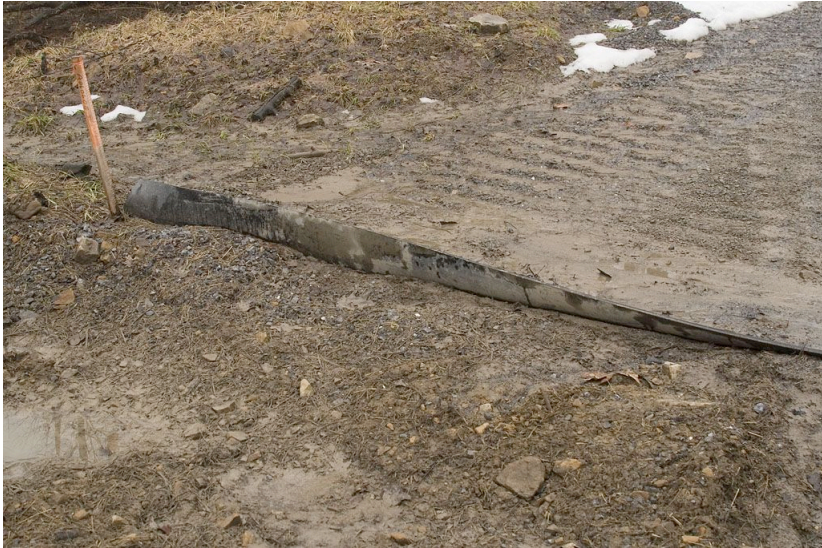
Thin strips of rubber are embedded across the road, but ineffective in stopping sediment-laden runoff.

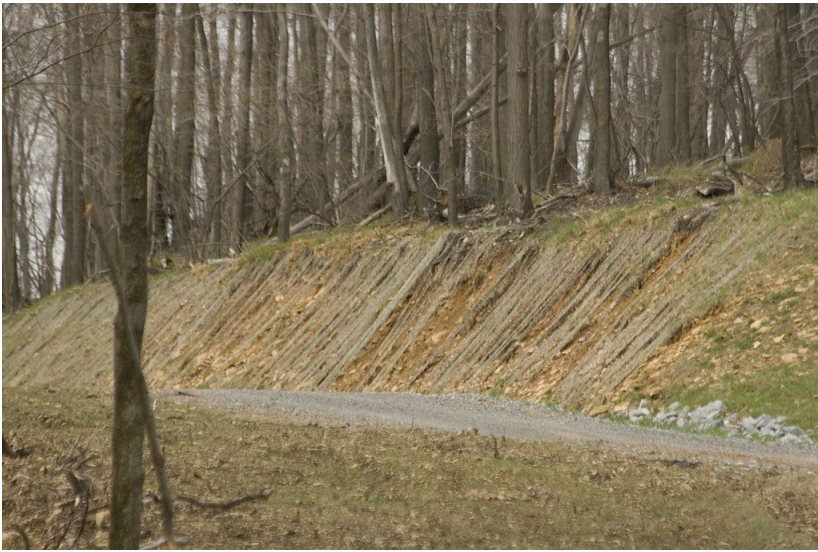
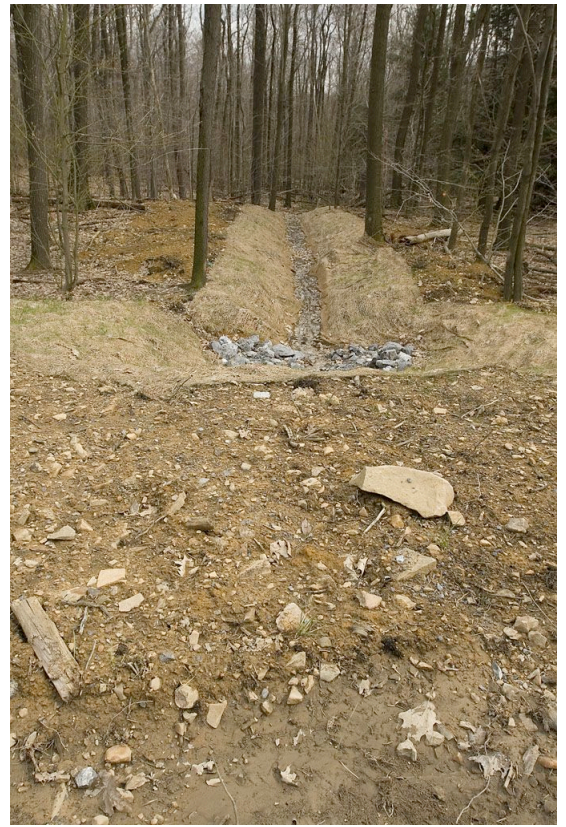
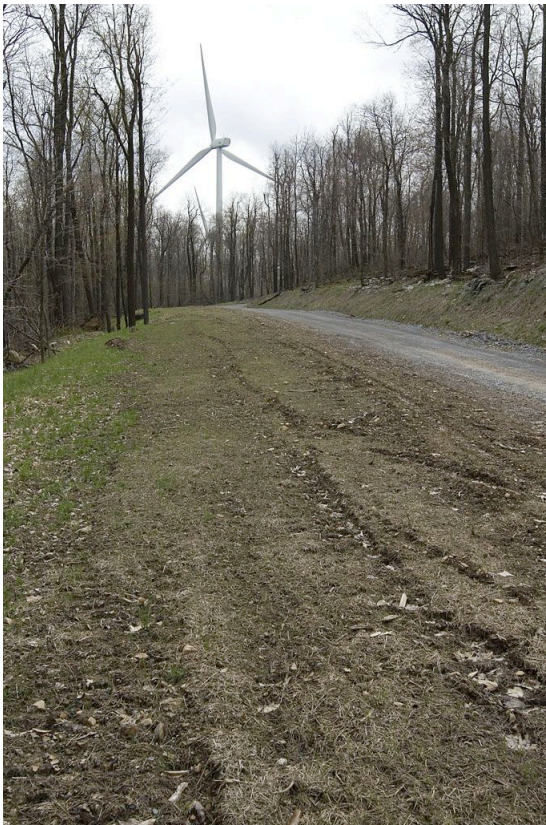
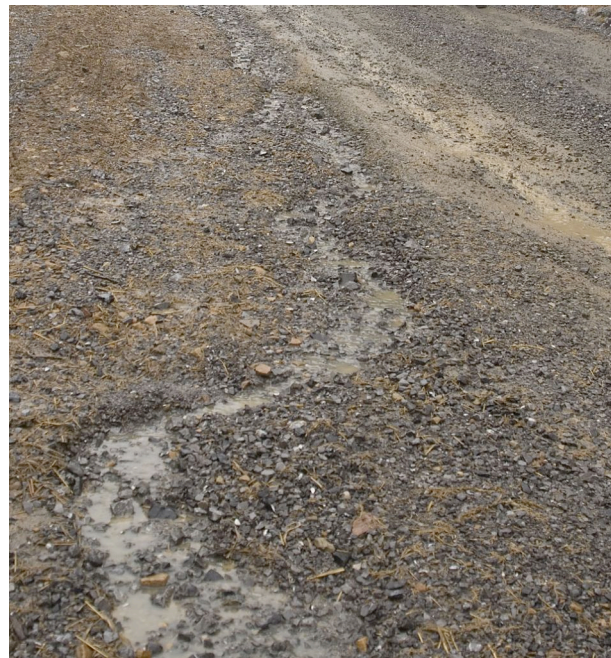
Erosion and sedimentation controls are ineffective, poorly designed, and inadequate for a watershed of this caliber. Cleared areas ranged from 41 feet to 150 feet in width. Some of the corridors included a thin layer of topsoil tailgated in place beside the roadbed, but much of it is exposed soil, vulnerable to erosion.
