CUPRA TAVASCAN

ANCAP SAFETY

TESTED 2024

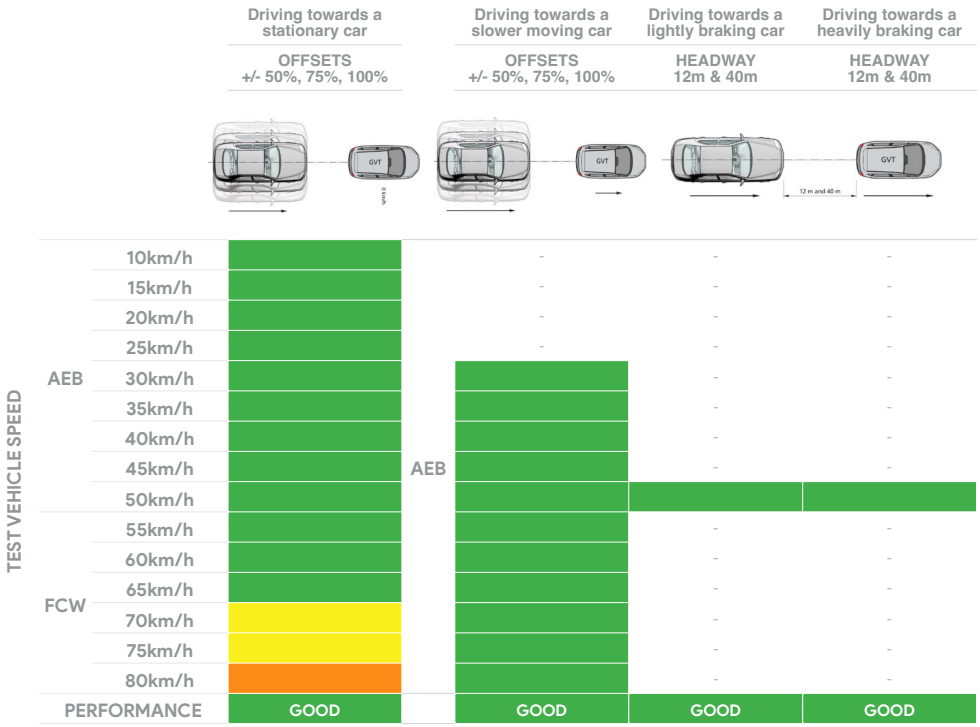
AUTONOMOUS EMERGENCY BRAKING (Car-to-Car)

Tests of the **AEB (Car-to-Car)** system showed GOOD performance with collisions avoided or mitigated in all car-to-car rear scenarios, as well as **AEB Junction** and some **AEB Crossing** scenarios where the test vehicle can autonomously brake to avoid crashes when turning across or into the path of an oncoming vehicle. Tests of **AEB Head-On** functionality showed ADEQUATE performance.

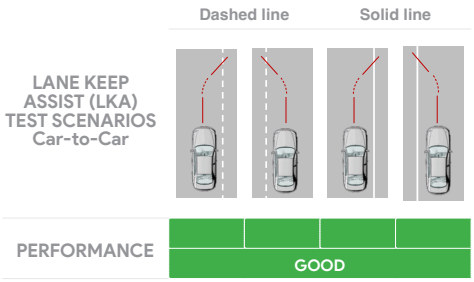
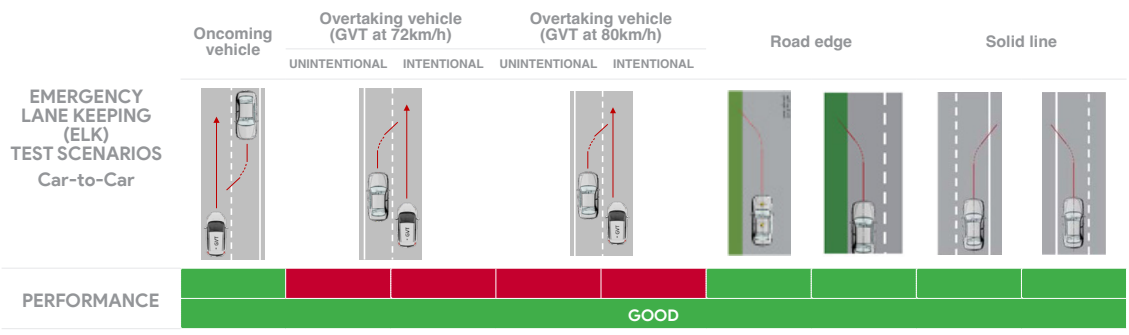
LANE SUPPORT SYSTEMS (Car-to-Car)

Tests of LSS functionality showed GOOD performance in lane keep assist scenarios, including in some of the more critical emergency lane keeping test scenarios.
