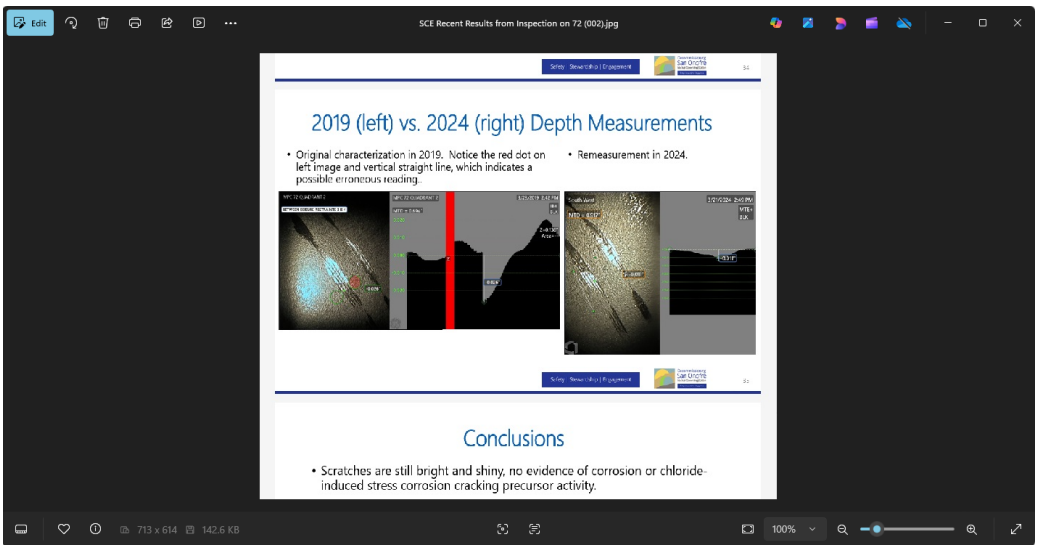
Edit
Canister-Gouging (002).jpg
MPC 72 QUADRANT 2
3/23/2019 11:07 AM
BETWEEN SEISMIC RESTRAINTS 3 & 4
786 x 599
306 KB
100%

Edit
SCE Recent Results from Inspection on 72 (002).jpg
2019 (left) vs. 2024 (right) Depth Measurements
• Original characterization in 2019. Notice the red dot on left image and vertical straight line, which indicates a possible erroneous reading.
• Remeasurement in 2024.
Conclusions
• Scratches are still bright and shiny, no evidence of corrosion or chloride-induced stress corrosion cracking precursor activity.
713 x 614
142.6 KB
100%
