TOYOTA LEXUS SCION

CRIB COLLISION REPAIR INFORMATION

TITLE:	**Scanning for Electrical System Faults**	**2016-191**
SECTION:	**Electrical**	Page 1 of 1
APPLICABLE VEHICLES:	**All Toyota, Lexus and Scion Models**	
DATE:	**July 2016**

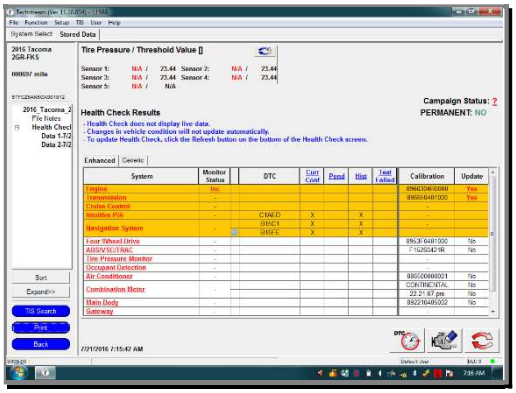
No MIL Illuminated →

DTCs found during Health Check

Considering the fact that a capable scan tool is the only way to identify some DTCs, Toyota requires that repairers perform a "Health Check" diagnostic scan if a vehicle has sustained damage as a result of a collision that may affect electrical systems. Additionally, Toyota strongly recommends that repairers perform a "Health Check" diagnostic scan before and after every repair to identify and document DTCs. If DTCs are identified pre-repair, then they can be considered to create a complete vehicle damage analysis report. If DTCs are identified post-repair, then they can be diagnosed and addressed before returning a vehicle to the customer.
