WOOD DESTROYING PESTS AND ORGANISMS INSPECTION REPORT

Building Address:	Date of Inspection	Number of Pages
6475 Malcolm Dr., San Diego, CA 92115	09/03/2026	6

Report # W22021
Lic. Registration # PR 10079
Escrow #

General Description:
Two story single family residence, raised foundation, shingle roof.

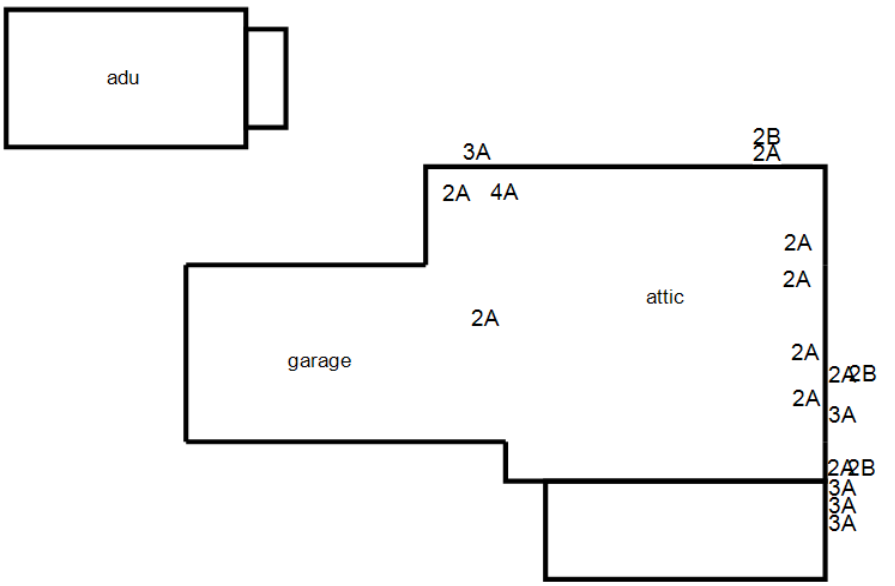
This Diagram is not to scale

2A PRICE: $800.00 (Section I)
FINDINGS: Evidence of drywood termite infestation noted at roof eaves, window frame, window sill, and subarea as indicated by 2A on the diagram.
RECOMMENDATION: Chemically treat visible and accessible infestations. Remove or cover accessible pellets. 4-year guarantee.

2B PRICE: $995.00 (Section I)
FINDINGS: Evidence of termite damage noted at roof eaves, rafter tails, window frame, and window sill as indicated by 2B on the diagram.
RECOMMENDATION: Repair or replace termite damage at roof eaves, rafter tails, window frame, and window sill. Diverse will apply one (1) coat of primer or similar matching paint to newly replaced/repaired wood member(s) at no additional charge. 4-year guarantee.

3A PRICE: See 2B (Section I)
FINDINGS: Fungus damage and/or dry-rot noted at roof sheathing, fascia, window trim, and window frame as indicated by 3A on the diagram.
RECOMMENDATION: Replace fungus damage and/or dry-rot at roof sheathing, fascia, window trim, and window frame. Diverse will apply one (1) coat of primer or similar matching paint to newly replaced/repaired wood member(s) at no additional charge. 4-year guarantee.

4A PRICE: Not Estimated (Section II)
FINDINGS: Water stains noted at ceiling as indicated by 4A on the diagram.
RECOMMENDATION: Contractor to inspect and give recommendations if any.
