**Analysis of Water Quality Impacts at
the Buckhorn Mountain Mine and
Recommendations for Improvement**
Final Report

Prepared for:
Okanogan Highlands Alliance

Stratus Consulting Inc.
PO Box 4059
Boulder, CO 80306-4059
303-381-8000

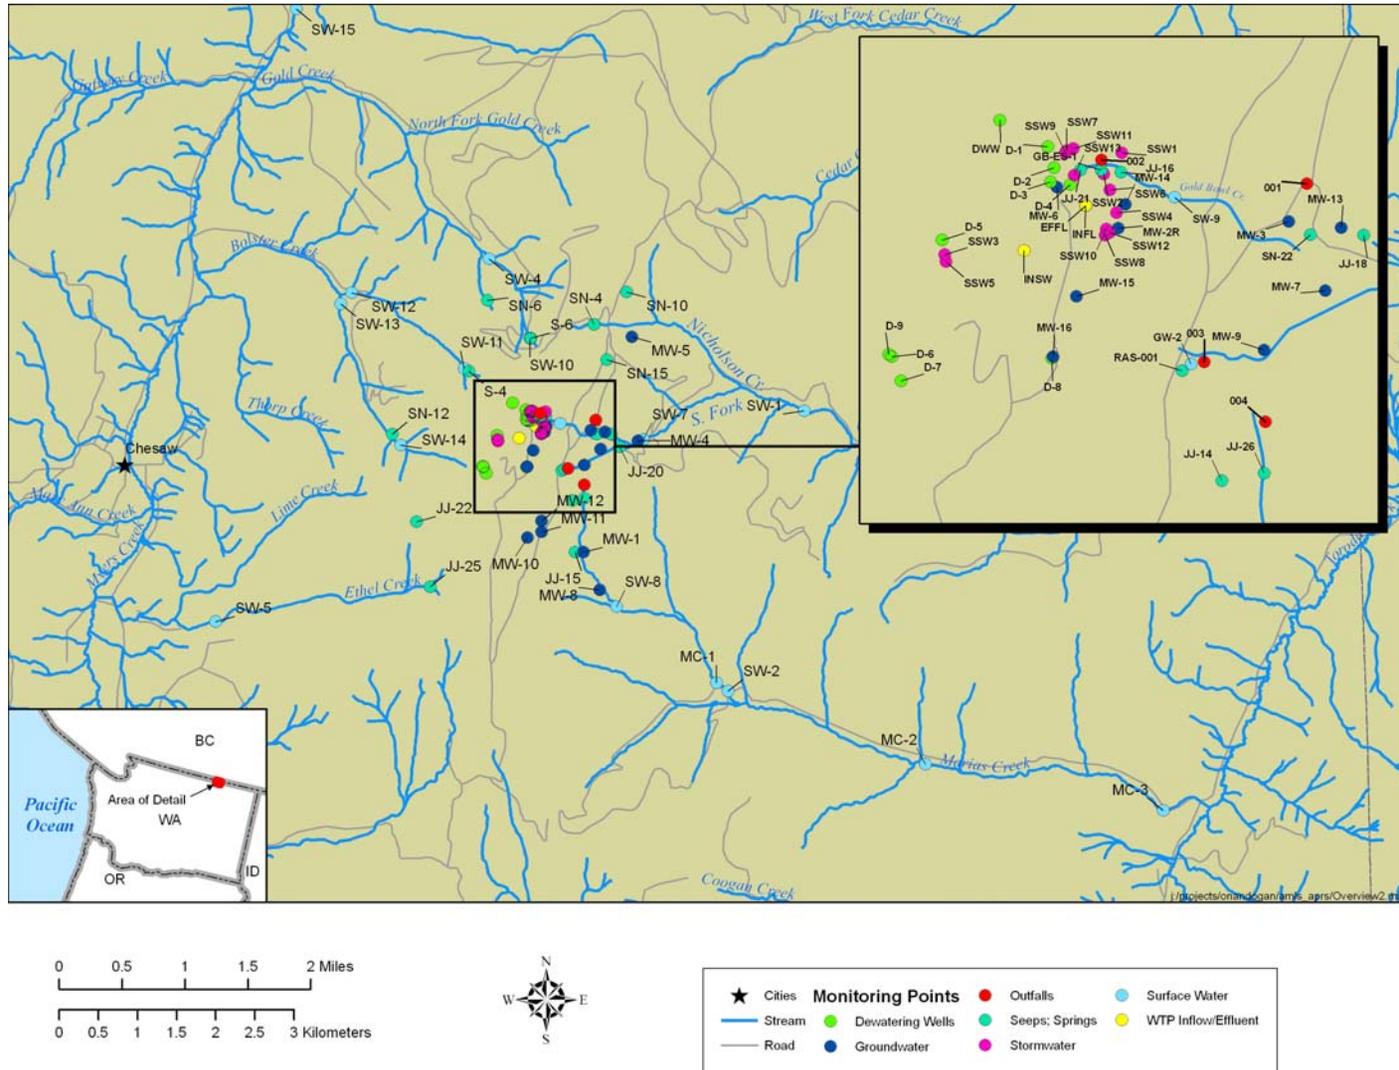
Figure 1. Monitoring location overview.

The mine has used Outfalls 1, 2, 3, and 4 for discharge of treated effluent since mining began (see Figure 1 for locations). The majority of the effluent has been discharged to Outfall 2, located in the headwaters of Gold Bowl Creek. Outfall 1 is the infiltration gallery, Outfall 3 is located at the Roosevelt Adit (Nicholson Creek drainage), and Outfall 4 is below the stock tank in the Marias Creek drainage basin. All outfalls are located on the east side of the mine.

As shown in Figure 4, concentrations of chloride and nitrate+nitrite increased in South Fork Nicholson Creek (SW7), Gold Bowl Creek (SW9), and Upper South Fork Bolster Creek (SW14) shortly after mining and effluent discharge to Outfall 002 began. Concentrations of mine-related contaminants are higher in SW9, which is located closer to the mine and the effluent discharge location (see Figure 1 for location of Outfall 002).
